The lost digit - Buk 3x2

A bellngcat Investigation

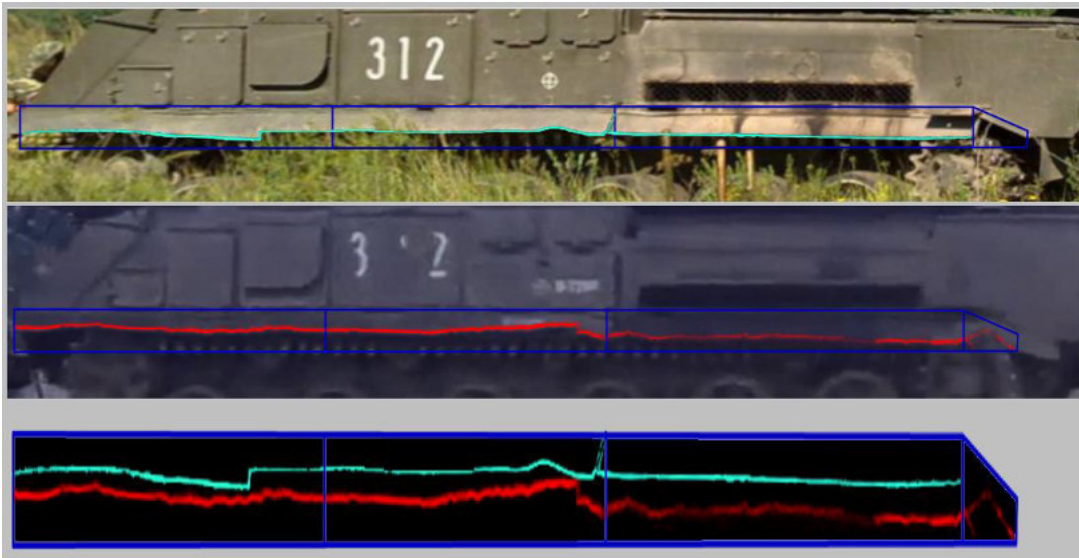
"Fingerprint" comparison between Buk 312 and Buk 3x2

Below are the three comparisons for each of the three Buks. It can be seen that each Buk has its own distinctive features and side skirt profile. The direct comparison reveals that none of the three Buks can be conclusively identified as 3x2 by only using this methodology. For each Buk, there are visible differences in the visible "wave form."

Obviously, the expectable similarity of the side skirt fingerprint depends on the passed time between the used materials for the comparison. The reason for the decreasing likelihood of an identical side skirt fingerprint is that the likelihood of an event affecting the visible wave form will be higher if more time passed. A repair of damaged parts or new damage occurred in exercises are two potential and obvious causes for an observed different wave form. Therefore, while it is possible that a certain wave form is visible for some years, this cannot necessarily be expected in all cases.

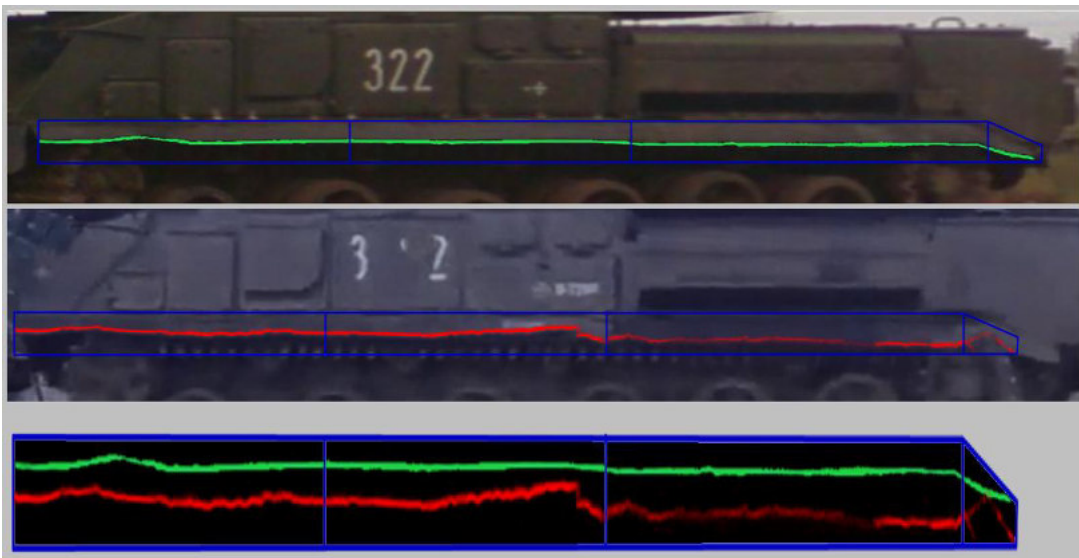
"Fingerprint" comparison between Buk 322 and Buk 3x2

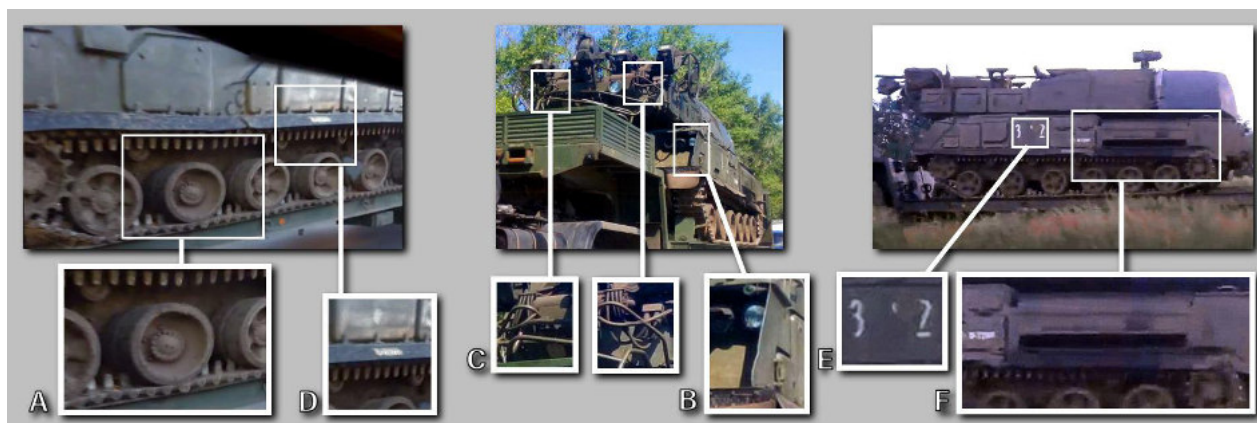
Individual features of Buk 3x2 – Details of video and photos^{20 21 22}

- A: wheel type (combination of hollow wheels and spoke wheels)
- B: dent in the left side panel
- C: arrangement of cable connections to the missile erector
- D: white mark on both side skirts
- E: font and exact spacing of digits
- F: shape and size of oil/soot deposits by exhaust

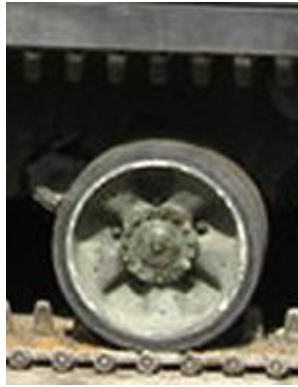
Spoke wheel

²⁴ For the purpose of this report, these two types of wheels will be called spoke and hollow wheels. The spoke wheel has five radial reinforcing ribs, and the hollow wheel is axially symmetrical without ribs.

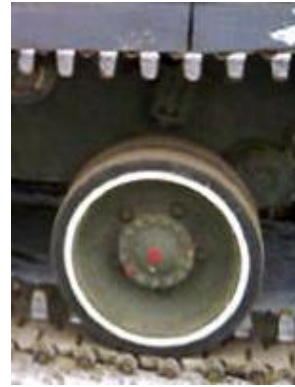
Hollow wheel

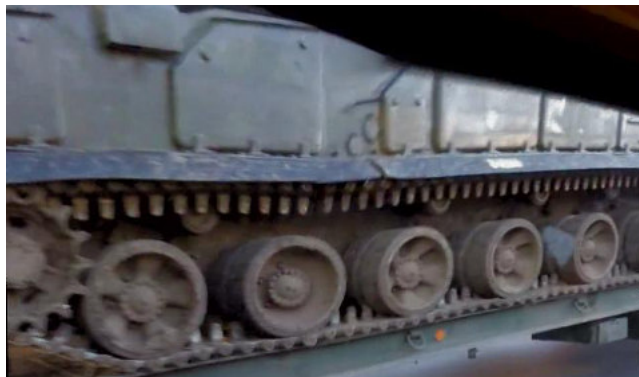
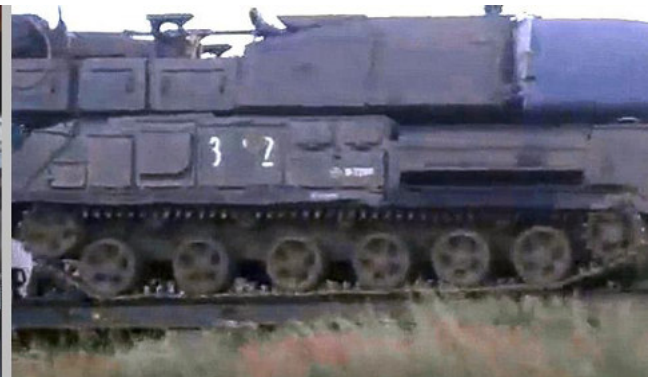
Buk 3x2 road wheels, right side²⁷

Buk 3x2 road wheels, left side²⁸

It is noticeable that Buk 3x2 has almost exclusively spoked wheels; however, at least one wheel is hollow.²⁹ This hollow wheel is located on the right at the second position from the left. It is not possible to identify the type of the last wheel on the right side.

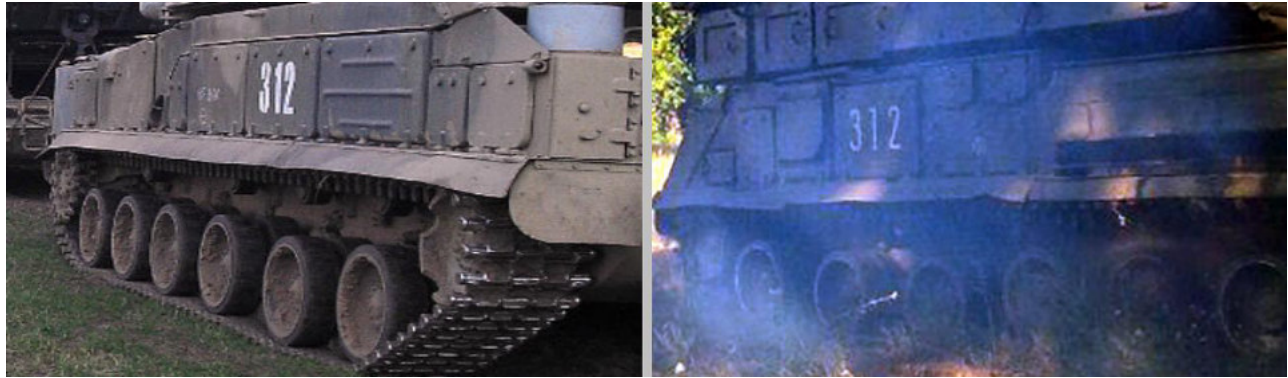
Buk 312 has exclusively hollow wheels. The exact arrangement and type of wheels for Buk 312 can be seen below:

Buk 312 road wheels, right side ³⁰

Buk 312 road wheels, left side ³¹

This comparison shows that Buk 312 can be excluded, since it has only hollow wheels. It seems implausible that 11 wheels were replaced before June 2014. Buk 322 has only spoke wheels and missed the hollow wheel on the right side. Buk 332, however, has the exact same visible wheel profile as 3x2: all spoked wheels, except for the second wheel on the right side being hollow.

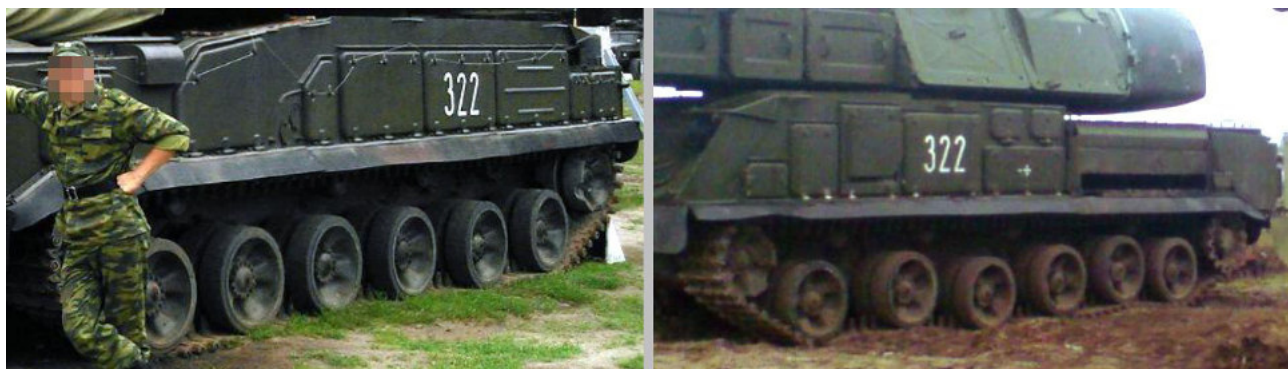
Buk 322 has exclusively spoked wheels. The arrangement and type of road wheels for Buk 322 can be seen below:

Buk 322 road wheels, right side ³²

Buk 322 road wheels, left side ³³

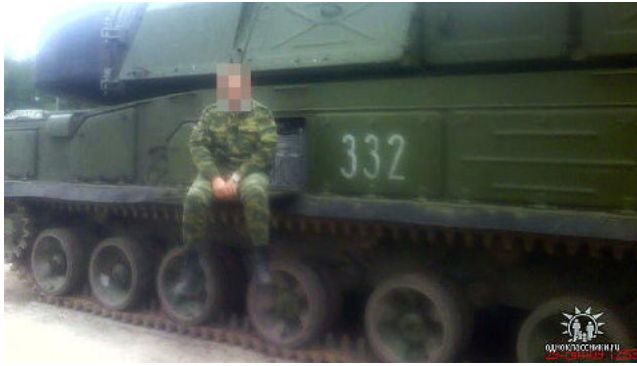
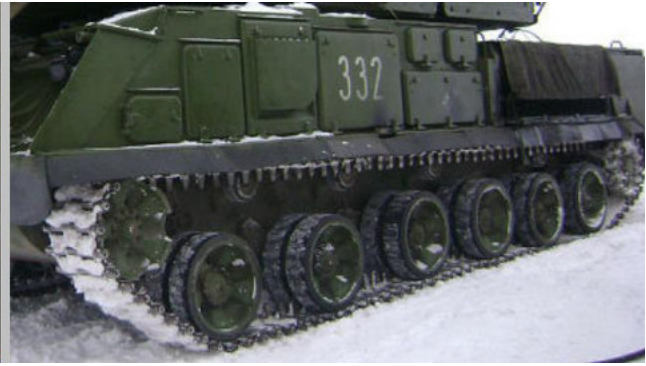
Buk 332 has exclusively spoked wheels except for a wheel on the right side. The roller on the second position on the right side is a hollow wheel. The arrangement and type of wheels for Buk 332 can be seen below:

Buk 332 road wheels, right side ^{34 35}

Buk 332 road wheels, left side ³⁶

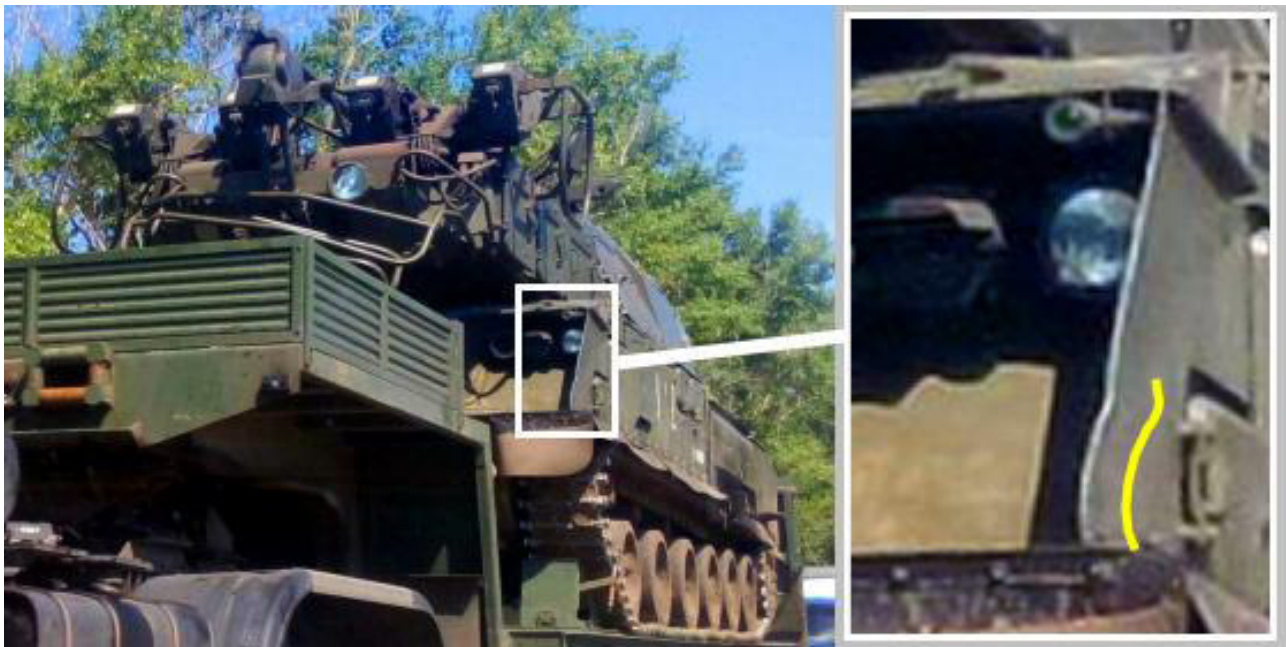
On a photo of Buk 3x2 taken near Alexeevka, Russia, an inverted S-shaped dent is visible on the left side panel. Below is an image from the June convoy and a highlighting of the damage. Only the lower part of the side panel is damaged with a quite specific shape, making this damage suitable for a comparison.

Buk 3x2 – Dent in the side panel ³⁷

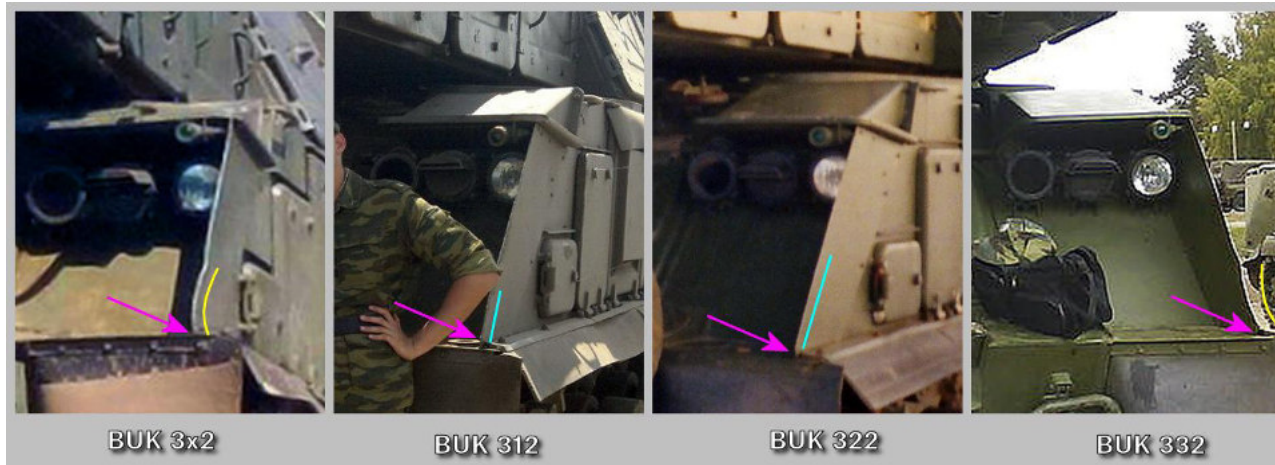
Compare - Dent in the side panel - Details of photos^{38 39 40 41}

The comparison clearly shows that only the side panel of Buk 332 shows the same type of damage. The damaged area of the side panel appears near identical compared to Buk 3x2.

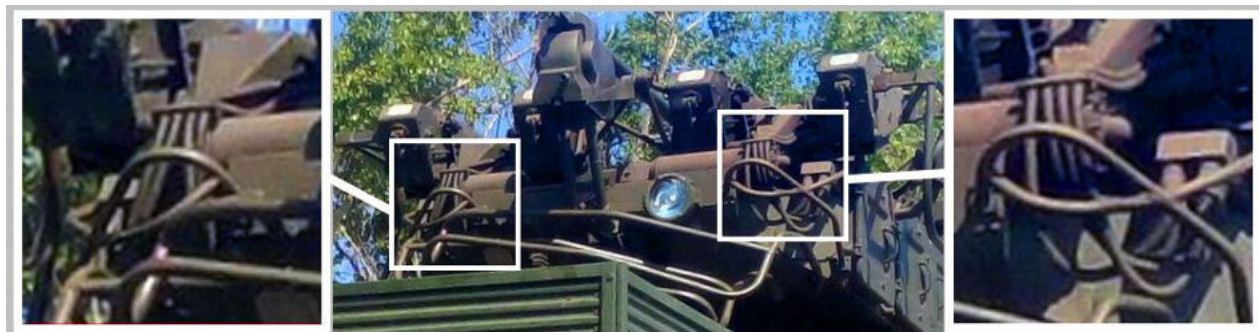
On the revolving turret of the Buk is a cable connection, where on each side there are four cables leading to the missile erector. In total, there are eight cables which can be compared.

Buk 3x2 - Cables connection to the missile erector - Details of photo⁴²

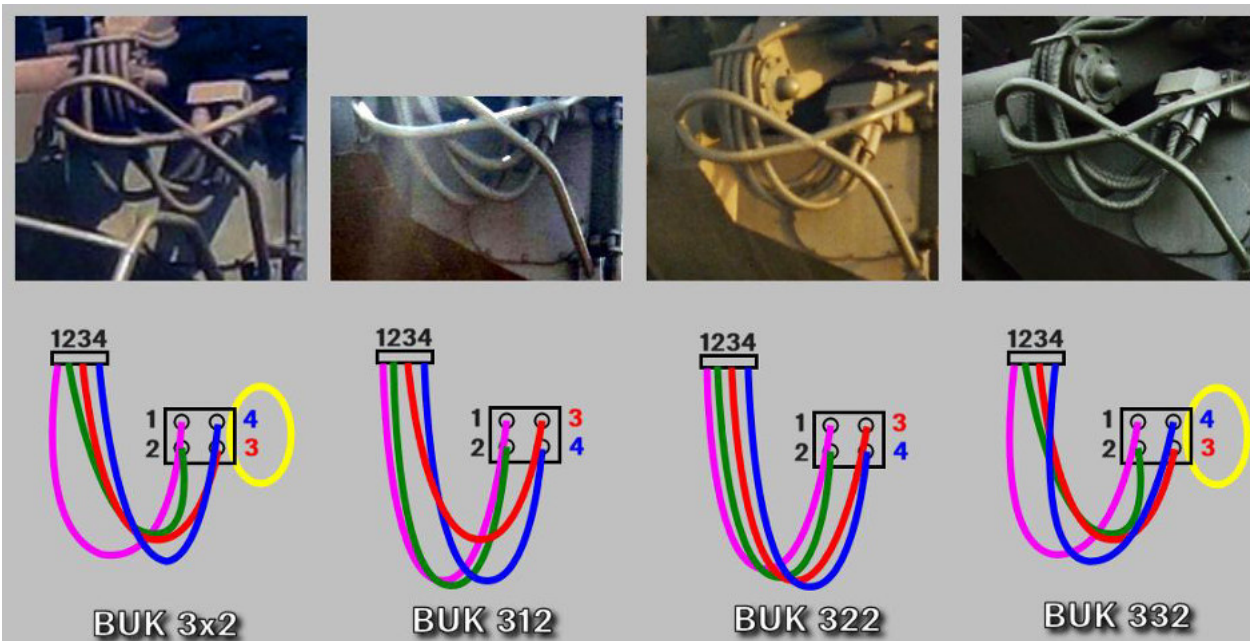
Buks 3x2, 312, 322 and 332 - cable connection on the right side - Details of photos ^{43 44 45 46}

Only Buk 332 has similarities with Buk 3x2's cables and connections. The blue-marked cable four is connected to the top plug on the turret chassis. Buk 312 and 322 show a different cabling, and cable four is connected to the bottom plug. Also, Buk 312, 322 and 332 show a distinct shape of the cabling, and only the shape of Buk 332 resembles that of the cabling of 3x2.

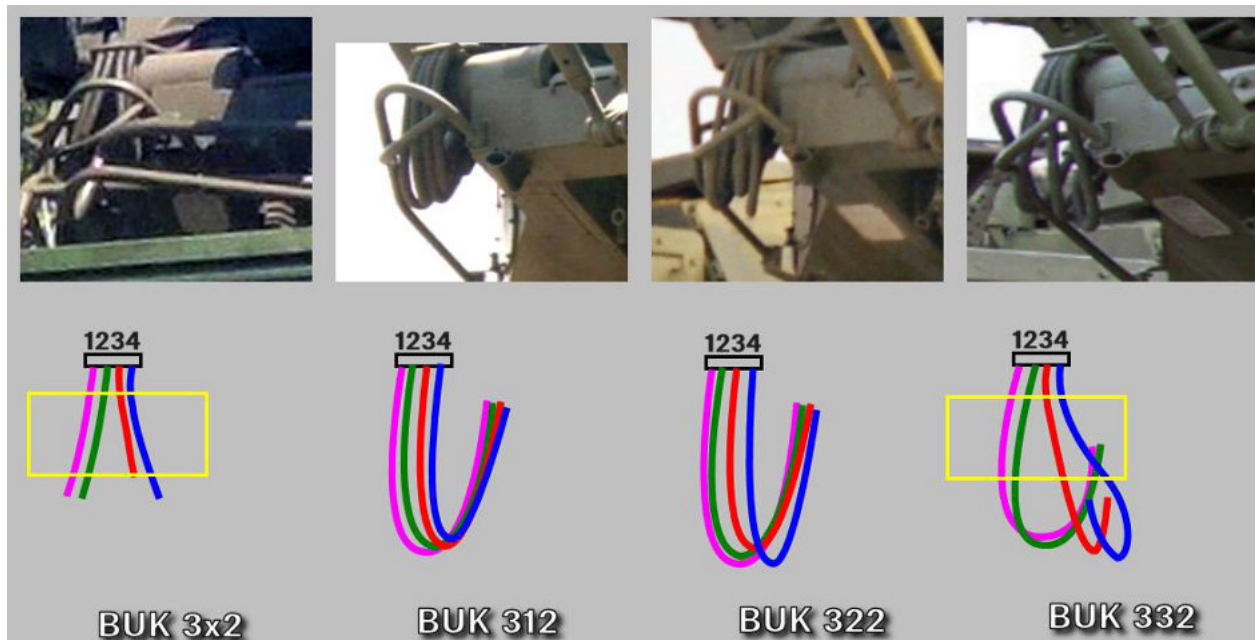
Buks 3x2, 312, 322 and 332 - cable connection on the left side - Details of photos ^{47 48 49}

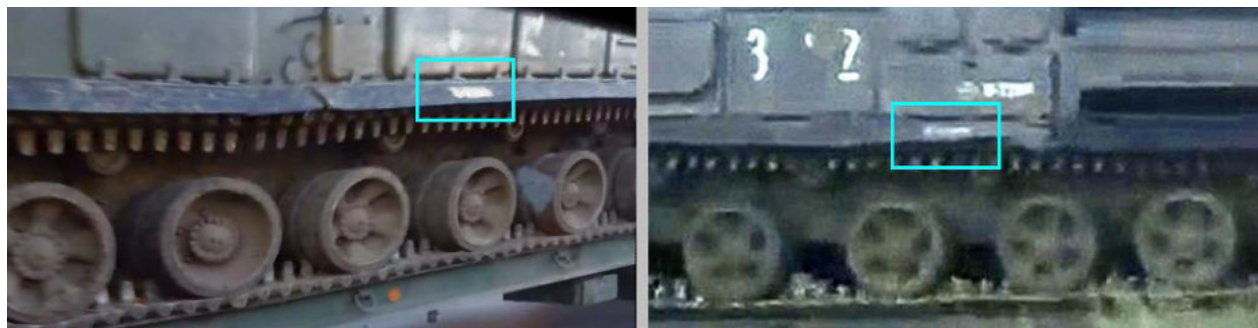
In the imagery available for Buk 3x2, white marks are visible on both side skirts directly below the center of gravity mark. Presumably, the white mark is the inscription "H-2200", a railroad transport code for dimensions of oversized cargo. Only Buk 3x2 had such a mark on the side skirts in the June convoy. Thus, in this convoy, the white mark on both side skirts is a unique feature of Buk 3x2.

Buk 3x2 - White marks on both sides of Buk - Details of videos^{50 51}

The reviewed photos of 53rd Anti-Aircraft Missile Brigade do not show this label on this position on Buk 312, 322 or 332. However, considering that this mark is added specifically before railway transport, the mark was likely added after the last available reference photo. Available photographs document that this position for the "H-2200" mark on the side skirt is used by the 53rd Anti-Aircraft Missile Brigade.

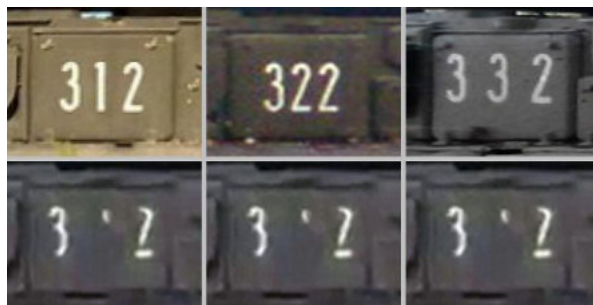
the three Bucs shows that the font is the same for all four; however, only Buk 332 shows the same spacing and alignment of the 3x2. Even more, the two visible digits are a perfect match.

Comparison of the font and the spacing between the digits – Details of photos ^{52 53 54}

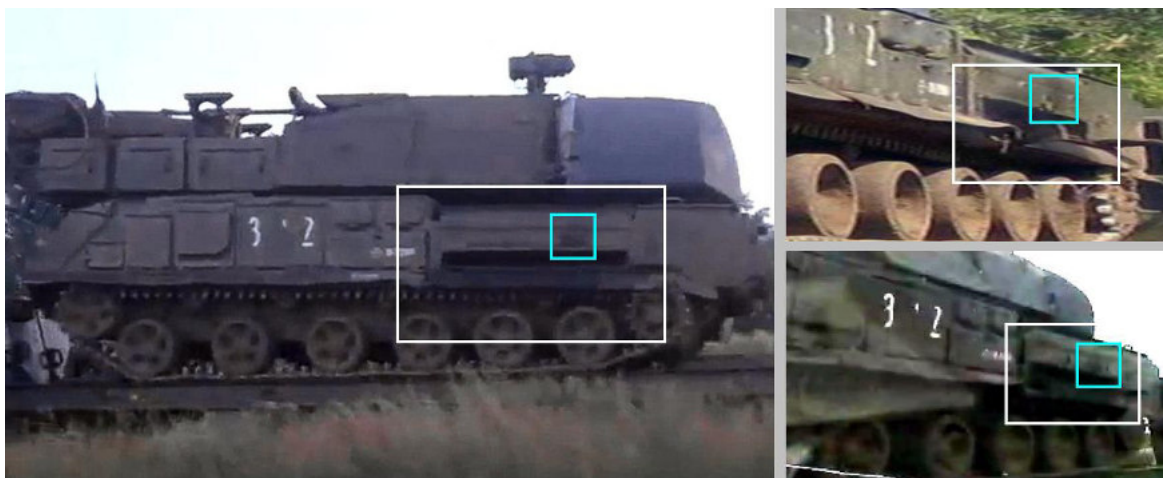
On all photos of the left side of Buk 3x2, strong dark patches can be seen on the side skirts below the exhaust. These patches are most likely caused by oil. Additionally, a striking soot or oil stain is located above the exhaust. Oil stains and soot deposits are certainly only a temporary feature because they can disappear by cleaning or repainting. However, a distinctive shape and position could also be caused by a special feature of the engine or the exhaust system, and a similar form at the same spot likely recurs, acting as indirect evidence of a persistent feature.

Buk 3x2 – Soot deposits or oil stains - Details of video and photos ^{55 56 57}

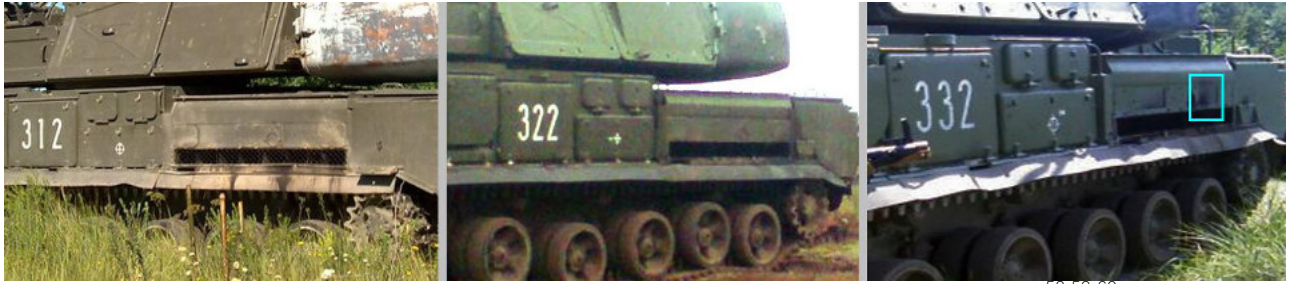
Soot deposits or oil stains at Buk 312, Buk 322 and Buk 332 – Details of photos^{58 59 60}

The oil stains on the side skirts are not recognizable in the photos of the three Buks. However, some photos of Buk 332 show a soot deposit above the exhaust, approximately at the same position as that of of Buk 3x2.

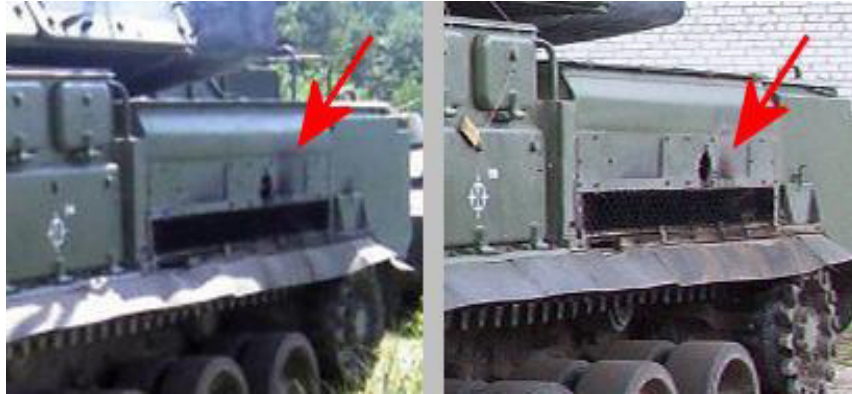
Buk 332 – Soot above the exhaust on Buk 332– details of photos^{61 62}

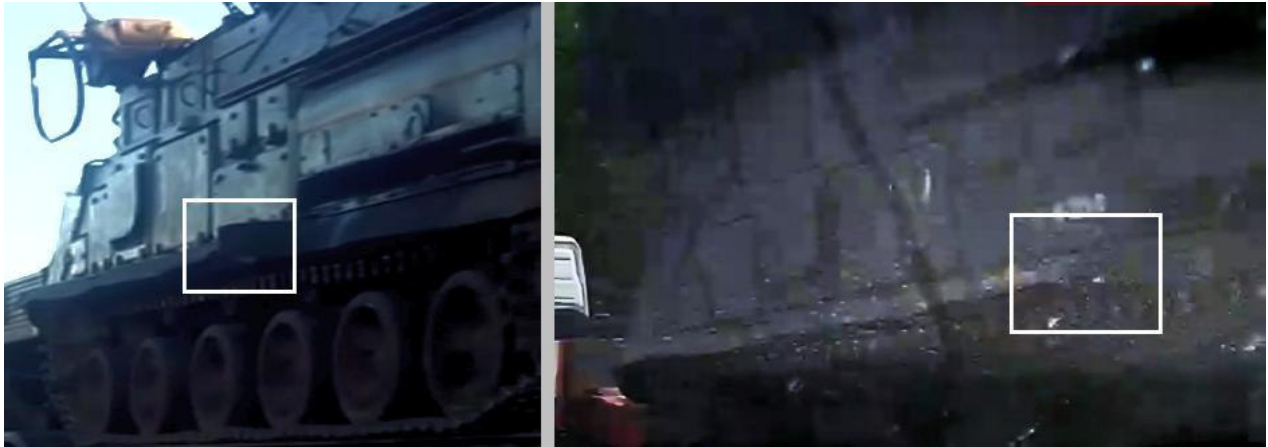
The damaged and torn side skirt close to the exhaust on the left side of the Buk can be seen in the photos from Paris Match showing the Buk on the trailer on 17 July in Donetsk. In the same area above the fourth wheel, a similar damage pattern can be seen on Buk 3x2 in a video made in Russia.

Damage to the side skirt - Details of Video⁶⁶ and photo⁶⁷

The comparison of the side skirts showed a strong match, however, there is one area with a notable change in "wave form". It was found that this can be explained by an observable deformation of the side skirt.⁶⁵

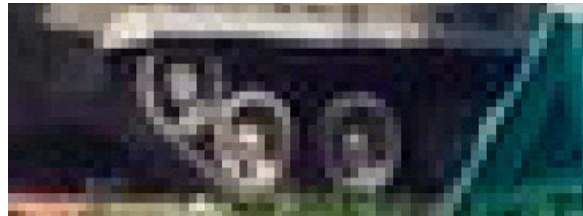
Road wheels left side - Original resolution - Detail of photo⁷⁰

The visible road wheels reflect the known arrangement of Buk 3x2. The left side only has spoked wheels, while there is one hollow wheel on the right side. Also, all Buks that have only hollow wheels can be excluded from being the 'Separatist' Buk.

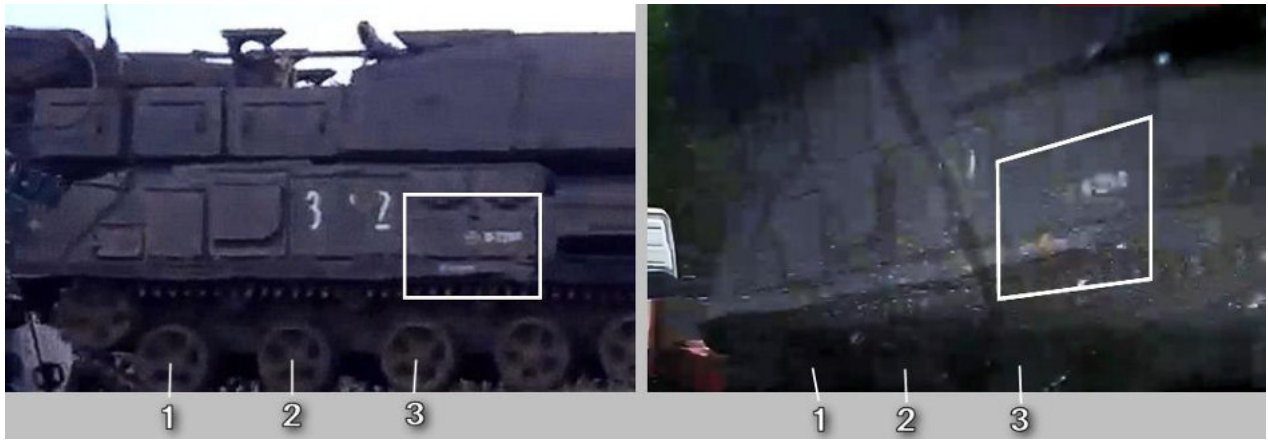
White mark left side - right above the third wheel from the left- Details of Video ⁷¹ and photo ⁷². See the numbered wheels (1, 2, 3) for reference of the mark's location in the space between the 3rd and 4th wheels.

The white marks on the Buk in the separatist-controlled area are in the exact same position as the white marks of Buk 3x2 in the Russian convoy in June 2014. The position of these transport markings is usually close to the sign marking the center of gravity. However, imagery of other Bucs with similar markings shows that these transport markings are not in the exact same locations.

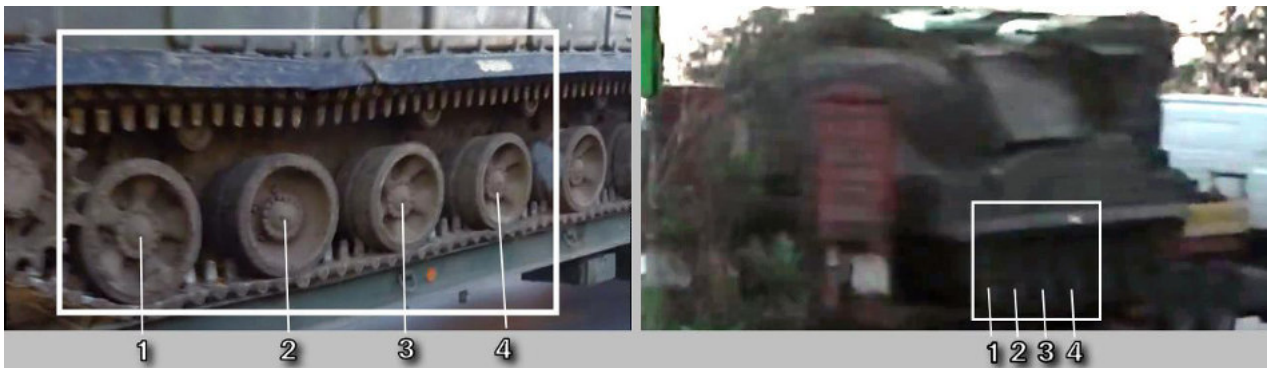
White mark right side- directly above the fourth wheel from the left - Details of videos ⁷³ ⁷⁴

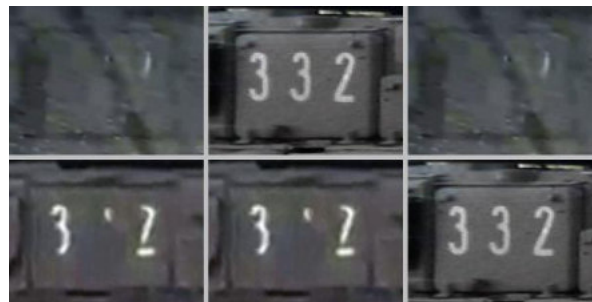
Comparison of digits or fragments of digits for Buk xxx, Buk 3x2 and 332

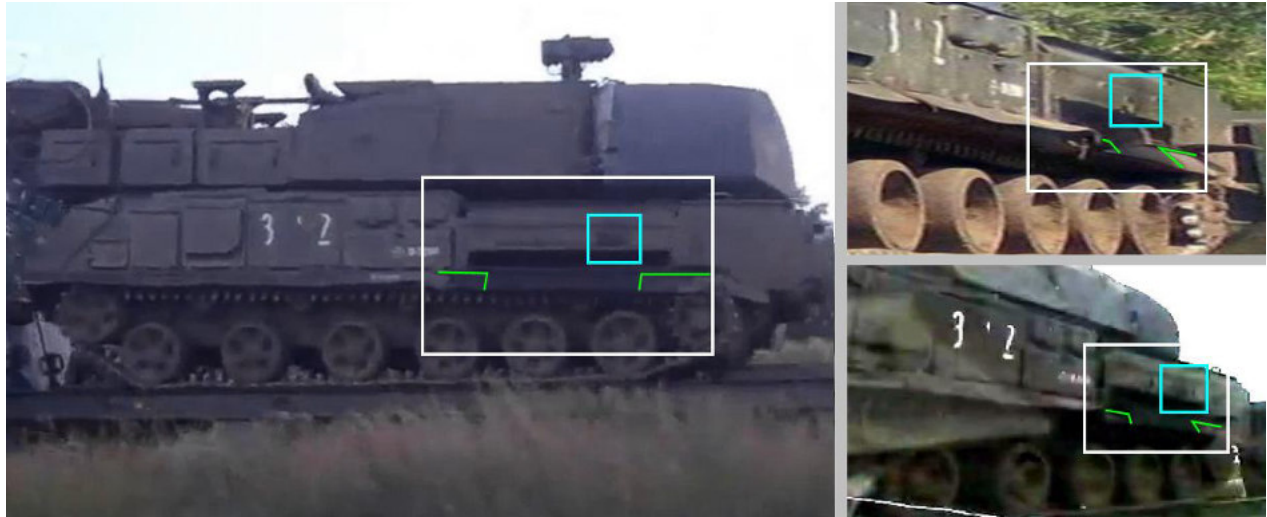
Another feature of Buk 3x2 are the oil stains and soot deposits above and below the exhaust.

Soot deposits / oil stains on Buk 3x2 - Details of videos^{75 76} and photo⁷⁷

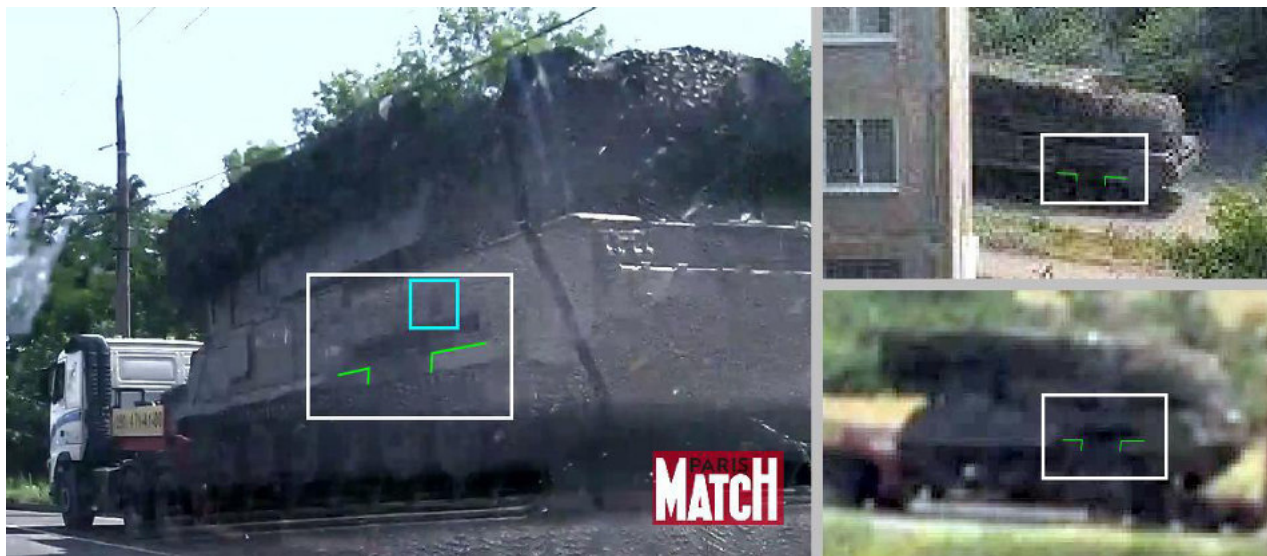
This characteristic oil stains or soot deposits are also found in two pictures and a video of Buk in separatist-controlled areas of eastern Ukraine.

Buk on 17 July 2014 in the separatist territory - soot deposits / oil stains - Photos^{78 79} and video⁸⁰
