MH17

The Open Source Investigation  
Two Years Later

## Introduction

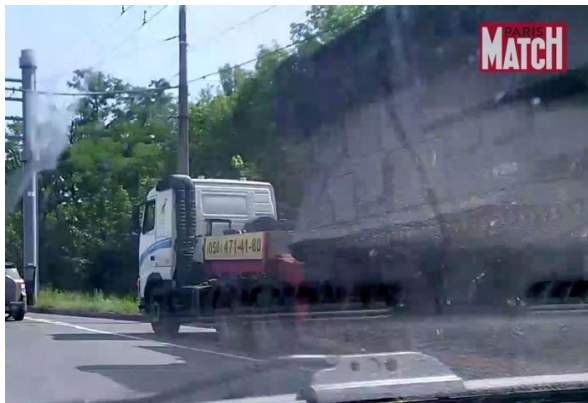
Figure 2: The first Paris Match photograph from Donetsk

The French tabloid magazine *Paris Match* has shared two images<sup>13 14</sup> showing the Buk in Donetsk. In the first image, a gray 2010 Toyota RAV4—matching the witness account from the “Donetsk is Ukraine!” VK group—is seen ahead of a Volvo truck hauling a Buk-M1 TELAR (Transporter Erector Launcher and Radar). In the second image, various details of the Buk missile launcher are clearer, including the netting above the four mounted missiles.

The exact time that these images were captured is unclear, but were certainly taken between 9:30am and 11:00am. *Paris Match* stated that the photograph was taken “about 11am” on the morning of July 17th.<sup>15</sup> There is far less uncertainty about the location of the images. The visible landmarks in the photograph reveal the exact location of the Volvo truck and Buk as near the Motel roundabout in eastern Donetsk.

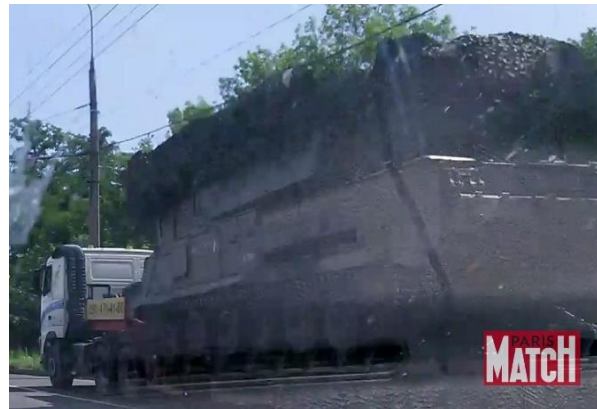
Figure 3: The second Paris Match photograph from Donetsk

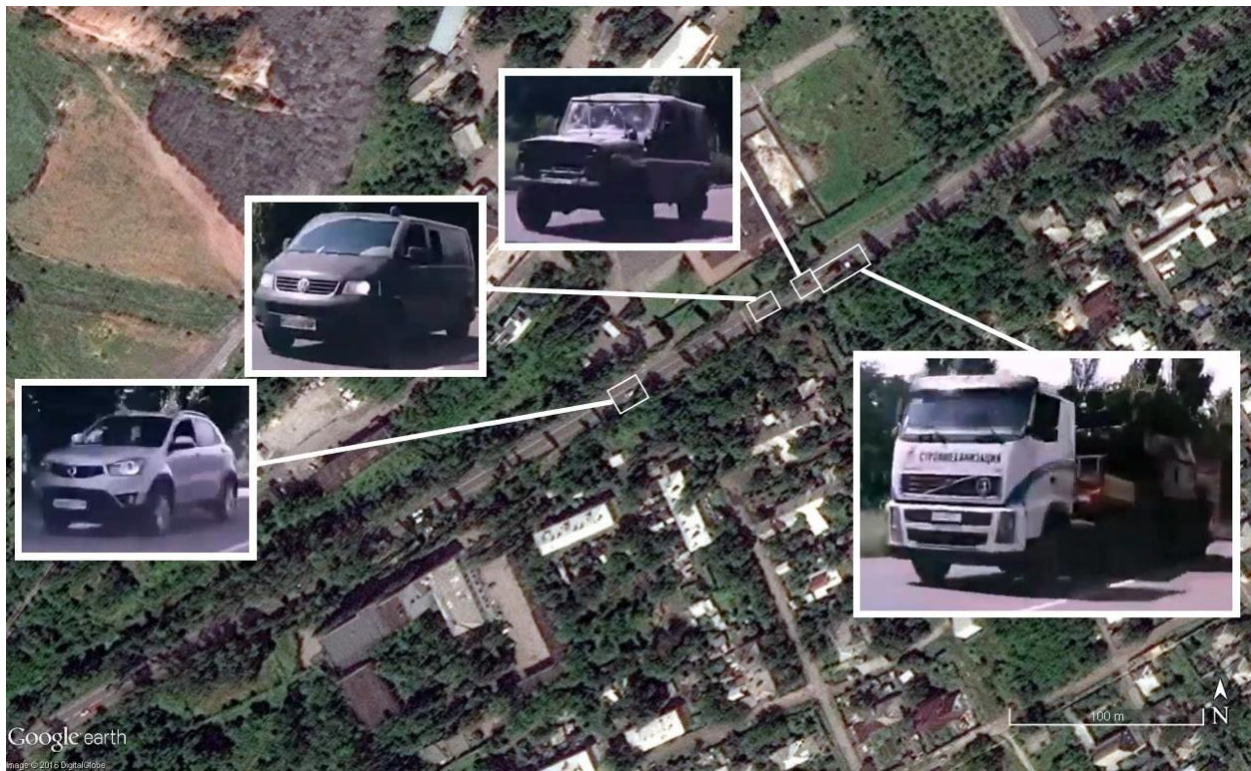
Figure 5: Positions of vehicles in the Makiivka video from satellite imagery dated July 17 2014 (Source - Google Earth/Digital Globe)

On June 22, 2016, Google published satellite imagery from Digital Globe of the area captured on July 17th 2014, showing the truck moving through Makiivka close to the location shown in the video.<sup>17</sup> Based on information from Digital Globe, the satellite image was captured at 11:08am local time.

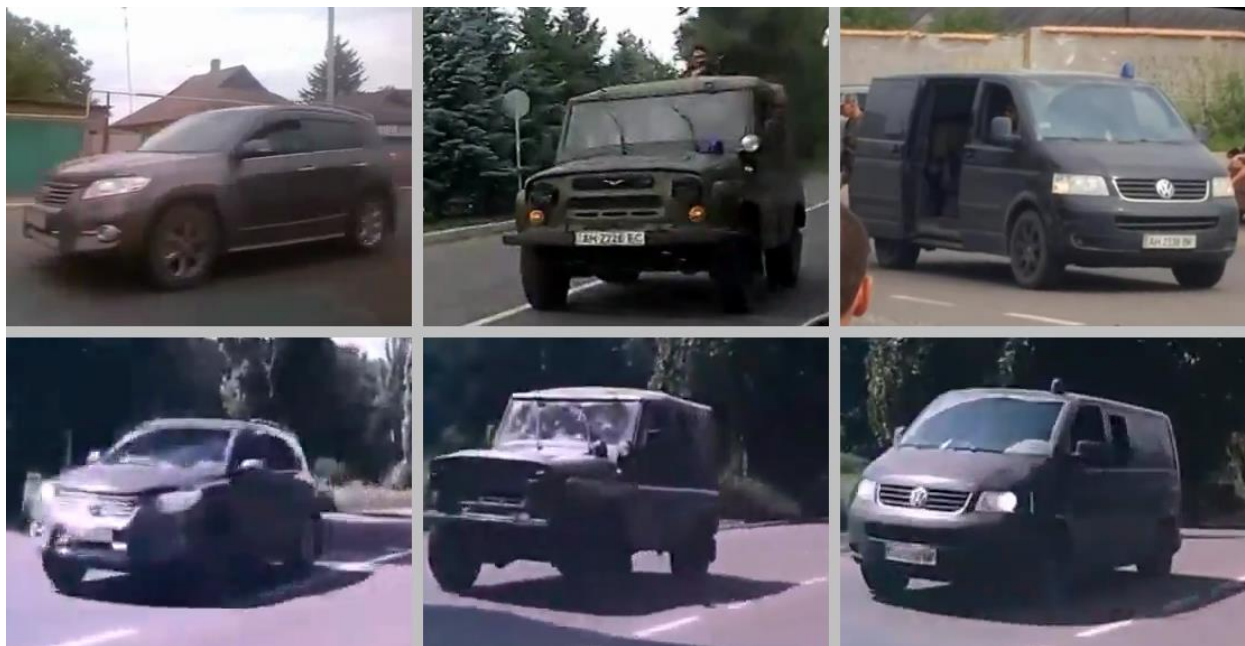
Figure 6: Comparison of vehicles in July 15 and 17 convoys

Notably, in addition to the truck and Buk, the Makiivka video also features other vehicles that appear to be in convoy with the truck, including a grey Rav4 SUV and a camouflaged UAZ, as described in the 10:40am post in the “Donetsk is Ukraine!” group. In addition to those vehicles, a black or dark blue Volkswagen van was also present, and all three vehicles featured in a video of another separatist convoy, this time transporting military equipment to Donetsk from Luhansk, filmed on July 15th.<sup>18</sup>

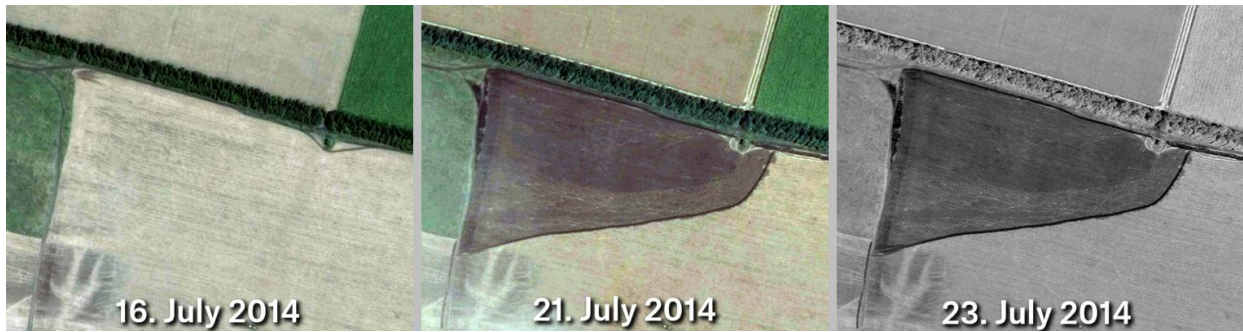
Figure 14: Field south of Snizhne between July 16 and 23 (Source Google Earth/Digital Globe)

Looking to the launch site itself, journalists Christopher Miller and Roland Oliphant visited<sup>50</sup> the field south of Snizhne on July 22, 2014. The two found a burned field with various pieces of debris, including a piece of plastic from a weapons container manufactured by Steklo Plastik, which had its offices raided of approximately \$25,000 worth of equipment by separatist soldiers about three weeks before the downing of MH17. Christopher Miller spoke with a resident of Chervonyi Zhovten, the nearest village from the field, who said that he saw and heard a missile launch from the field immediately before the downing of MH17.

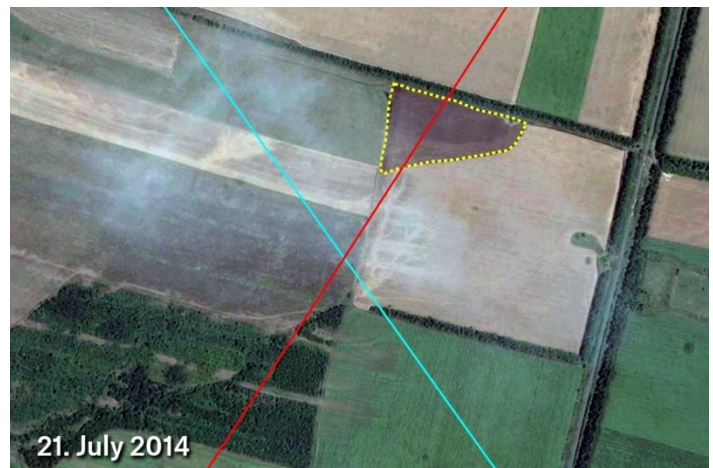
Figure 16: Approximate origin point of SBIRS data

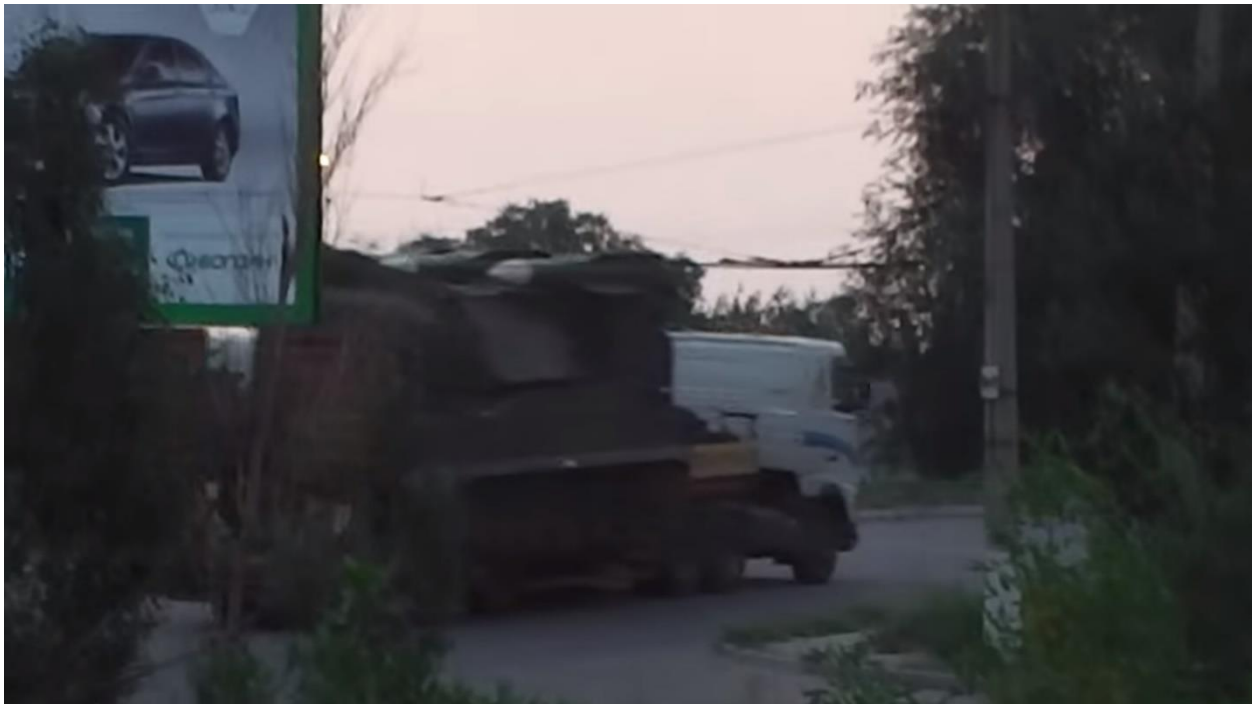
Figure 17: Frame from the July 18 2014 Luhansk video

On July 18, the Ukrainian Ministry of Interior published a video that was filmed in the separatist-controlled city of Luhansk, in which they claimed to show a Buk heading towards the Russian border on the morning of July 18.<sup>52</sup> The Buk had three missiles, instead of the four missiles a fully armed Buk usually carries, and as the Buk was photographed having in Makiivka, approximately five hours before the MH17 shutdown. Arsen Avakov, the Ukrainian Minister of Interior, later published the coordinates<sup>53</sup> of where the video was recorded, which were confirmed both by geolocation and news organizations visiting the site, including 60 Minutes Australia and Correctiv.<sup>54</sup>

Other than the Buk itself, the most obvious similarity to this video and the previous photographs and videos of the Buk in Ukraine is the white Volvo with red low-loader. This Volvo truck is hauling the Buk missile launcher in all of the sightings in eastern Ukraine on July 17, except after the Buk was unloaded in Snizhne. The truck can be recognized by the phone number on the red low-loader, the yellow Stroymekhanizatsiya elephant logo on the cabin, a blue stripe across the doors, and orange siren lights on top of the white cabin.

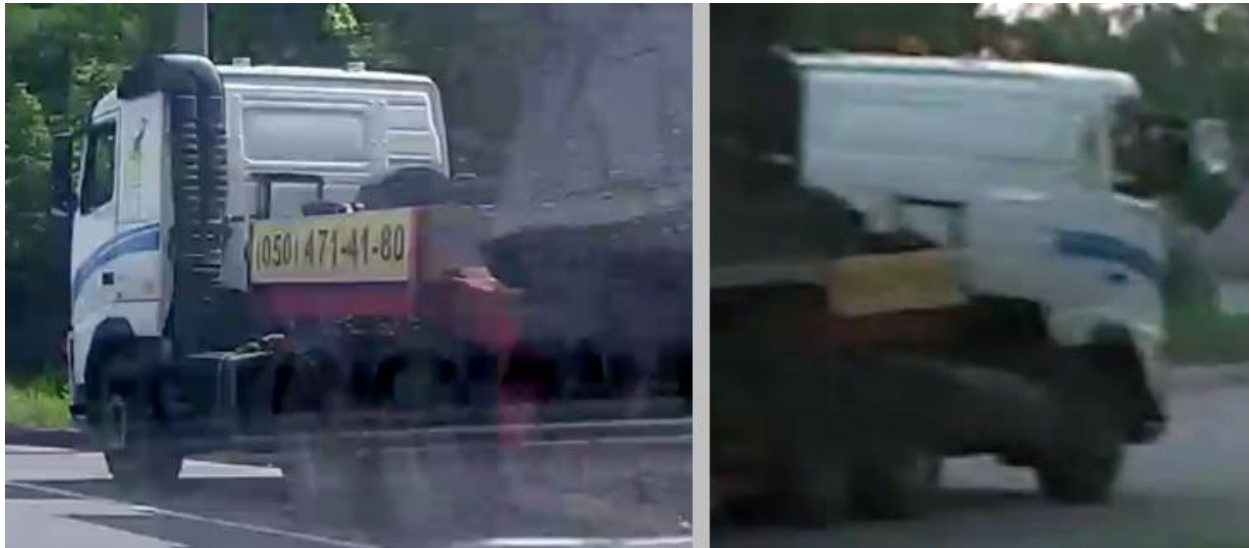
Figure 18: Comparison of the truck in the Donetsk Paris Match photographs (left) and Luhansk video (right)

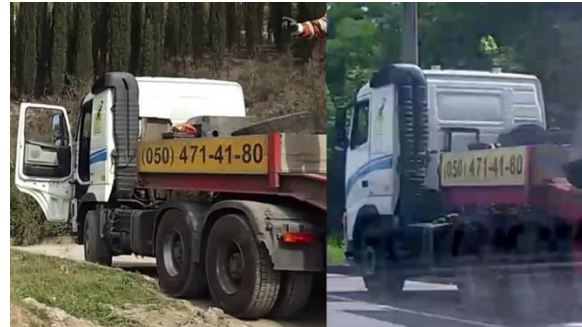
Figure 19: Comparison of the truck filmed in 2013 (left) and photographed in Donetsk on July 17 2014 (right)

Soon after the downing of MH17, journalists contacted the owner of the truck, confirming that the vehicle that hauled the Buk is the same that was captured by separatists in Donetsk:<sup>56</sup>

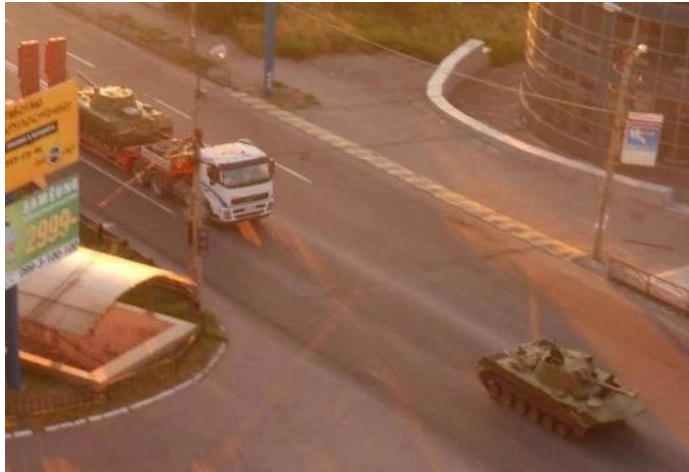
Figure 20 - Truck seen on July 17 and 18 2014 photographed on August 6 2014

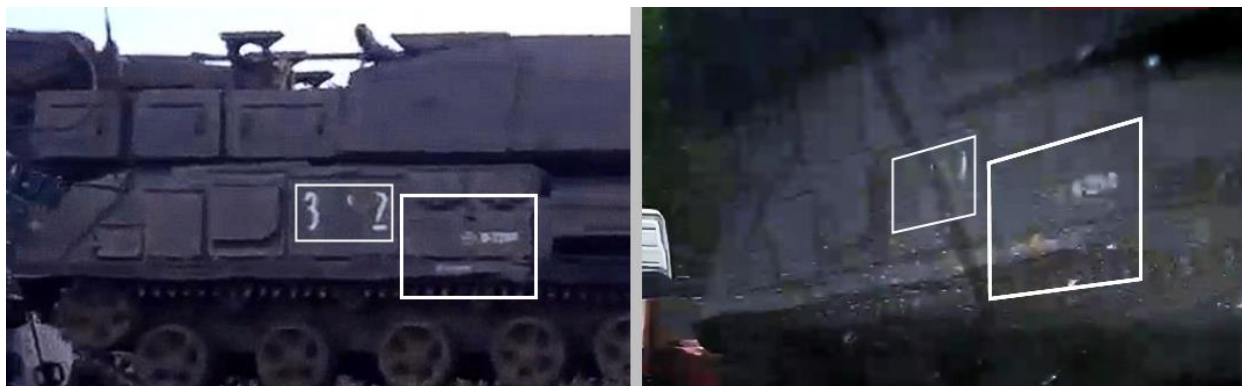
Figure 21: Markings on Buk 3x2 filmed in Russia in June 2014 (left) and markings from the Buk in the Donetsk Paris Match photographs (right)

This Buk has many similarities with the one photographed and filmed in Ukraine on the day of the MH17 downing. This Buk seen in Russia was dubbed “3x2” due to an obscured number on the side of the vehicle. Since early investigations, we have been able to determine that this Buk was originally numbered 332 after comparing the various characteristics from photographs and videos going back to 2010.<sup>62</sup> The remaining fragments of the numbers of the Buk seen in the Paris Match images, as well as the railway transport markings, center of gravity mark, white paint on the rubber side skirt, and other features were in the exact same positions.<sup>63</sup>

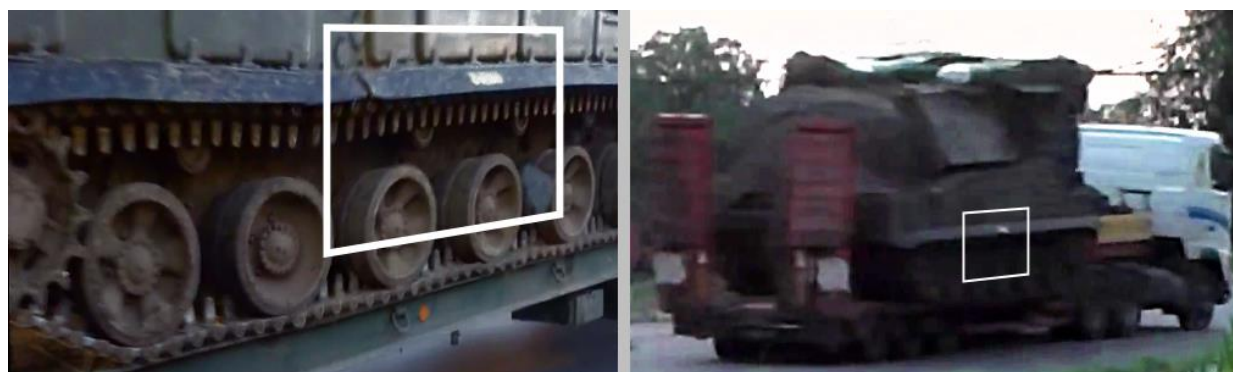
Figure 22: White mark on Buk 3x2 in Russia in June 2014 (left) and the white mark on the Buk filmed in Luhansk, Ukraine on July 18 2014

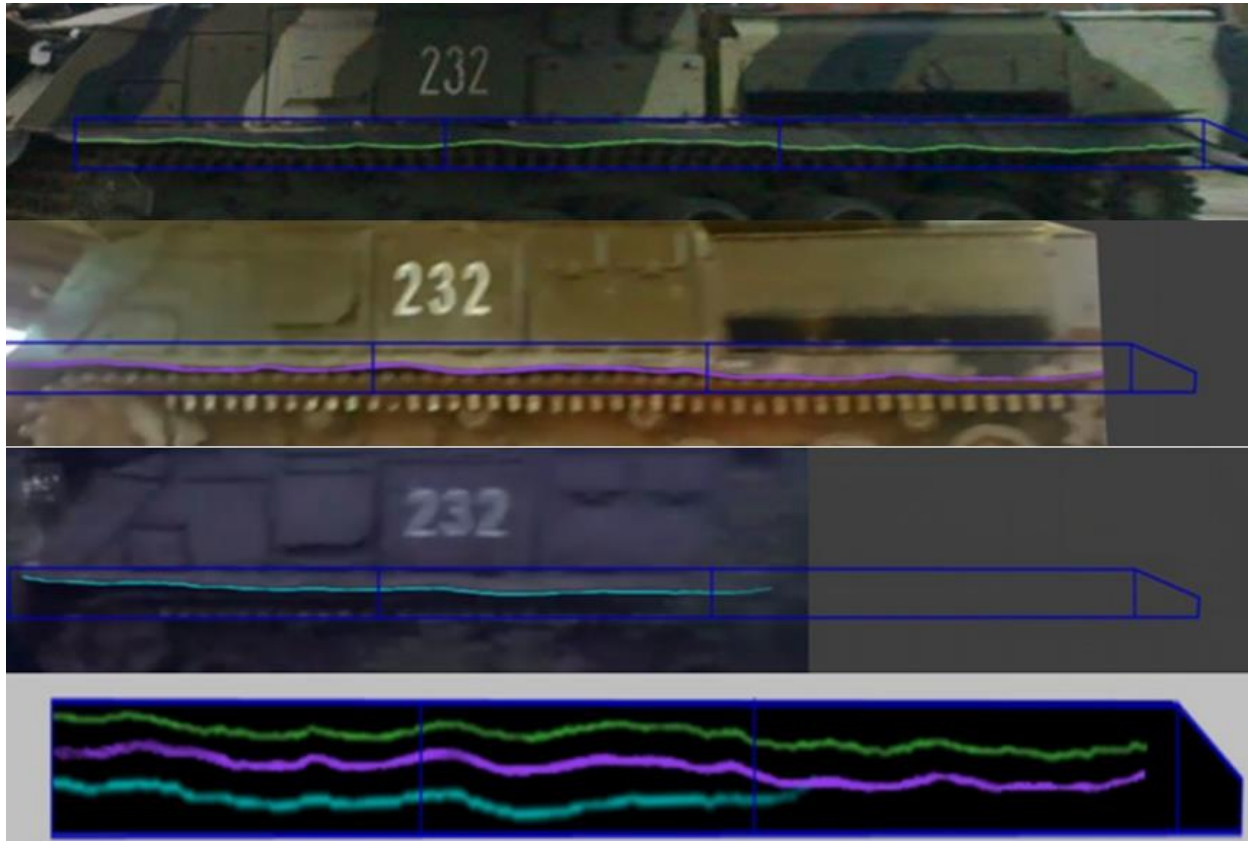
*Figure 23: Side skirt comparison of Russian Buk 232 over a period of a year*

sustain damage over time, creating a unique “fingerprint.” Comparing these side skirt damage patterns, or “fingerprints,” we can identify and match Buk missile launchers with one another. For example, below is a comparison of the side skirt fingerprints of a Russian Buk numbered 232. All three photographs were taken in the same year.

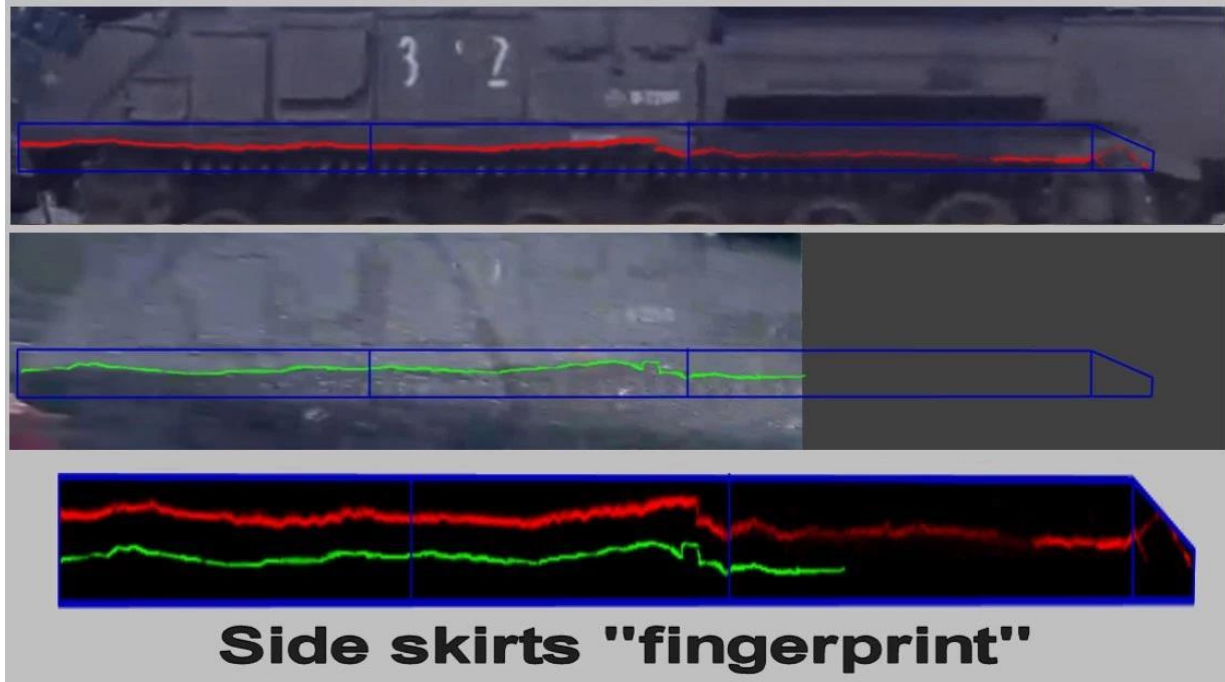
Figure 24: Side skirt comparison between June and July 2014 of Buk 3x2 and the Buk in the Paris Match photographs.

When comparing the side skirt profiles of Buk 332, the Russian Buk seen headed towards the Ukrainian border in late June, and the Buk photographed in eastern Ukraine on the day of the tragedy, there is a positive identification:

The strong “spike” in the waveform below the white marking (which reads “H-2200,” a code used for oversized railway cargo frequently found on Russian military equipment) can be identified by examining photographs of the Buk in Russia and Ukraine.

This tear on the rubber side skirt can be identified in the exact same location on the Buk seen in Ukraine. Over the past two years, members of the Bellingcat investigation team have compared the features of Buk 332, seen both in Russia and Ukraine in the summer of 2014, with every other Buk photographed or filmed in 2013 and 2014 in Russia and Ukraine discovered by investigators. No other Buk has even half of the same details seen on this Buk, including the number, exact placement of the various white marks, the side skirt “fingerprint”

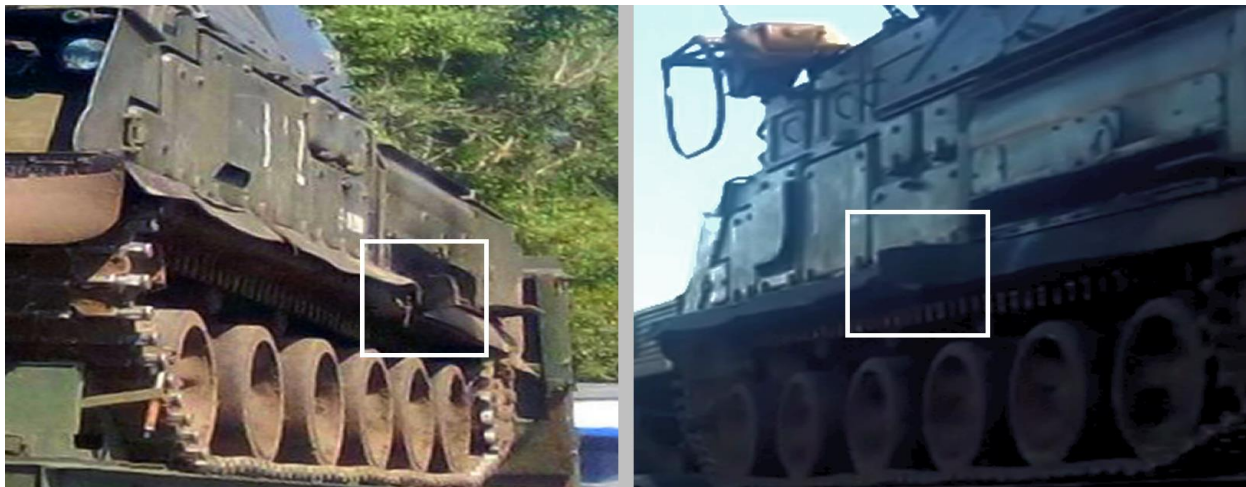
Figure 25: Damage to the side skirt visible on Buk 3x2

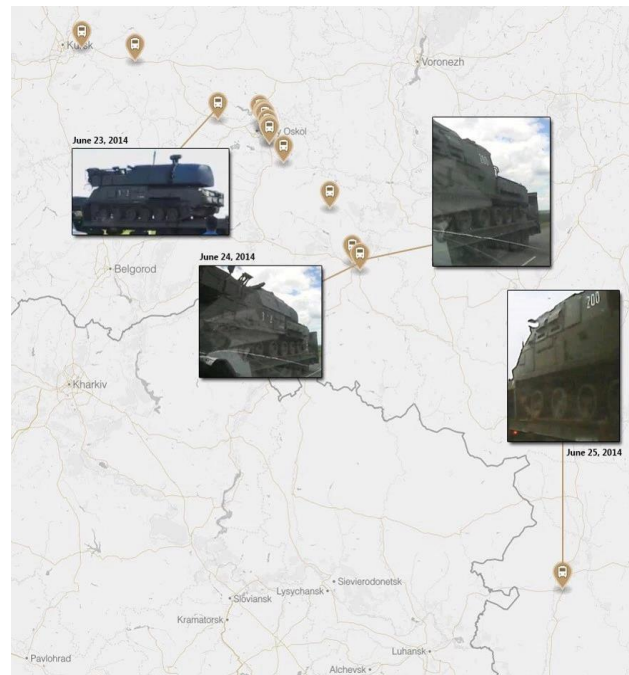
*Figure 26: Geolocated photographs and videos of the June 23 - 25 2014 convoy in Russia*

This convoy, which included Buk 332, was photographed and filmed by ordinary Russian civilians who lived along this convoy's route. Each of the images and videos were geolocated to the exact location where it was captured, providing an accurate representation of the convoy's route.

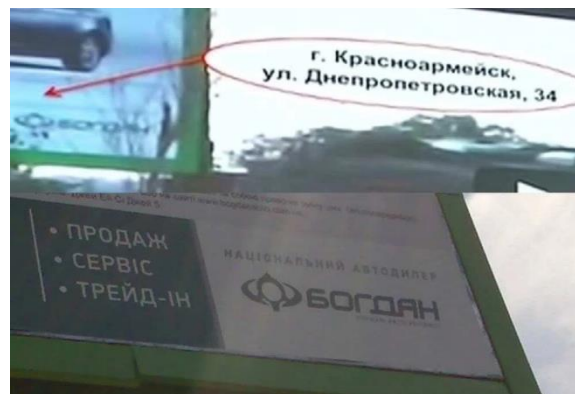
Figure 29: Comparison between the billboard text presented by the Russian Defence Ministry (top), and the actual text (bottom)

For example, media circulated a video supposedly showing a Buk system being moved from Ukraine to Russia. This is clearly a fabrication. This video was made in the town of Krasnoarmeisk, as evidenced by the billboard you see in the background, advertising a car dealership at 34 Dnepropetrovsk Street. Krasnoarmeisk has been controlled by the Ukrainian military since May 11.

However, it was possible to establish the true location the video was filmed using open source investigation techniques, which confirmed the billboard's exact location in separatist-controlled Luhansk. This location was visited by a Luhansk local who took photographs of the area which both helped confirm the location, and what was written on the billboard.

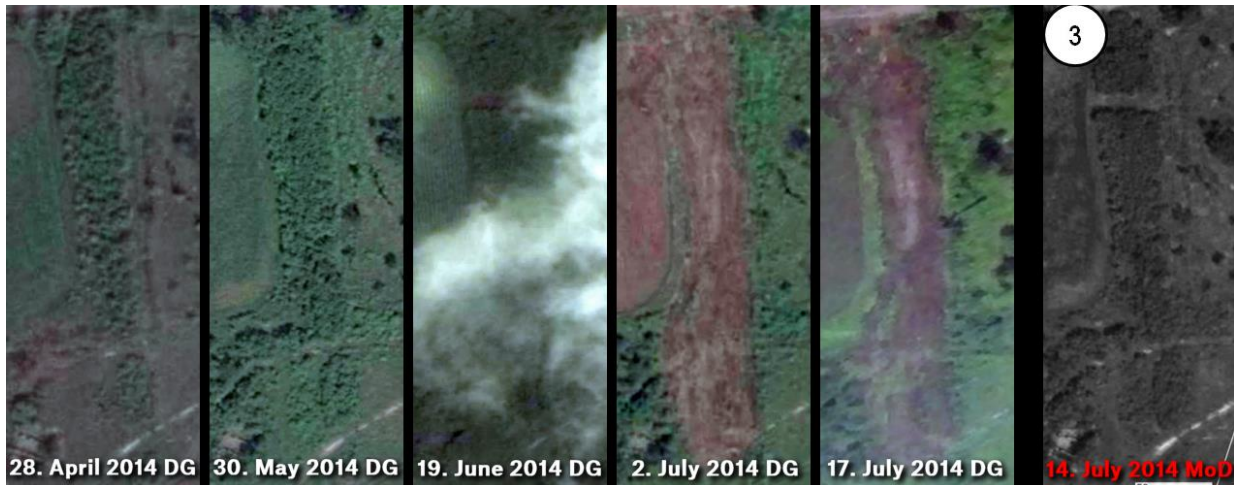
Figure 33: Comparison of missing vegetation on different dates to Russian Defence Ministry satellite imagery

Historical satellite imagery of the same location from July 2 and 21 of the same area on Google Earth confirms that the vegetation had been cleared weeks before July 17. Patches of worn-away grass visible in the Russian Defence Ministry imagery were also absent in the Google Earth July 17 imagery.

But, as with some of the other discrepancies between the images, the patches of missing grass were visible in earlier historical imagery on Google Earth, clearly showing the Russian Defence Ministry images were from weeks before MH17 was shot down.

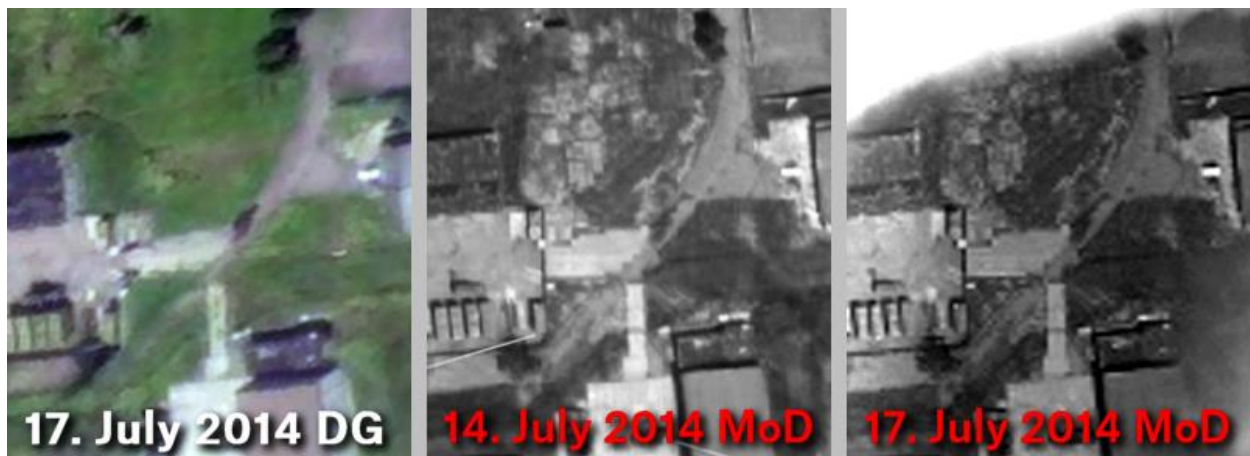
Figure 34: Comparison of Digital Globe July 17 2014 imagery to Russian Defence Ministry July 14 and 17 2014 satellite imagery

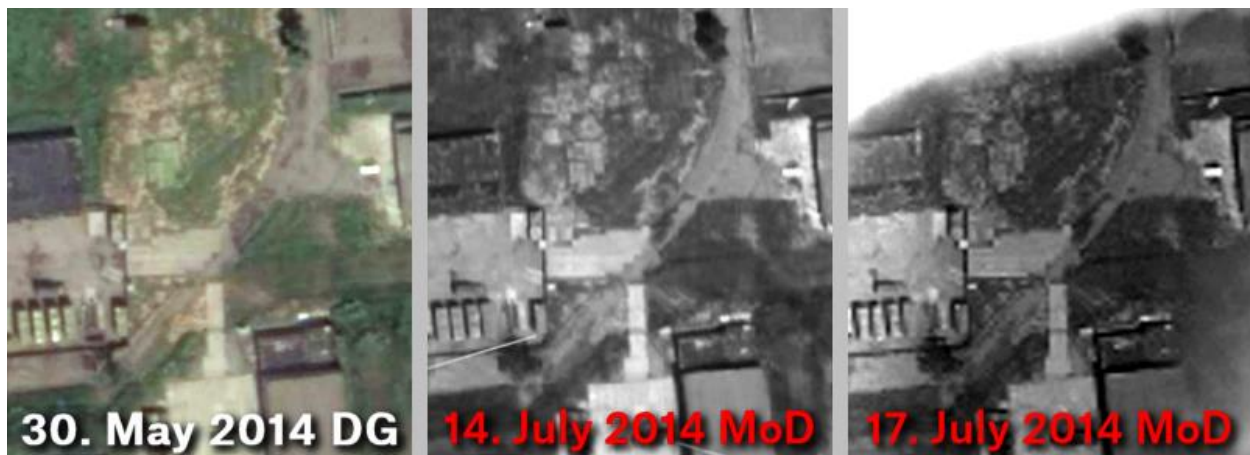
Figure 35: Comparison of May 30 2014 Digital Globe imagery and Russian Defence Ministry satellite imagery dated July 14 and 17 2014

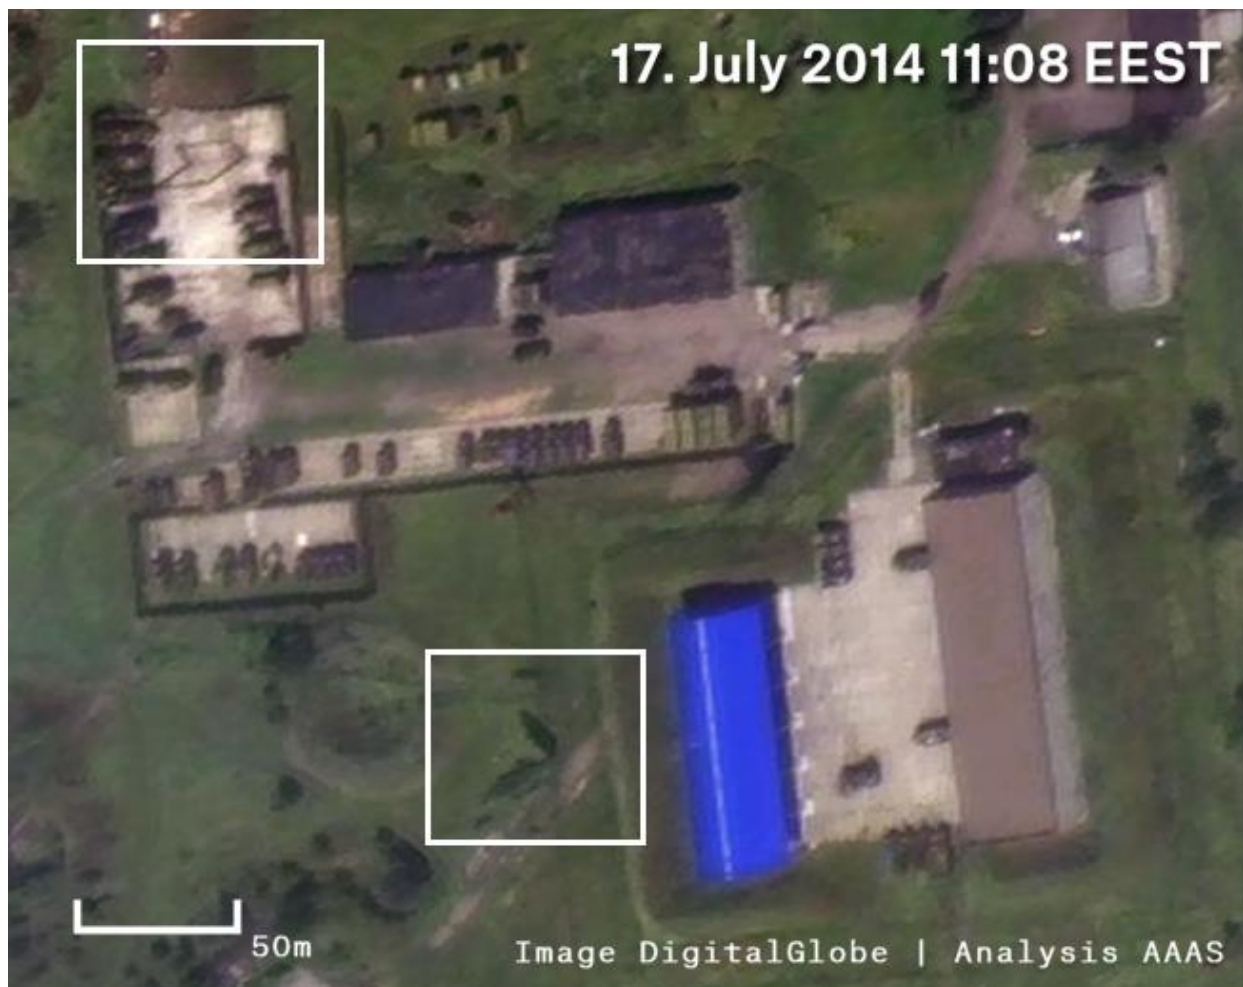
Figure 36: Image highlighting the object used to measure solar azimuth

AAAS were provided with Digital Globe images of the Ukrainian A1428 military base on June 7 2014 and July 17 2014.<sup>78</sup> The AAAS analysts applied shadow analysis techniques to examine the Digital Globe and Russian Defence Ministry imagery of the A1428 military base, with the first step being to determine how accurately the solar azimuth and elevation could be derived from the features present in each image. Three points were identified that were visible in Russian Defence Ministry Imagery and the Digital Globe imagery, two poles on an archway, and a tall tree located southeast of the archway.

First examining the June 7 2014 and July 17 2014 Digital Globe images analysts found the solar azimuth in the metadata and NOAA solar azimuth were identical, with the mean solar azimuth deviating from between 0.20 and 1.85 degrees on the archway's poles, and 3.15 to 4.80 on the tree. The great deviation was stated to be likely due to the trees irregular shape reducing the accuracy of the measurement.

The July 14 2014 Russian Defence Ministry image of the A1428 base was found to have a mean azimuth deviation of 15.91 and 11.41 on each pole, and 7.41 on the tree, while the July 17 2014 image, where only the tree is visible, had deviation of 9.76.

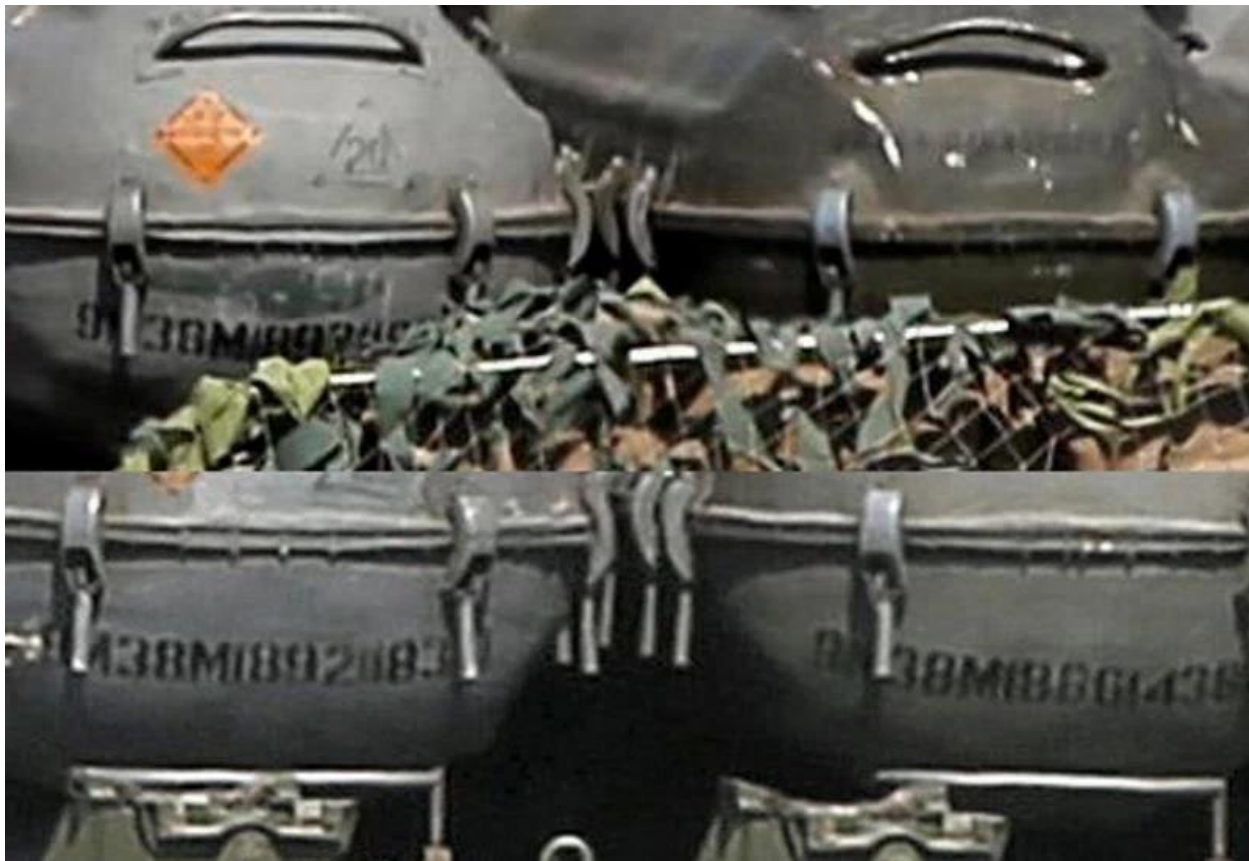
Figure 39: Magnified sections of photographs taken at Kamensk-Shakhtinsky in August 2014 (Source - Reuters)

Trucks in the photographs are carrying a number of missile crates, and their markings give a clear indication of their likely contents.

These crates are marked 9M38M1, and it was also possible to identify two vehicles in the Reuters' photographs as being part of the June 23 – 25 53rd Brigade convoy transporting Buk 3×2 to Millerovo.<sup>86</sup> It is also possible to identify missiles in videos<sup>87</sup> of the 53rd Brigade convoy as having the long tail fins associated with the 9M38M1 missile.

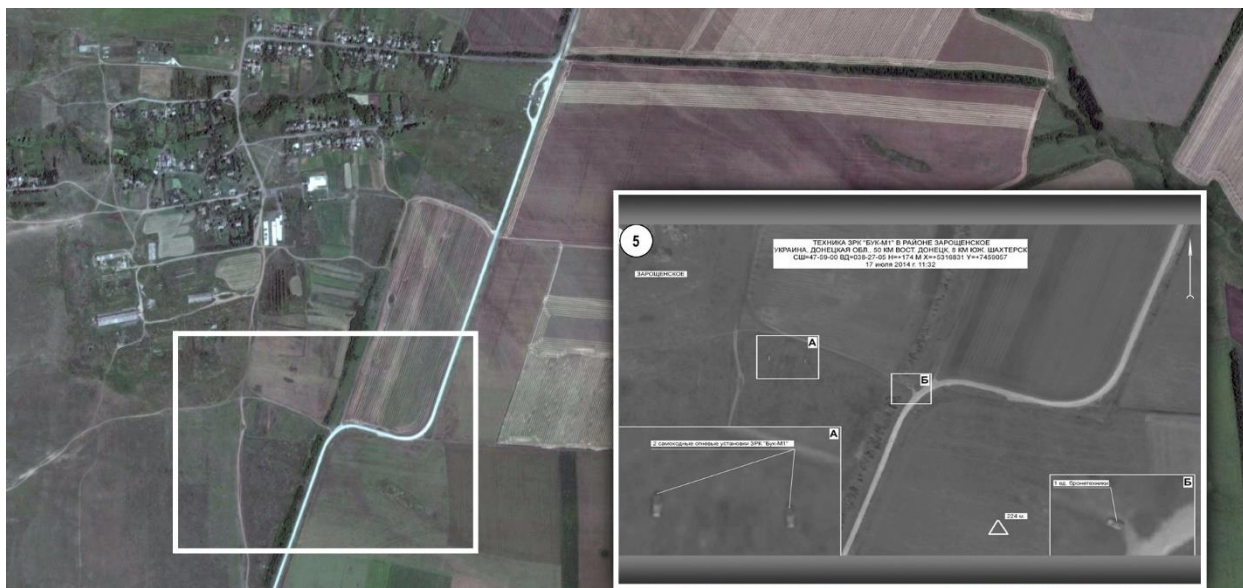
Figure 41: Area within Almaz-Antey's proposed launch site compared to Russian Defence Ministry satellite imagery

Satellite images captured on July 16, 2014 and July 21, 2014 show no signs of any track marks from the movements of large vehicles or burn marks from missile launches at the site shown in the Russian Defence Ministry satellite imagery. In addition, satellite imagery analysis by Dr. Jeffrey Lewis using the Tungstène forensic imagery analysis software shows the Russian Defence Ministry imagery of the area close to Zaroshchenske are heavily modified, and it appears as if the Buk missile launchers features were digitally altered or added into the image.

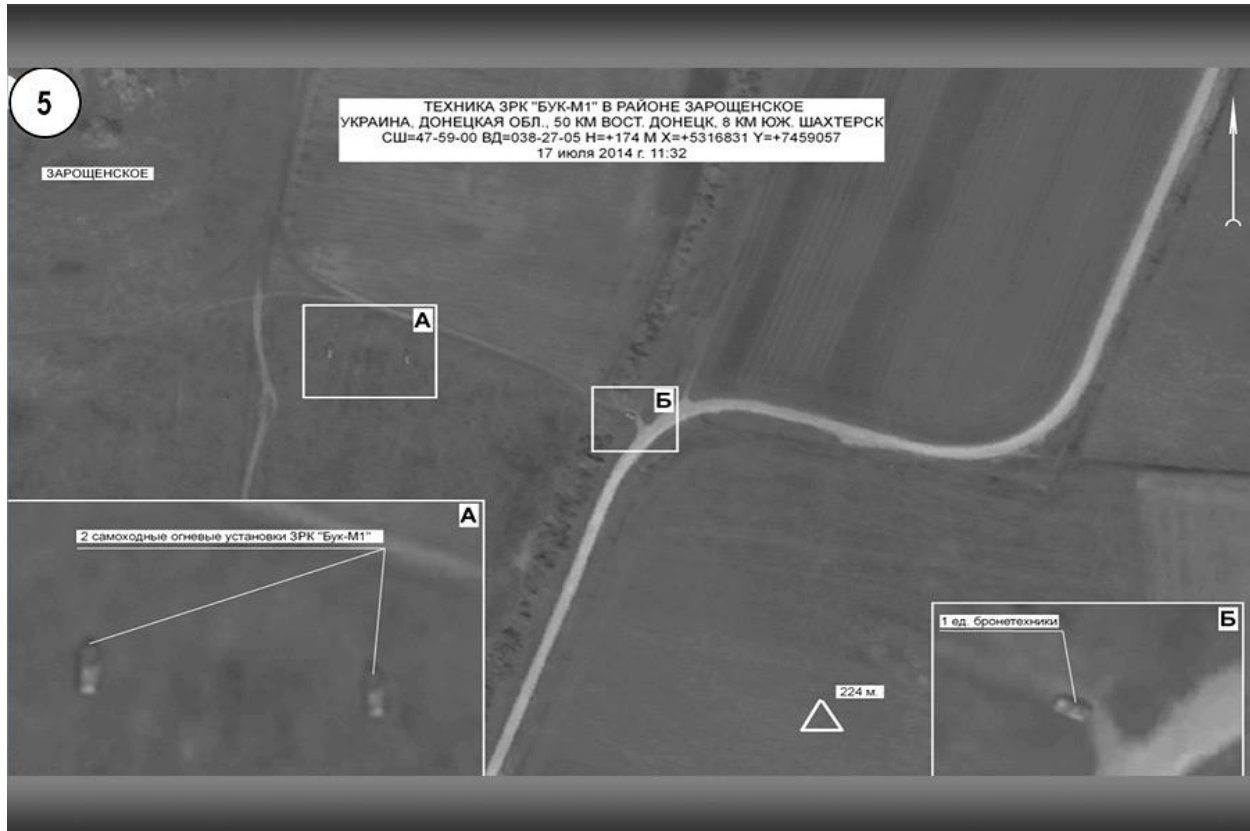
Figure 42: Russian Defence Ministry satellite images from July 17 2014 claiming to show two Buk missile launchers near Zaroshchenske

However, unless the Russian images were fabricated and/or misdated, this is not the case. Another image presented by the Russian Defence Ministry showing presumably this same Buk missile launcher in a field near Zaroshchenske was supposedly taken at 11:32am on July 17, 2014.<sup>94</sup>

The Avdiivka base and the field in Zaroshchenske are 53 kilometers apart as the bird flies, not even considering the roundabout route that the Ukrainian military would need to take around separatist-held territory. Even in the absolute best conditions, without any traffic, military checkpoints, or logistical concerns of loading or unloading a large piece of military equipment, it is physically impossible for a Buk missile launcher to travel between these two points within 24 minutes. In short: the Russian Defence Ministry fabricated and purposefully misdated satellite images of the Ukrainian anti-aircraft base and a field near Zaroshchenske in an attempt to create a narrative of a particular Ukrainian Buk missile launcher being deployed shortly before the MH17 shoot down.
