# MH17

## The Open Source Investigation Three Years Later

## Introduction

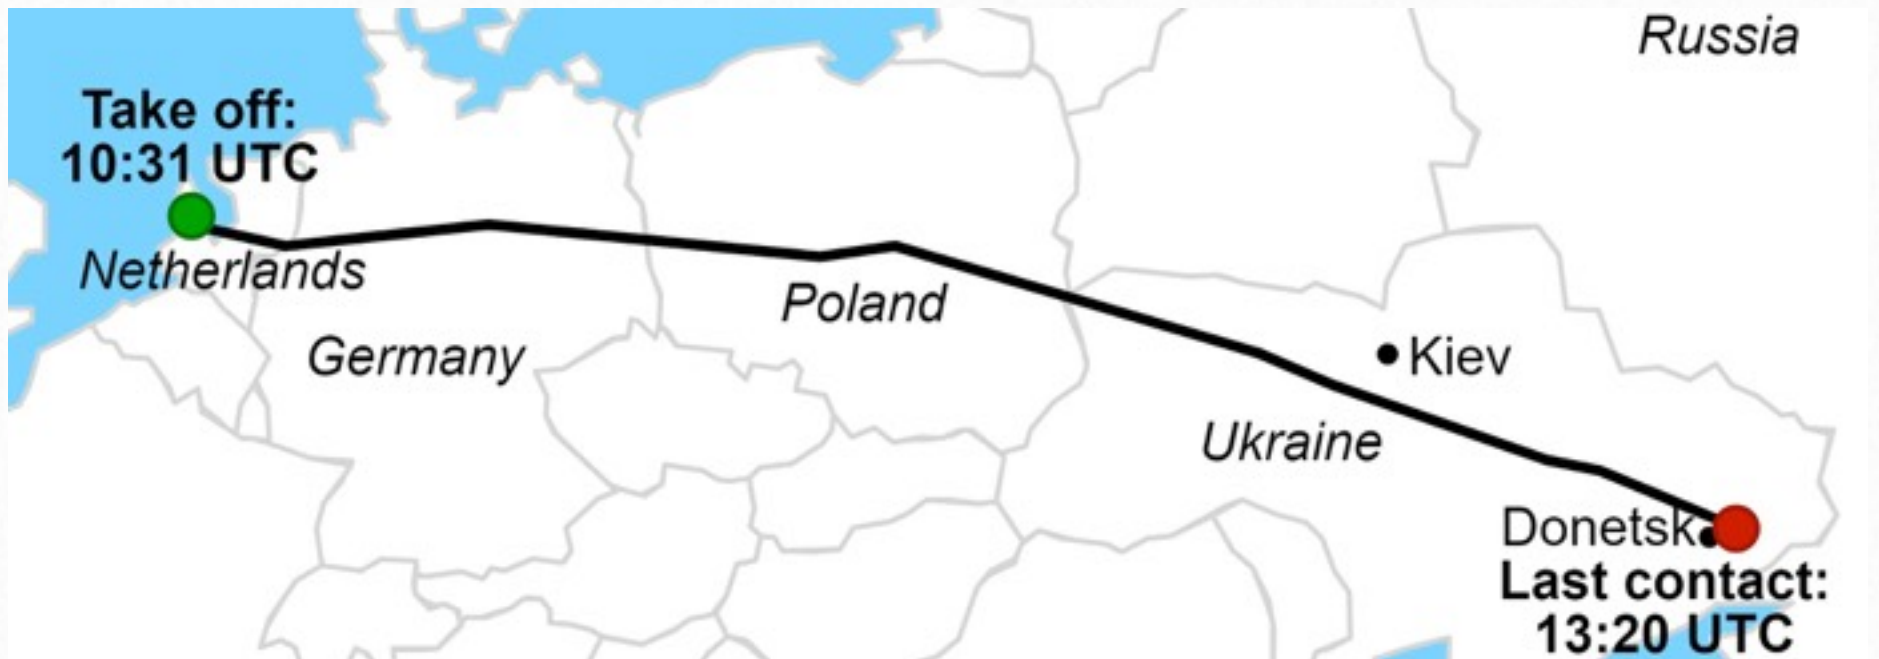
### The flight path of Malaysian Airlines Flight 17 on July 17, 2014

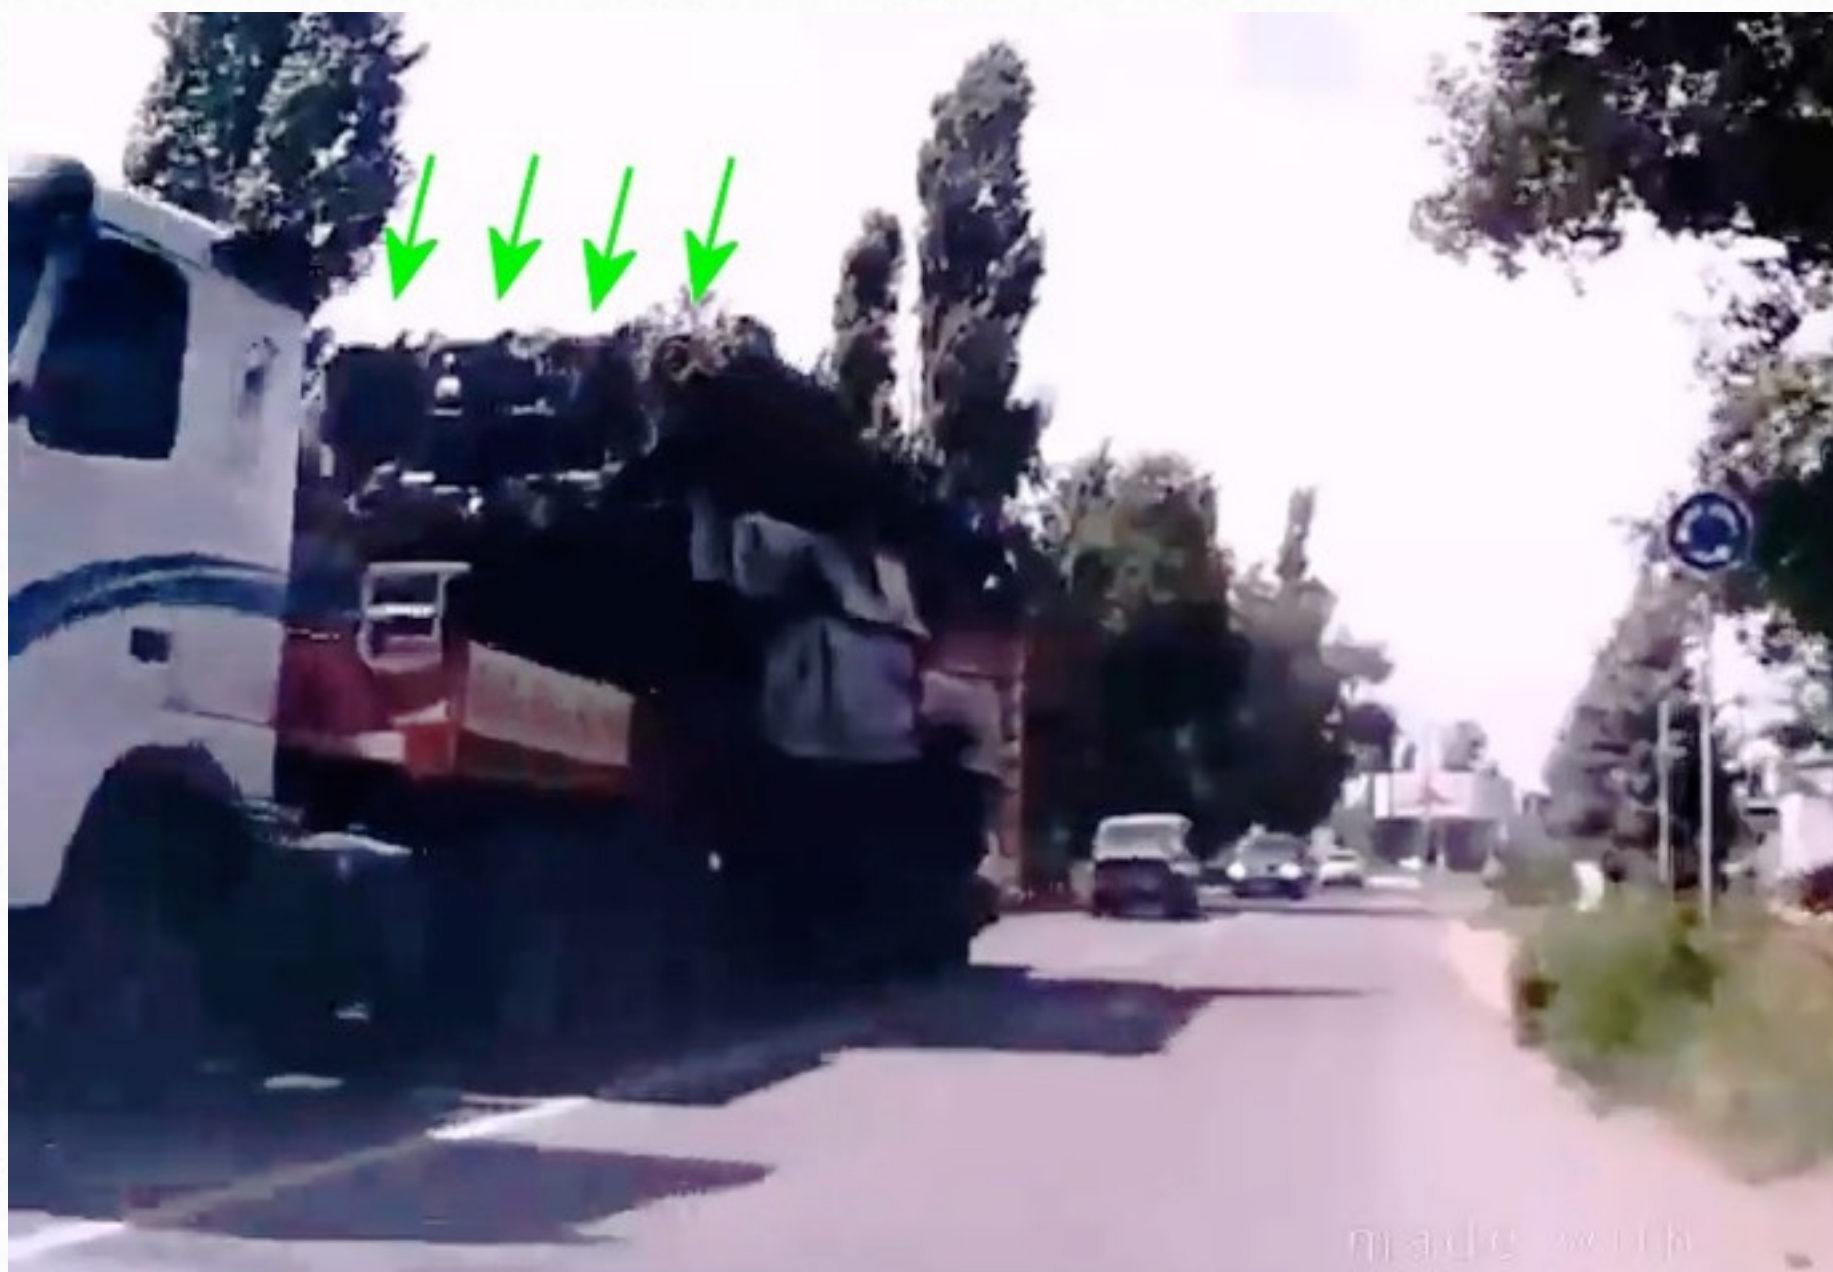
**Buk 332, with four mounted missiles, being transported eastward through the separatist-controlled city of Makiivka on July 17, 2014**

On May 3, 2016, [a video was uploaded onto YouTube](#) showing Buk 332 being hauled through Makiivka by the same Volvo truck and on the same red trailer with a yellow placard showing a phone number. Just as in the video filmed in Donetsk, Buk 332 has four mounted missiles covered with netting. Additionally, the same vehicles that were filmed with the Buk in Donetsk - a Toyota RAV4, a dark-blue Volkswagen van with a blue siren, and a UAZ-469 jeep - are escorting the missile launcher through Makiivka in this video.

The location of this video provides additional clues regarding the route of the Buk on July 17, showing that the convoy took a detour through Makiivka before reaching the H21 highway again. This detour was likely taken to avoid a low-hanging bridge along the highway, which may have not been high enough for the vehicle hauling a Buk with mounted missiles.

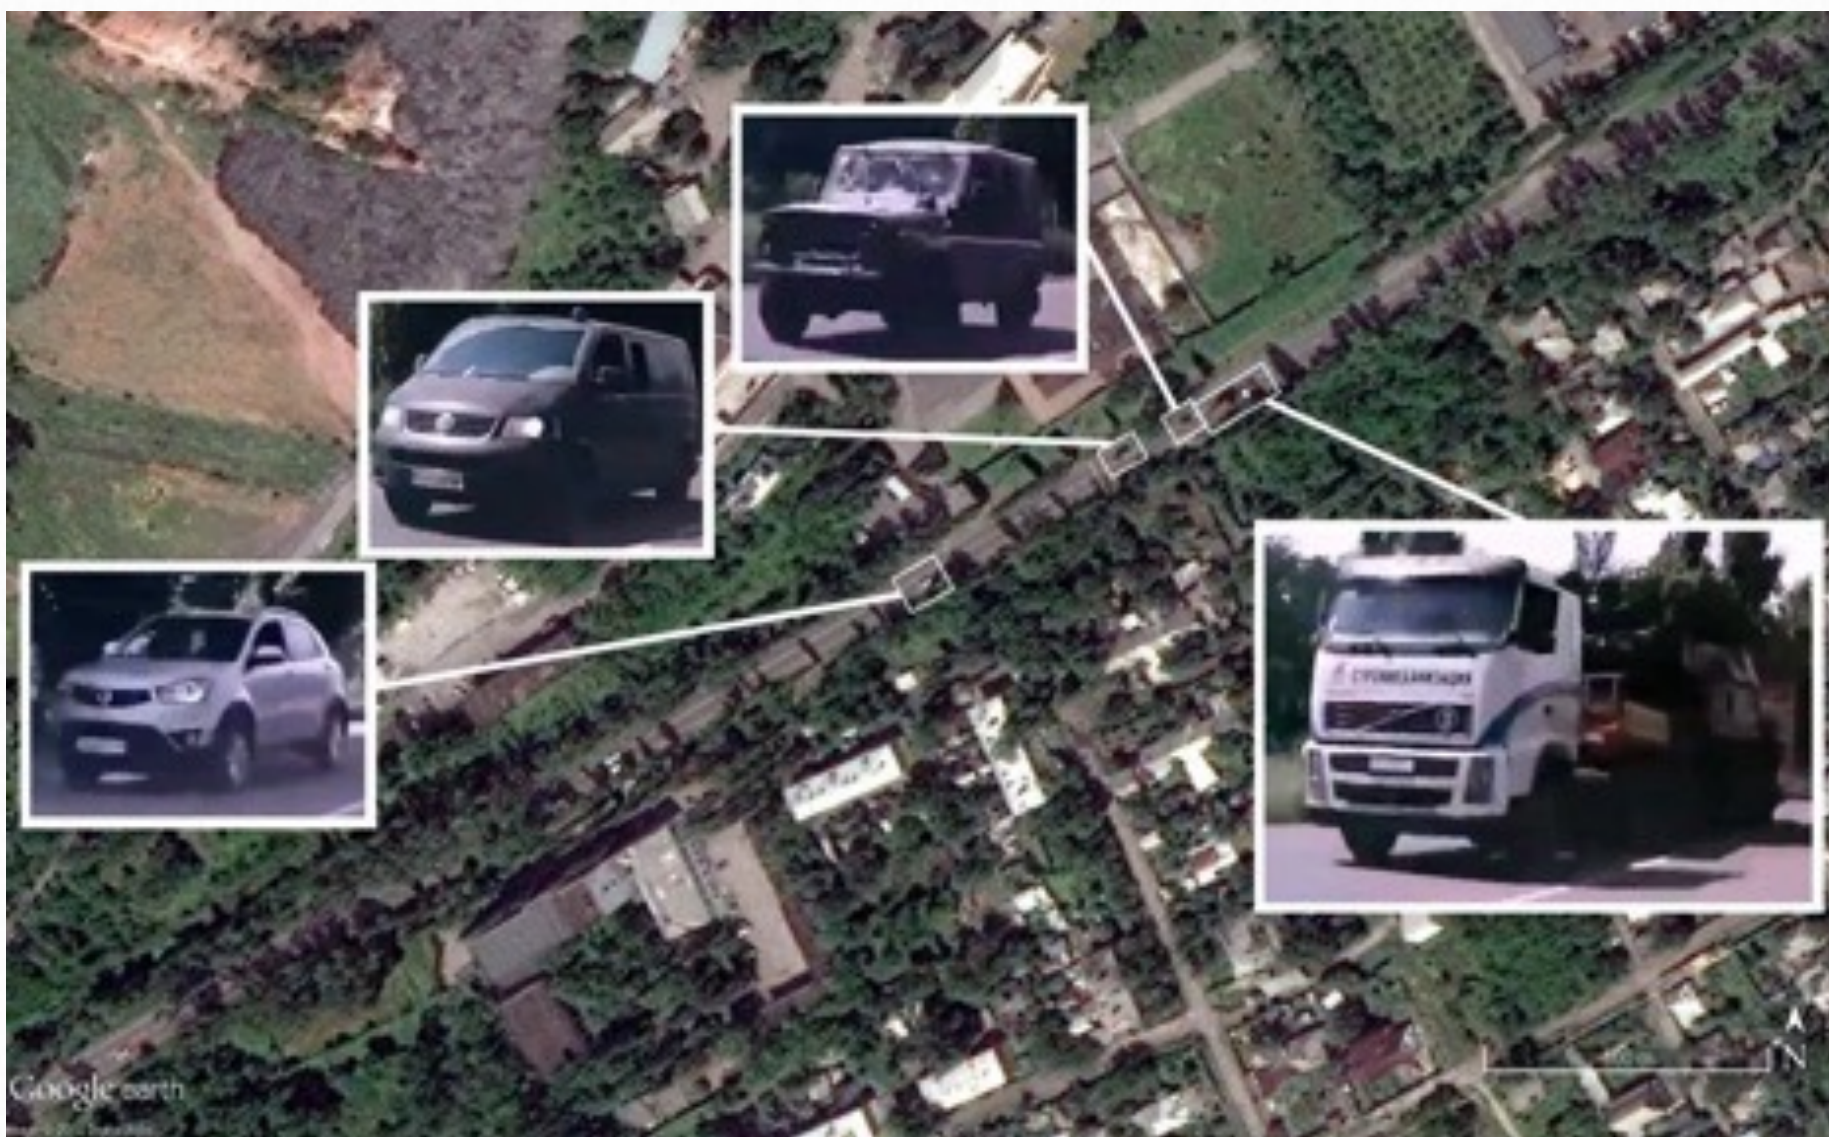
**Satellite image from 11:08am, July 17, 2014, showing the Buk convoy traveling through separatist-controlled Makiivka**

The private intelligence firm Stratfor [published a segment of a satellite image](#) they purchased soon after the Makiivka video was published. On this satellite image, we can see the Buk convoy. Soon after Stratfor published this finding, Google Earth updated its coverage of eastern Ukraine to include this image, snapped by the satellite company Digital Globe, shot at 11:08am local time on July 17, 2014, just moments after the convoy video was filmed. In the image, which can be accessed via Google Earth at coordinates 48.020725, 37.991579, we can see the Volvo truck hauling a Buk, the UAZ-469 jeep, VW van, and RAV4.

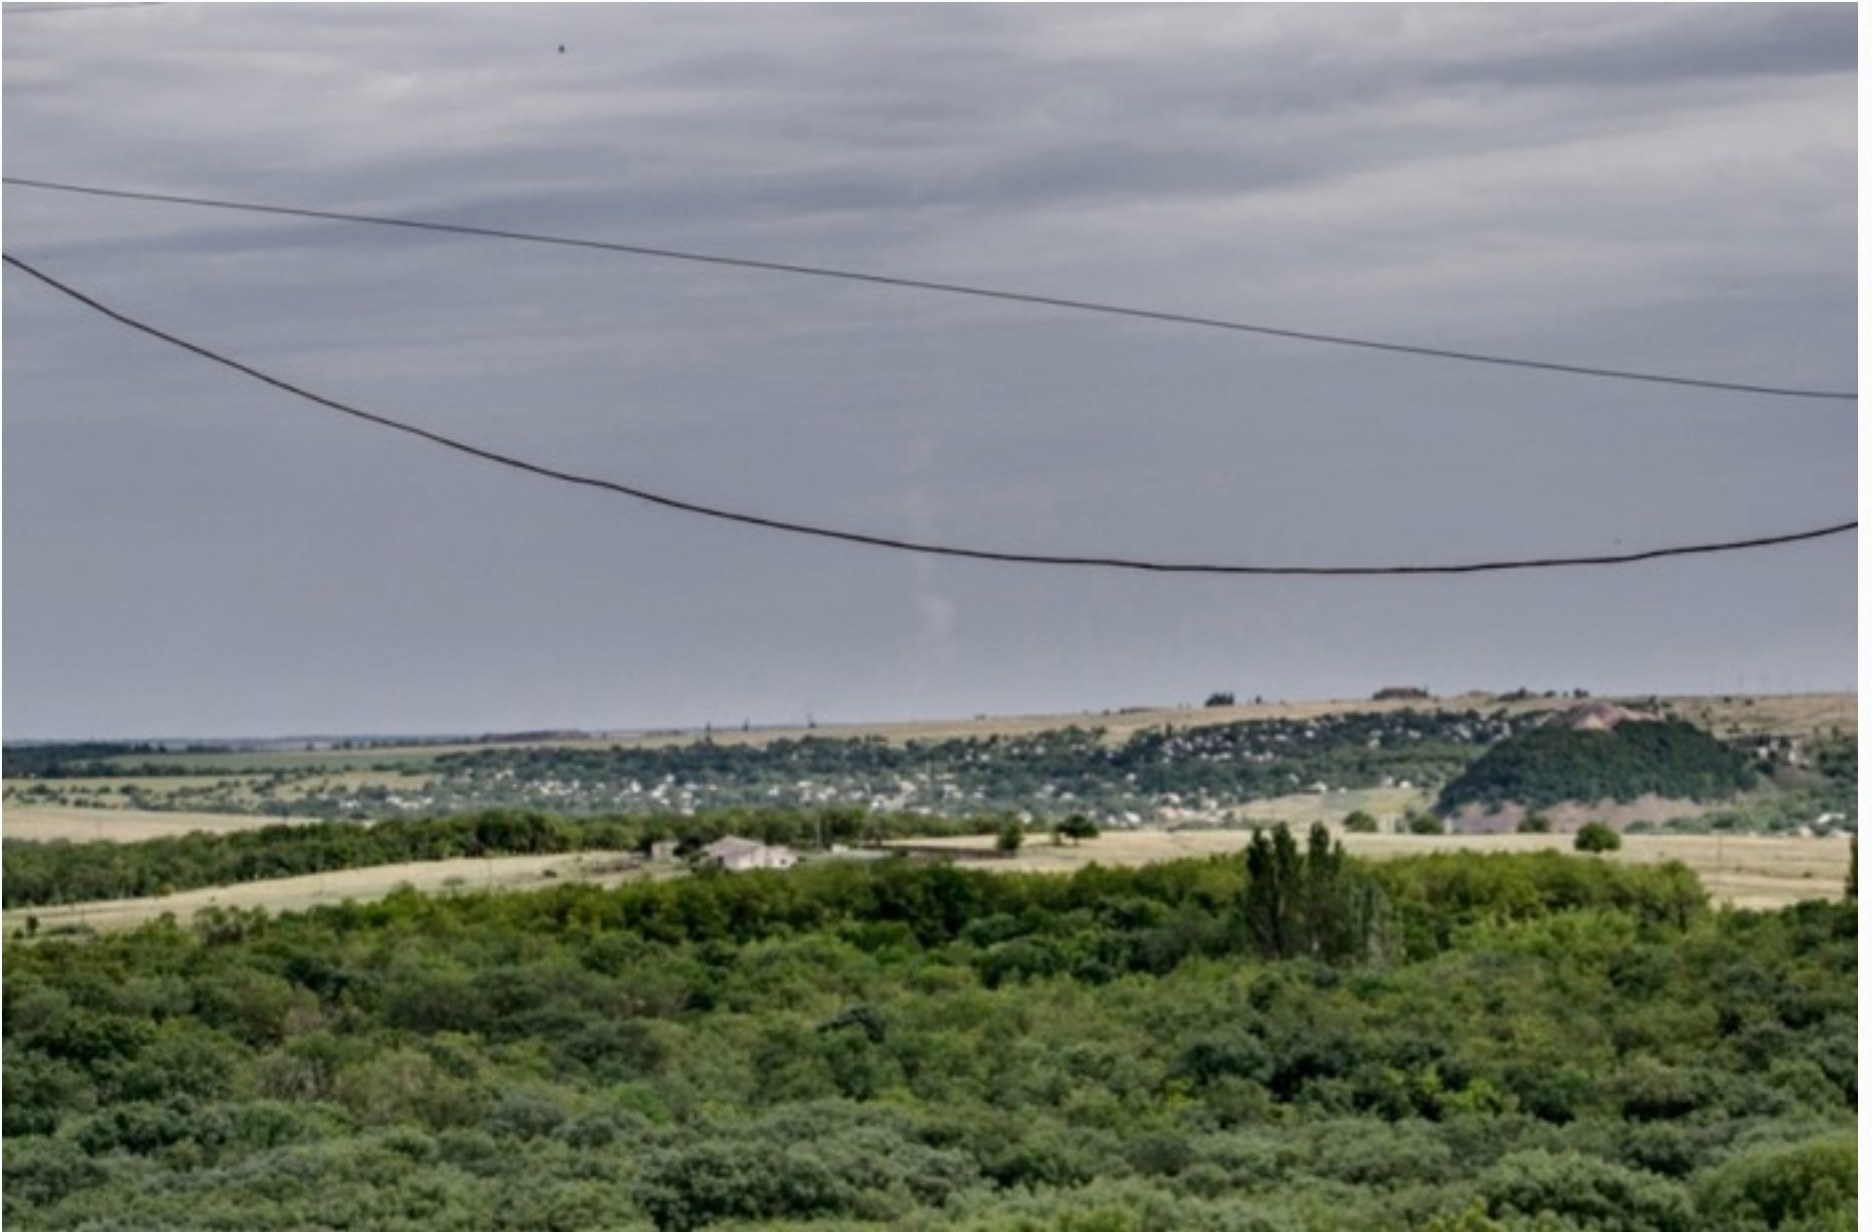
### **Smoke trail from the missile that downed MH17, taken from Torez**

Shortly after local residents heard the first of a pair of loud noises, a man who lives in Torez took the photograph seen above, showing the white trail of a missile launch from a field south of Snizhne, Ukraine. This photograph, which is one of three known images showing the trail of the Buk missile that downed MH17, was shared on Twitter hours after the shoot-down, and has since been analyzed and verified by multiple independent experts.

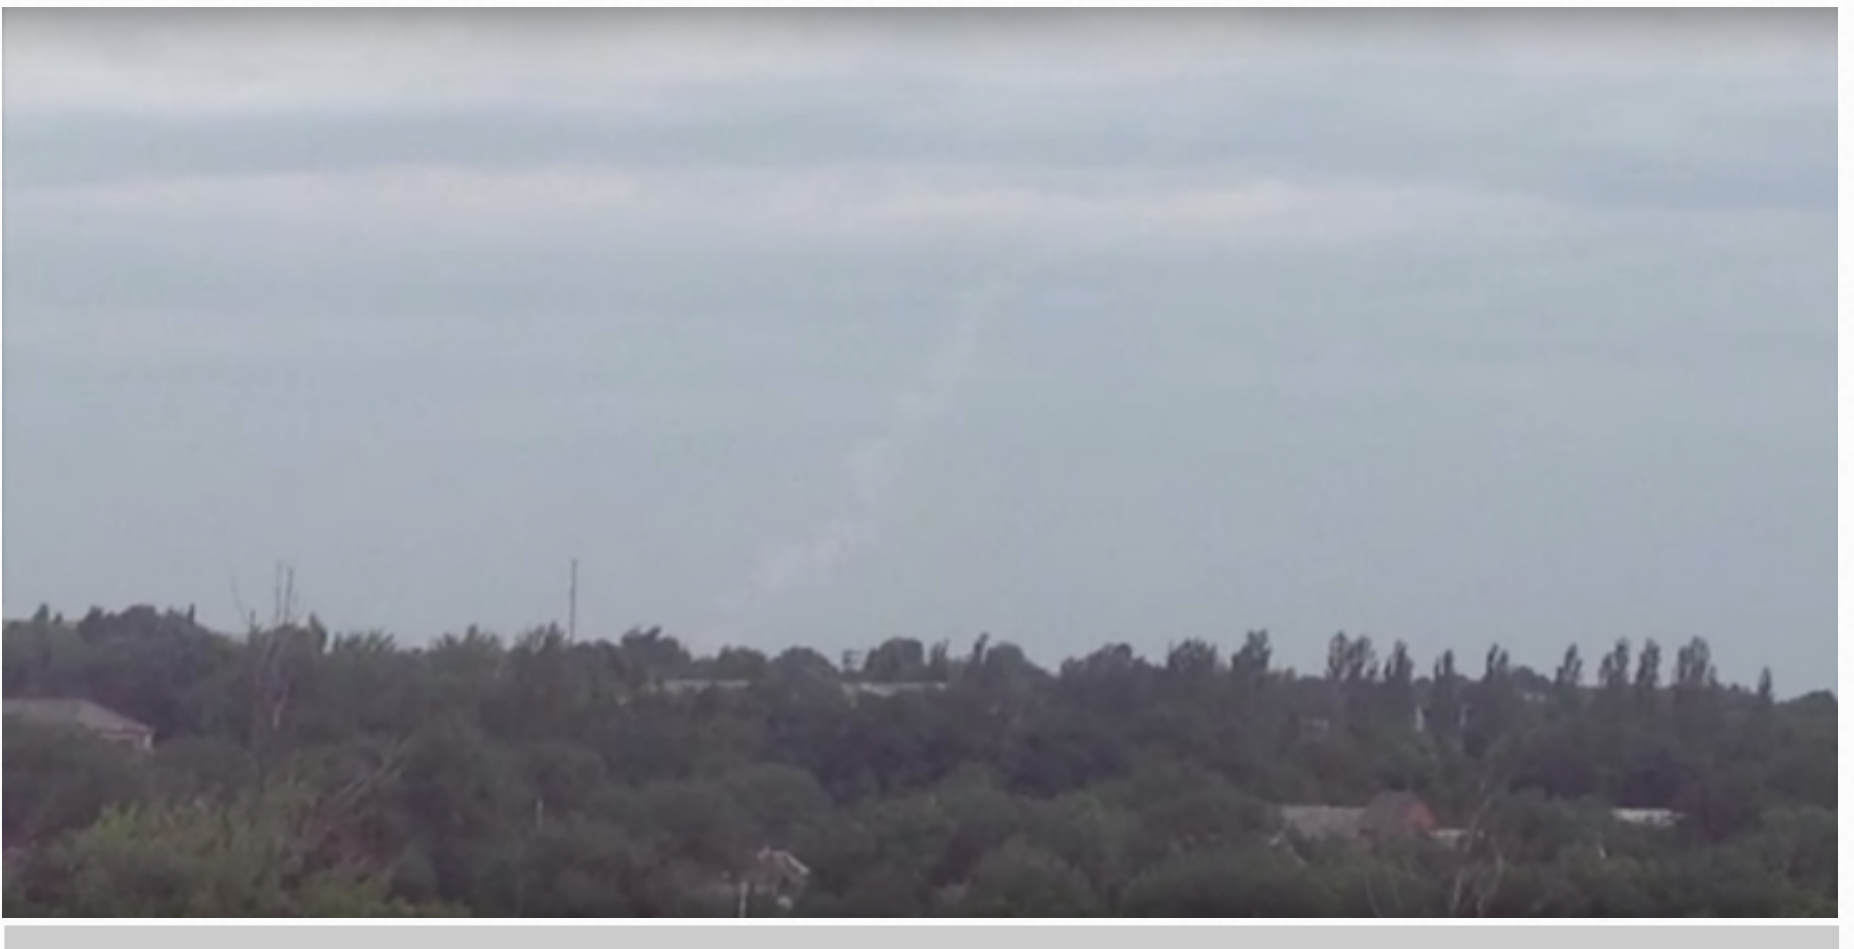
Both the forensic investigation into the downing of MH17, the Dutch Safety Board (DSB), and the criminal investigation, the JIT, have confirmed this assessment, pointing to a field south of Snizhne as the launch location for the Buk missile that downed the plane. At their September 28, 2016 press conference, the JIT published a photograph received from a local witness that had not been previously published. In this photograph, taken from north of the launch location, we see the same smoke trail as in the image shared by @WowihaY.

### **Buk missile smoke trail shown by the JIT in a press conference**

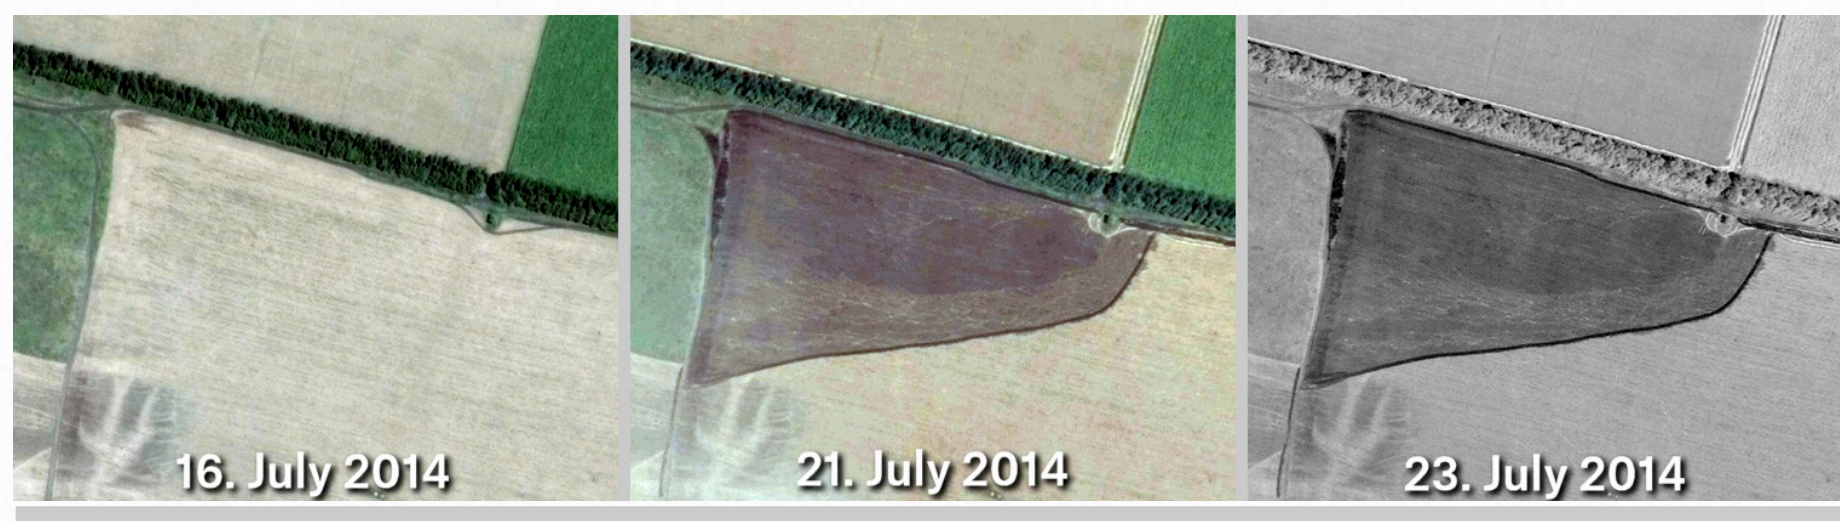
Satellite imagery of the site reveals that between July 16 and 21, 2014 the corner of the field was significantly altered, and new track marks appeared in the area between the dates.

**Field south of Snizhne between July 16 and 23 (Source Google Earth/  
Digital Globe)**

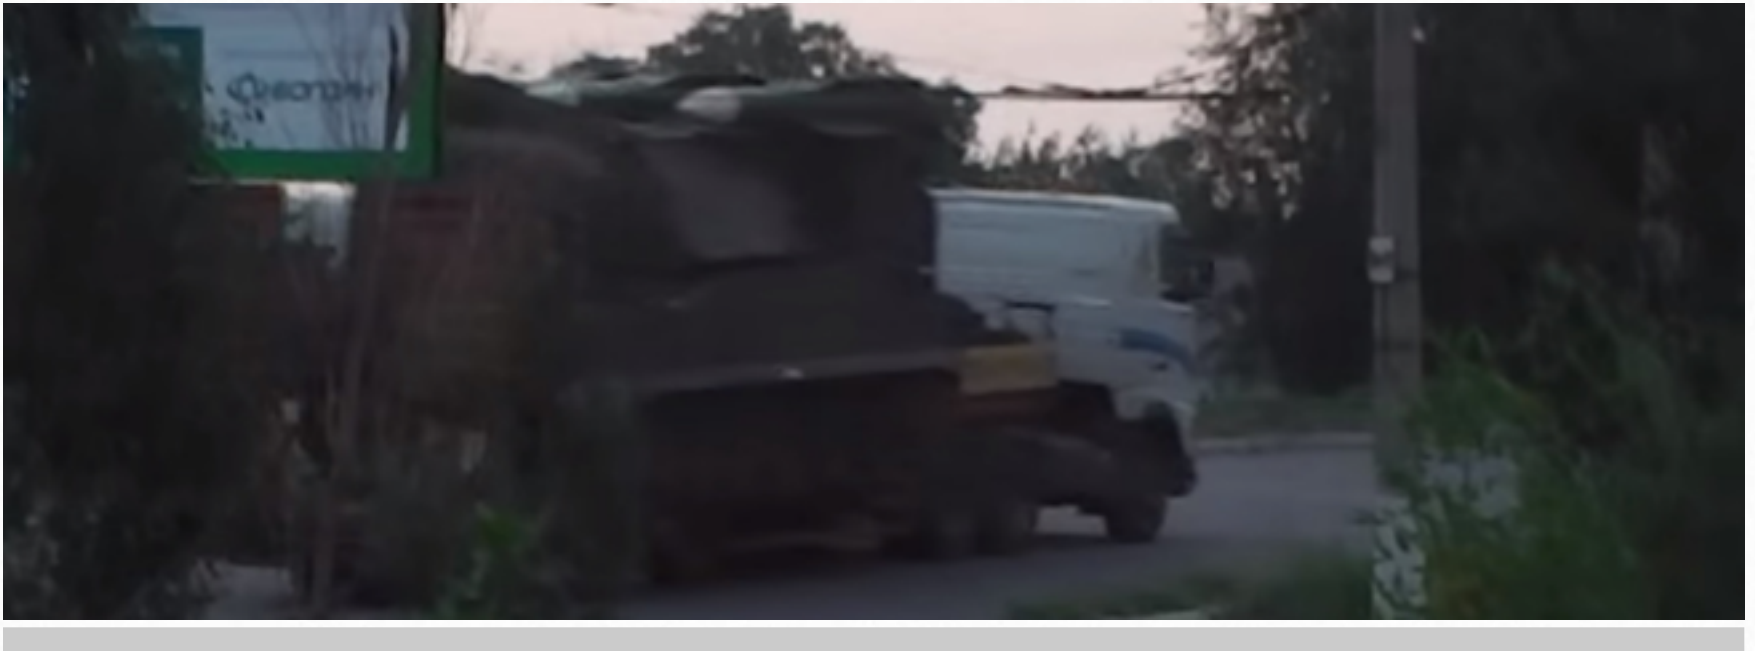
**Buk 332 being transported through Luhansk on July 18, 2014**

On July 18, 2014 the Ukrainian Ministry of Interior [published a video](#) filmed in the separatist-controlled city of Luhansk, in which they claimed to show a Buk heading towards the Russian border on the morning after the downing of MH17. A recent report from the Dutch channel NOS reports that this video was filmed by a Ukrainian policeman from a safe-house, whose job was to report on all military convoys moving along the filmed road. In this video, the Buk only had three missiles, instead of the four missiles that it had in Makiivka approximately five hours before the shoot down. Ukrainian Minister of Interior Arsen Avakov later [published the coordinates](#) of where the video was recorded, which were confirmed both by geolocation and news organizations visiting the site.

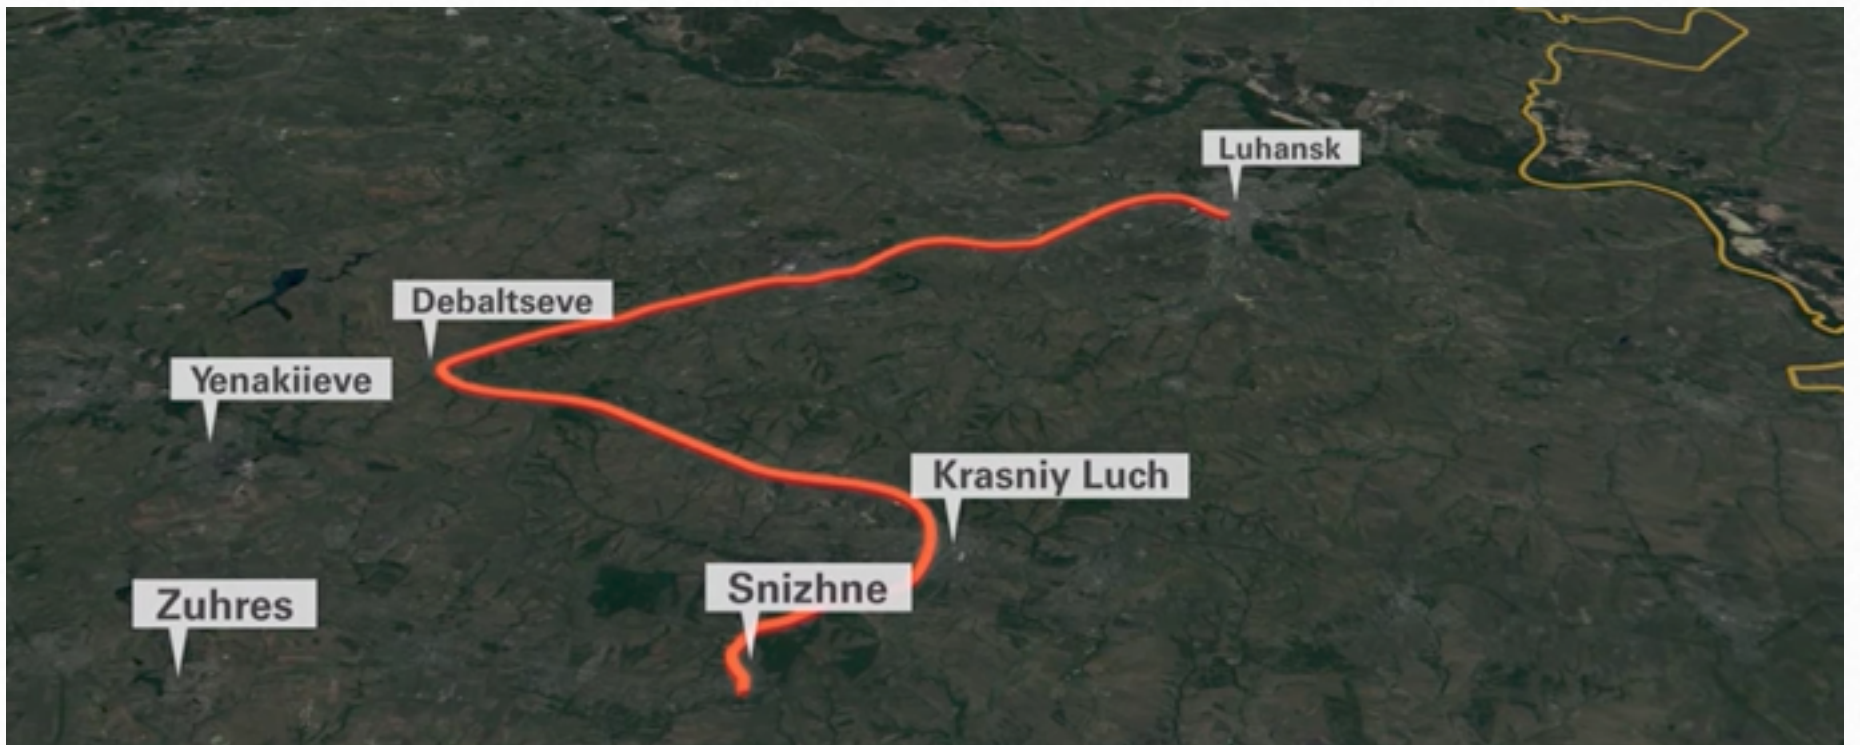
**JIT graphic showing the Buk's route from Snizhne to Luhansk**

The JIT has determined that before the Volvo and Buk reached Luhansk, where it was filmed in the early hours of the morning, it traveled a roundabout route through through Krasniy Luch, to Debaltseve, and finally to Luhansk, where it was filmed passing along Vu-lytsia Pavlivska-Nechuya Levytskoho. The JIT determined that this route was taken through information received through “telecommunications data.”

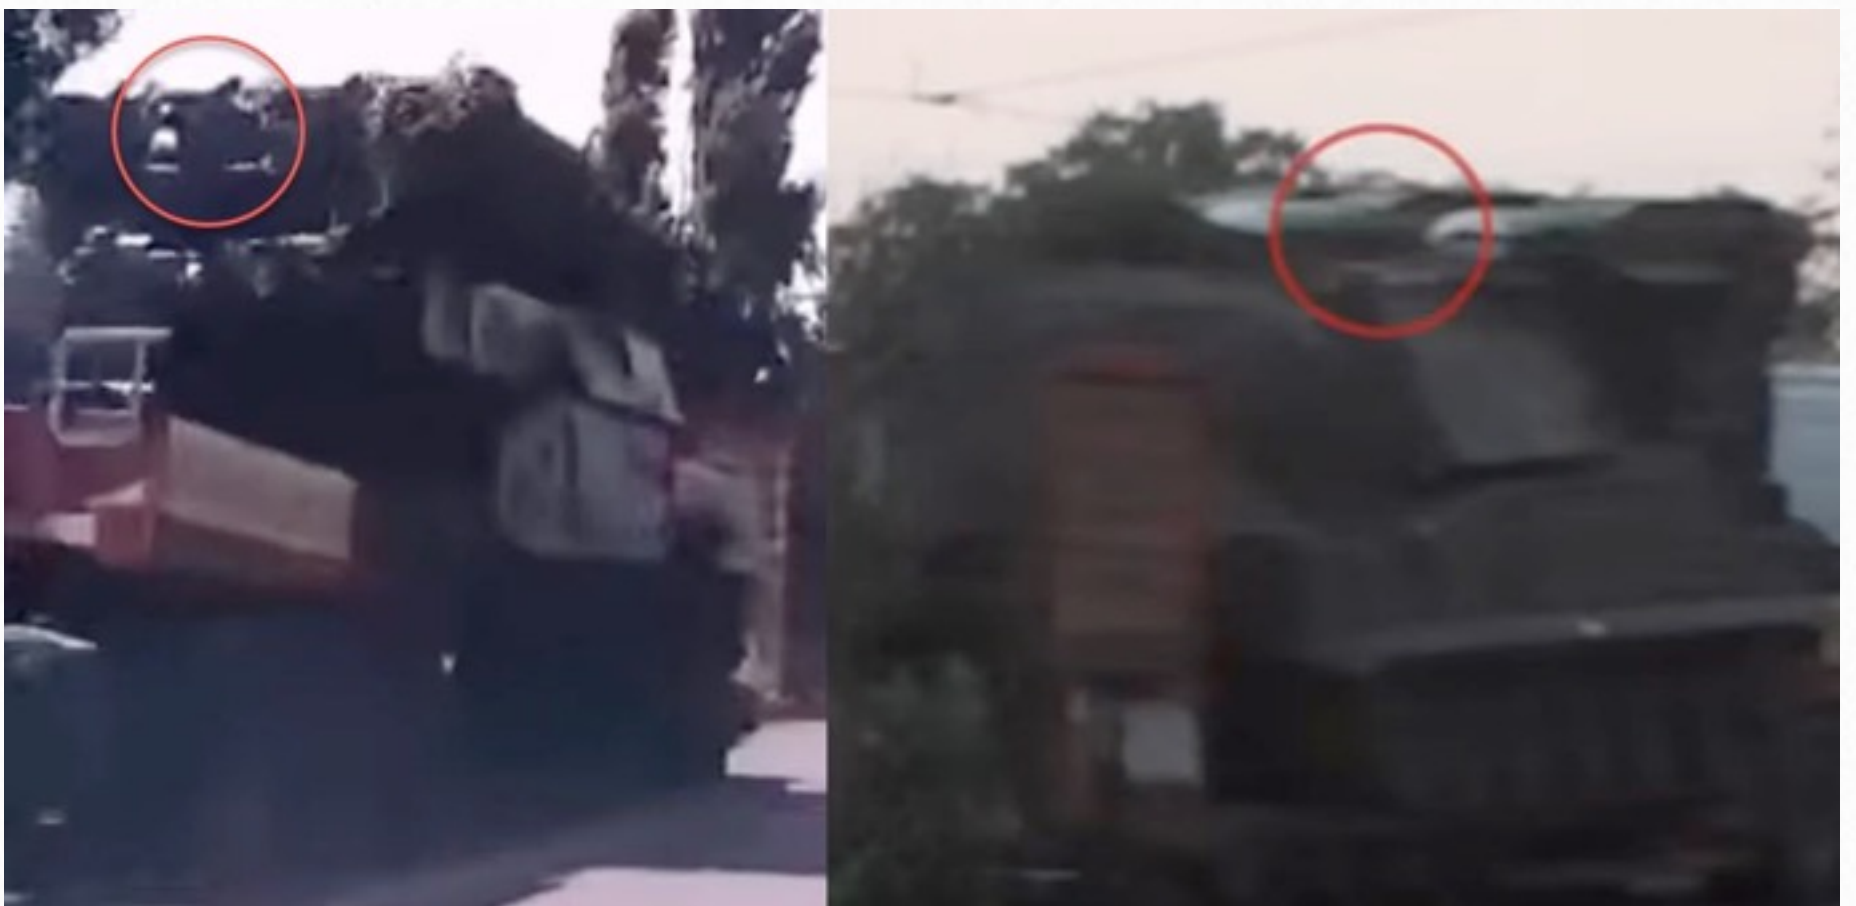
**Comparison of Buk 332 in Makiivka on July 17, 2014 (left), with the third missile from the driver's side present, and Buk 332 in Luhansk on July 18, 2014 (right) from the JIT's September 28, 2016 press conference, with the third missile from the driver's side missing**

- Buk 332 was next filmed traveling east through the separatist-controlled city of Luhansk on the morning of July 18, 2014 missing one missile. Intercepted communications indicate that the missile launcher was taken into Russia shortly after this video was filmed.

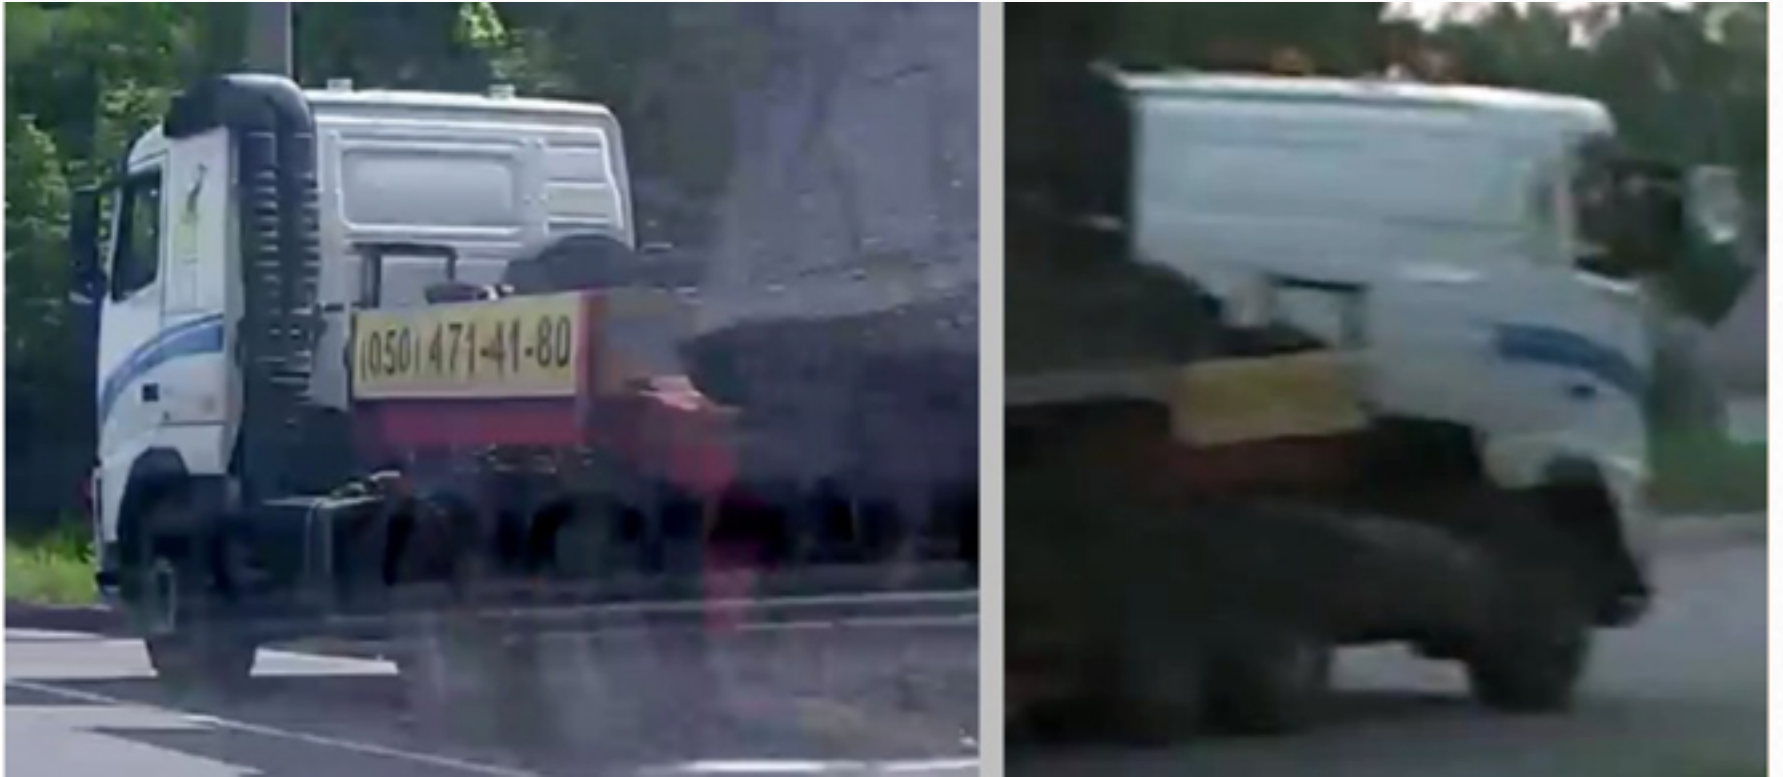
### **The Volvo truck in Donetsk (left) and Luhansk (right)**

The Volvo truck that transported the Buk on July 17 and 18 was seized by separatists from the vehicle yard of Stroymekhanizatsiya, located in northern Donetsk. A [2013 video filmed in Crimea](#) shows this same Volvo being used, including the same yellow placard with a phone number. Soon after the downing of MH17, [journalists contacted the owner of the truck](#), confirming that the vehicle that hauled the Buk is the same that was captured by separatists in Donetsk. In the interview, he told the journalists:

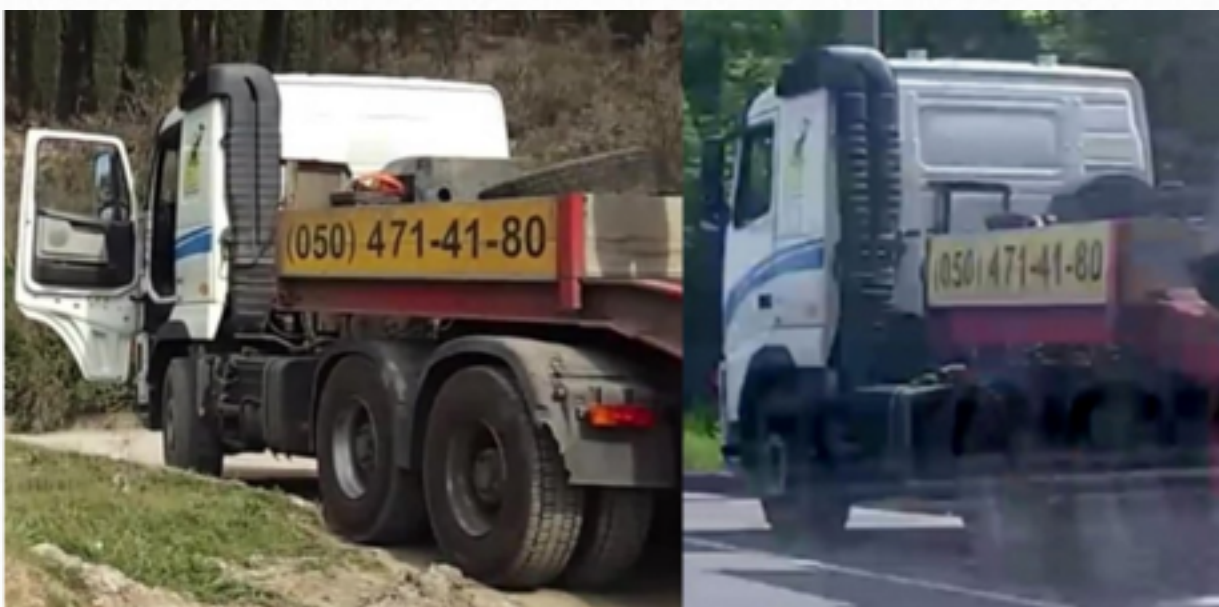
**The Volvo truck when it was filmed by its owners, Stroymekhanizatsiya, in Crimea in 2013 (left) and with the Buk in Donetsk on July 17, 2014 (right)**

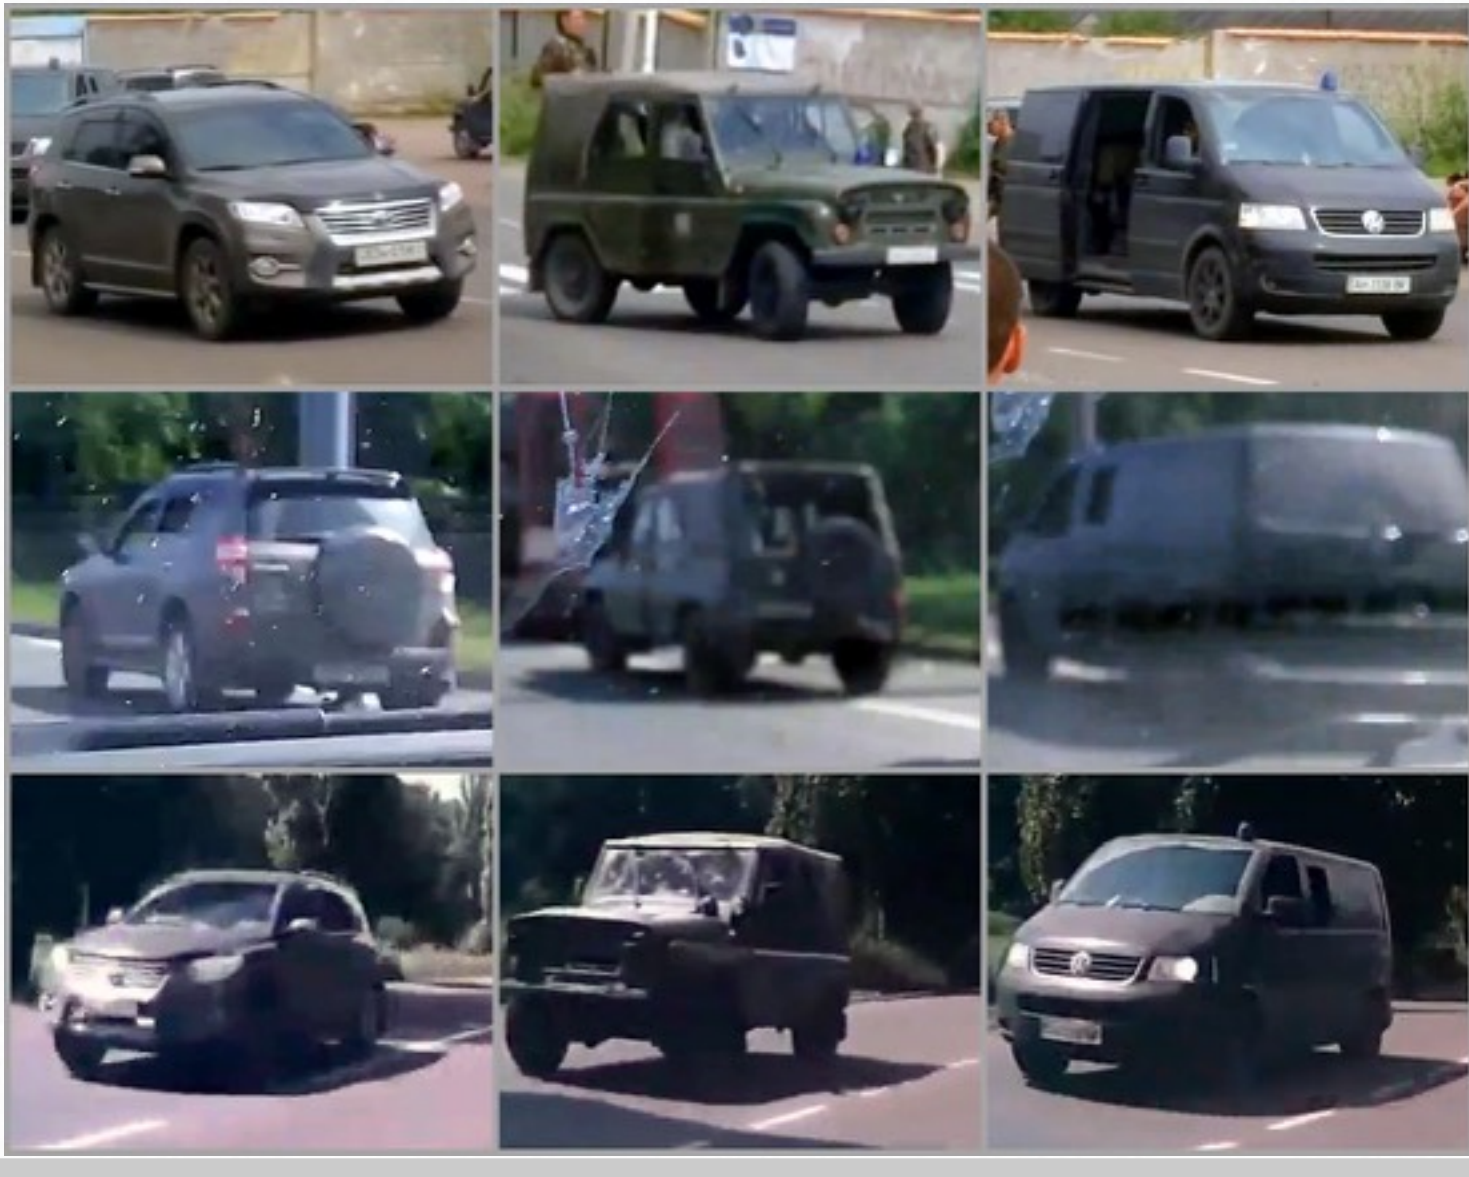
**The three vehicles that escorted the Buk through Ukraine on July 15 (top), July 17 in Donetsk (middle), and July 17 in Makiivka (bottom)**

The Buk that downed MH17 was hauled by a Volvo truck and accompanied by three vehicles operated by DNR forces: a dark-blue Volkswagen van, a Toyota RAV4 SUV, and a UAZ-469 jeep. These three vehicles were a part of a convoy on July 15 (two days before the downing) on roughly the same route that the Buk traveled on in eastern Ukraine.

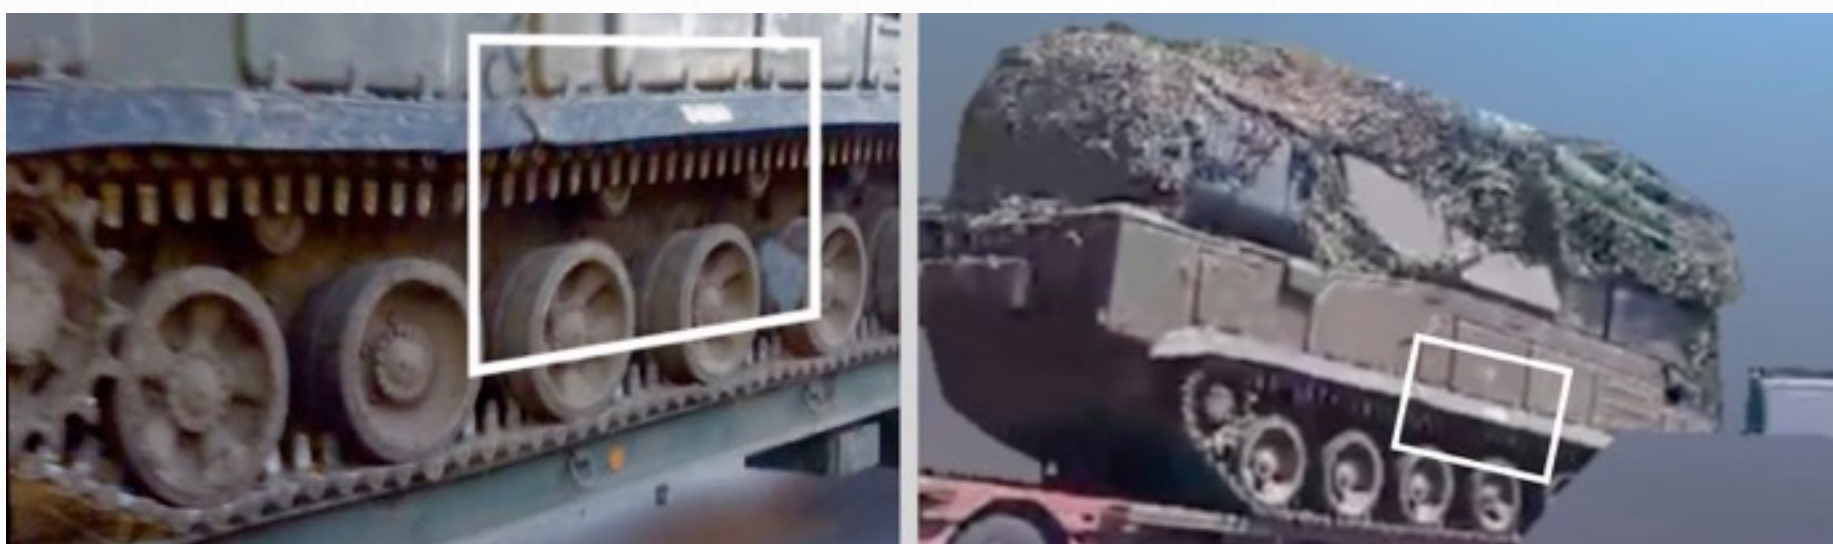
**White mark on Buk 332 in Russia in June 2014 (left) and the same white mark on the Buk filmed in Torez from the JIT press conference (right)**
