# MH17

## The Open Source Investigation Three Years Later

## Introduction

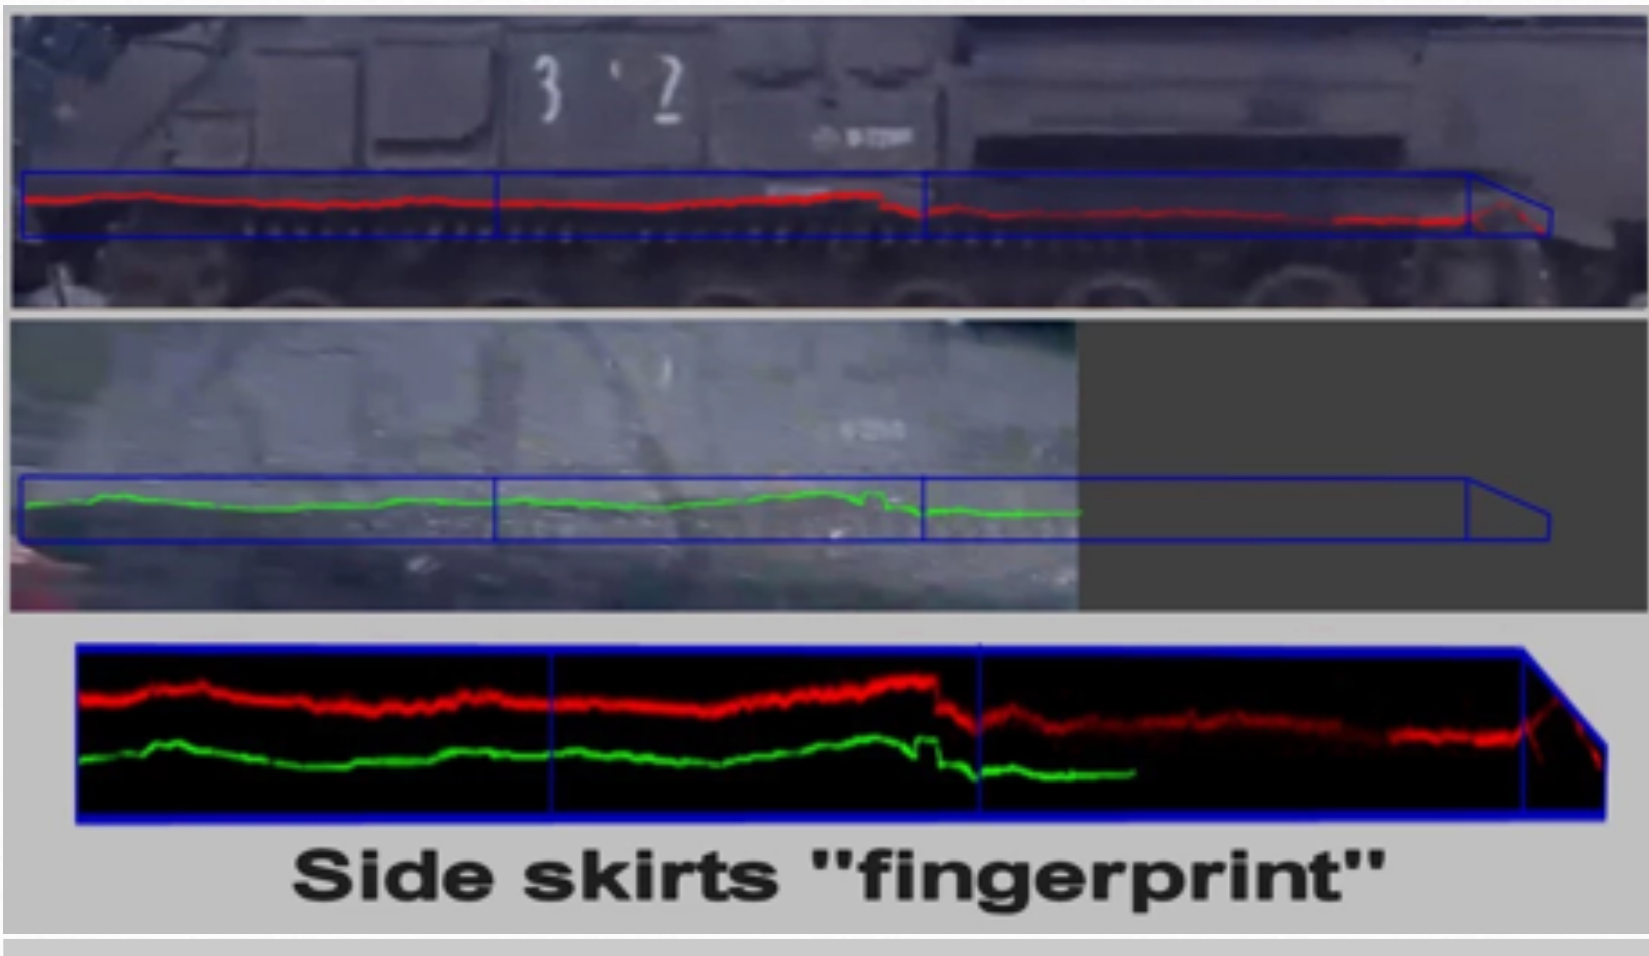
When comparing the side skirt profiles of Buk 332, the Russian Buk seen headed towards the Ukrainian border in late June, and the Buk photographed in eastern Ukraine on the day of the tragedy, there is a positive identification:

**Side skirt comparison between June (above, in Russia) and July (below, in Ukraine) 2014**

The strong “spike” in the waveform below the white marking (which reads “H-2200,” a code used for oversized railway cargo frequently found on Russian military equipment) can be identified by examining photographs of the Buk in Russia and Ukraine.

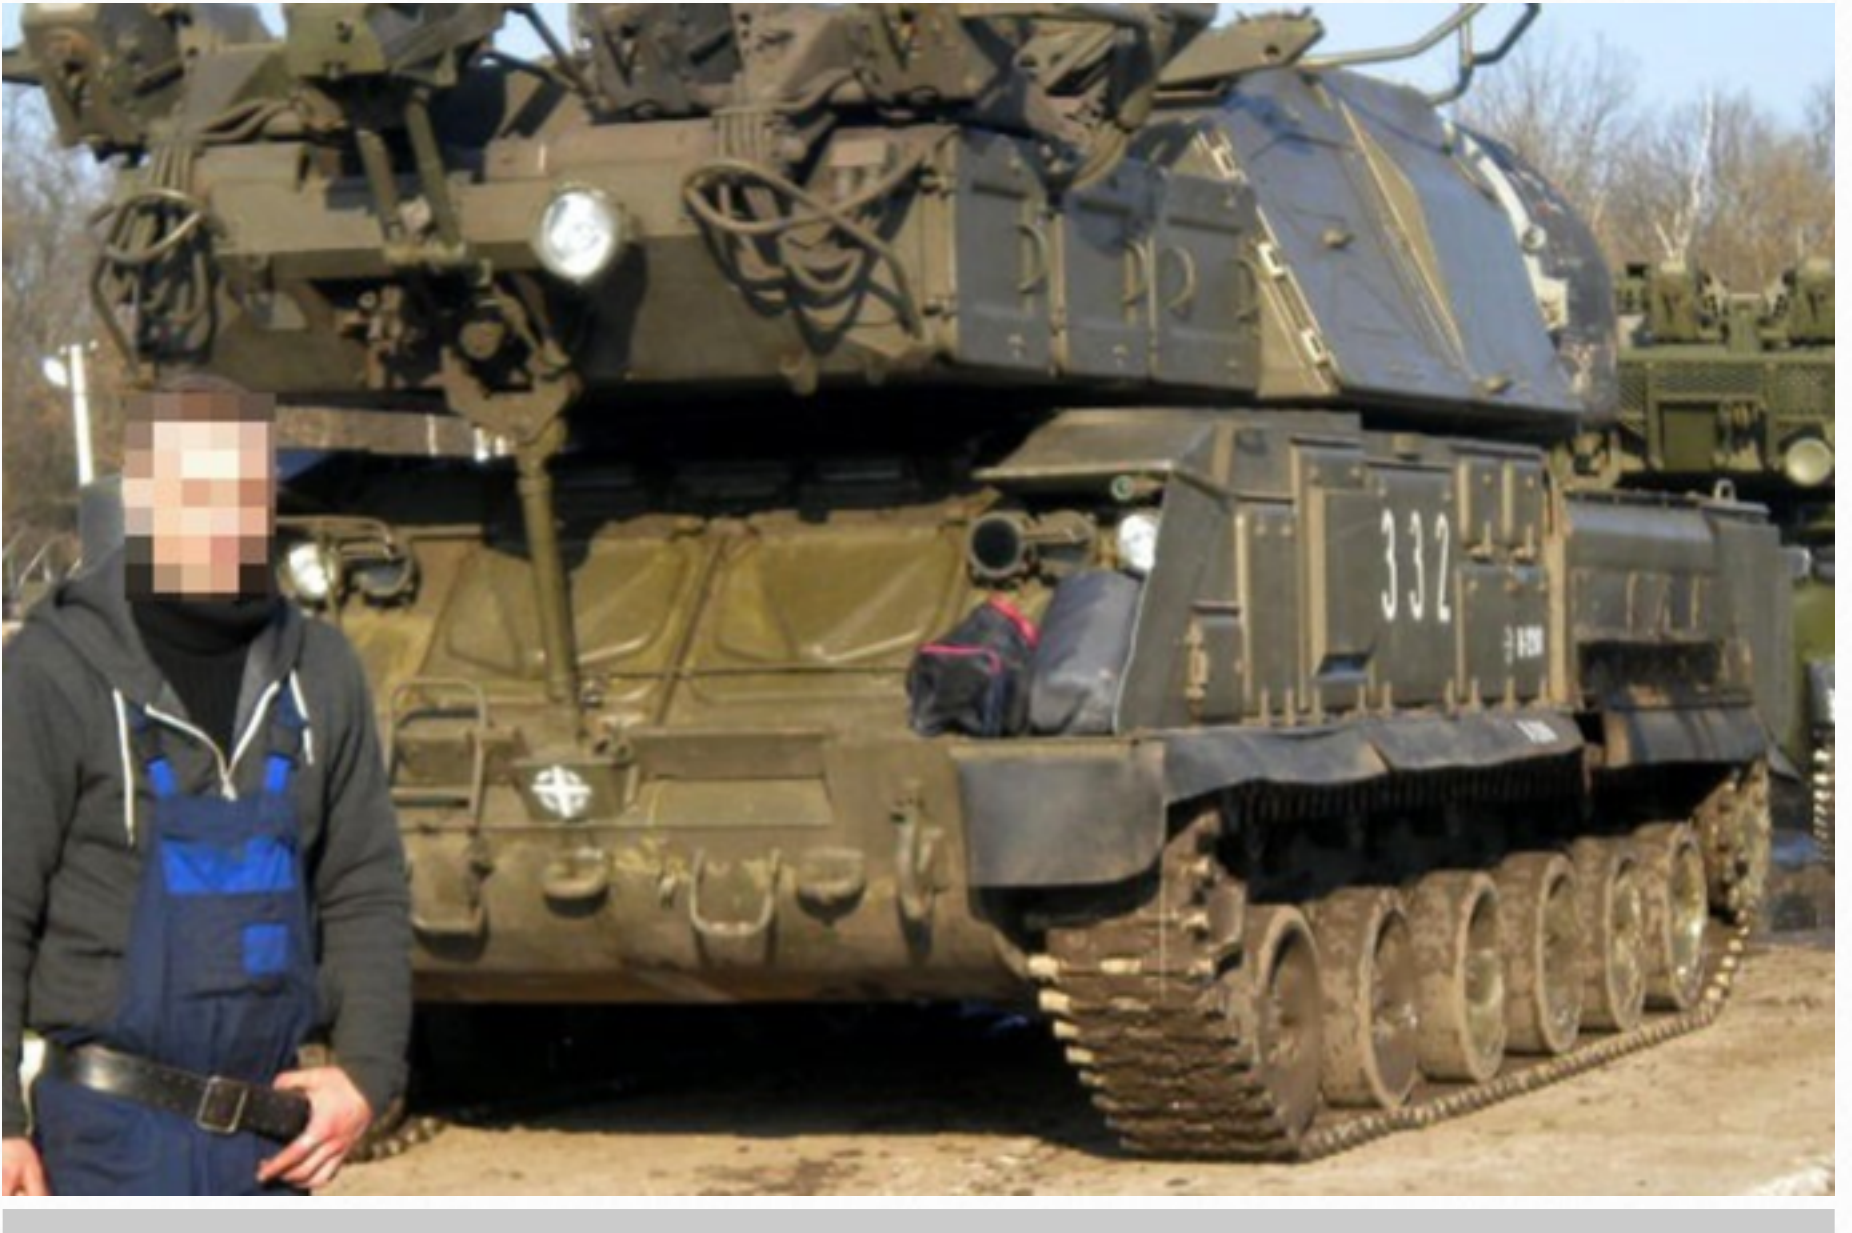
### **Buk 332 in Russia, in the spring of 2013**

This tear on the rubber side skirt can be identified in the exact same location on the Buk seen in Ukraine. Over the past three years, members of the Bellingcat investigation team have compared the features of Buk 332, seen both in Russia and Ukraine in the summer of 2014, with every other Buk photographed or filmed in 2013 and 2014 in Russia and Ukraine discovered by investigators. No other Buk has even half of the same details seen on this Buk, including the digits, placement and dimensions of the various white marks, the side skirt “fingerprint” profile, and other features. The censored video made public by the JIT showing Buk 332 further confirmed this identification and allows a match of the features of both sides of the Buk, rather than just the left side.

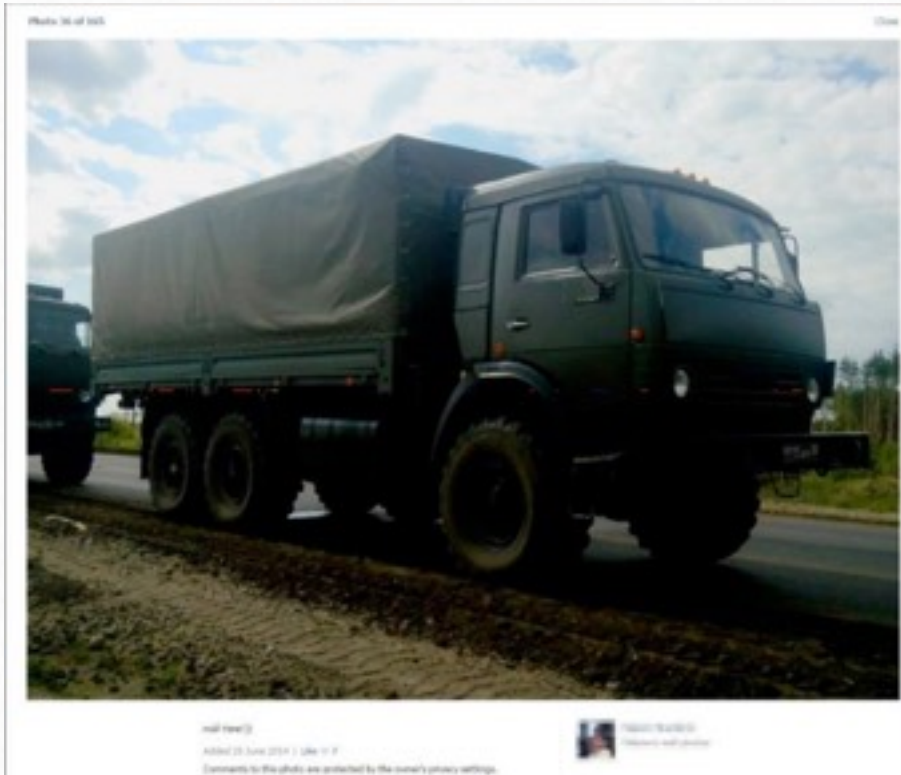
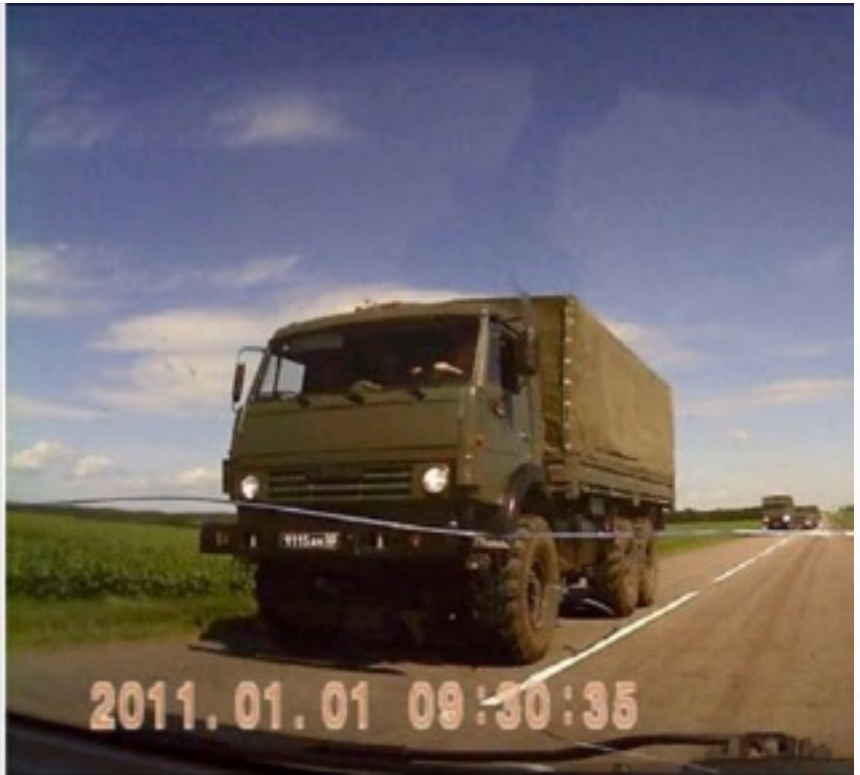
### Vehicle in the June 23-25, 2014 convoy on VK and dash cam

The full power of open source information gathering can be seen in the reconstruction of the convoy of the 53rd Anti-Aircraft Missile Brigade from their base near Kursk to the Russia-Ukraine border in June 2014. This convoy, which included Buk 332, was photographed and filmed by ordinary Russians who lived along this convoy's route. Each of the images and videos were geolocated to the exact location where it was captured, providing an accurate representation of the convoy's route.

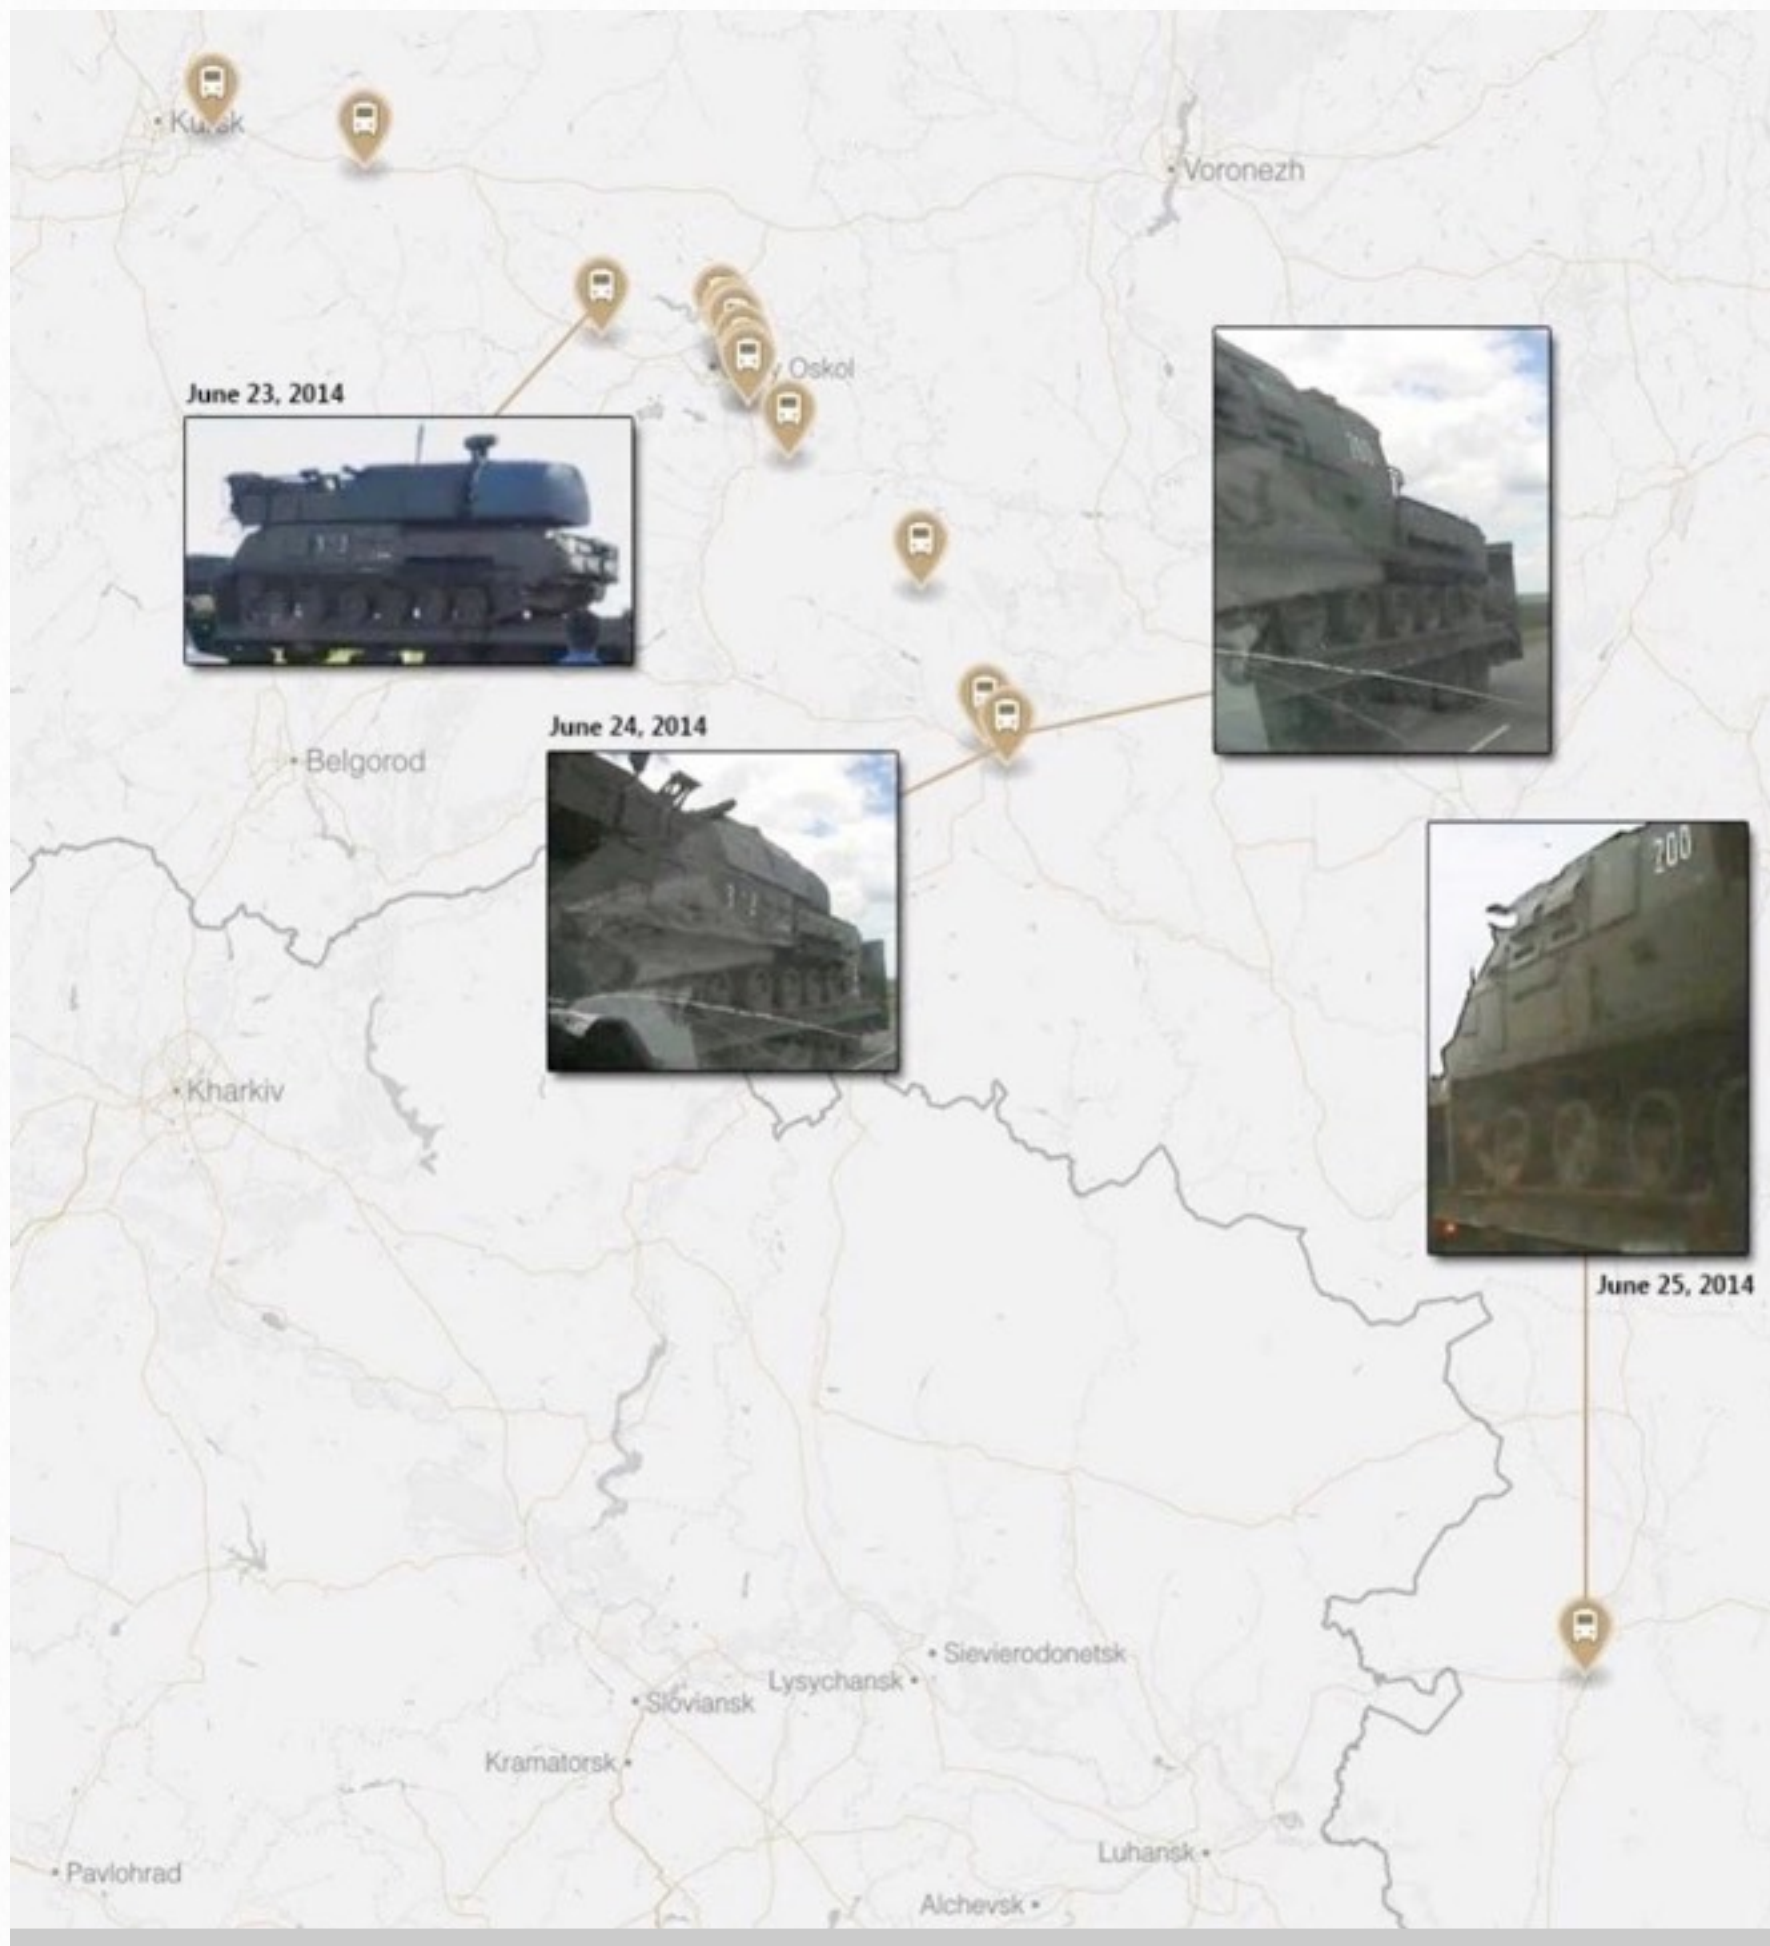
**Route of the June 2014 convoy that transported Buk 332 from near Kursk, Russia to Millerovo, by the Russia-Ukraine border**

By combining information regarding the organization structure of Russia's 53rd Anti-Aircraft Missile Brigade (seen in the previous page), and identifying the vehicles filmed in the June 23 - 25, 2014 convoy, we were able to determine that the second battalion of the brigade was involved in transporting the Buk that downed MH17 from its Kursk base to near the Russia-Ukraine border. While Buk 332 has a unit designation for the 3rd battalion, it was with the 2nd battalion because it served as a replacement for Buk TELAR 222, which was not present in the convoy.

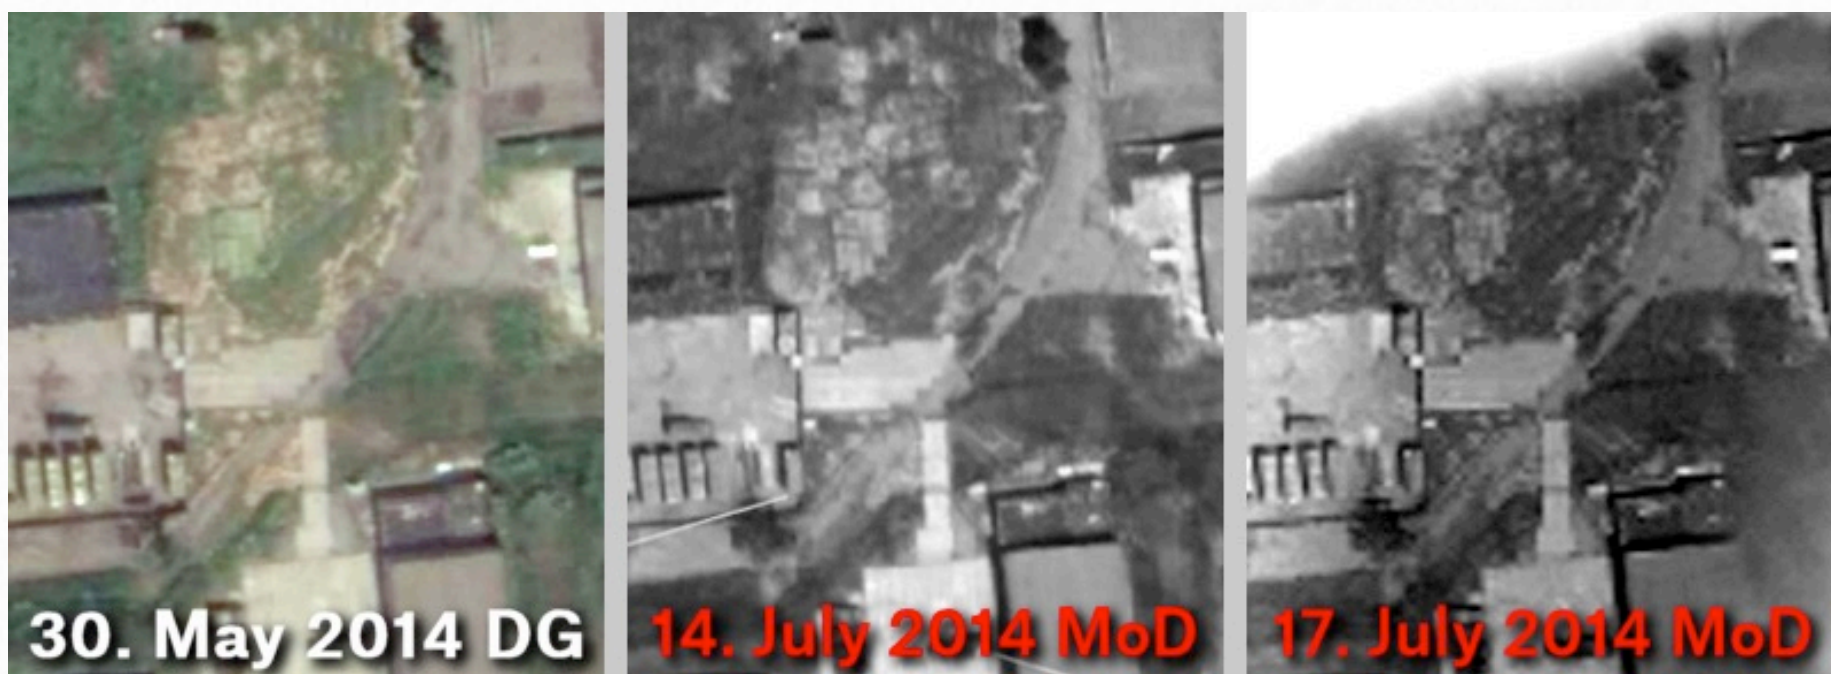
This is not the only discrepancy between the satellite imagery published by the Russian MoD and satellite imagery of the same location freely accessible on Google Earth. There is also an area where patches of grass were worn away in May 2014, but regrew by July 17. In the Russian MoD satellite imagery supposedly taken on July 14 and 17, this area strongly resembles satellite imagery taken on May 30, and looks nothing like that of July 17.

**Comparison of satellite imagery from Digital Globe of May 30, 2014 with the July 14 and 17 imagery published by the Russian MoD**

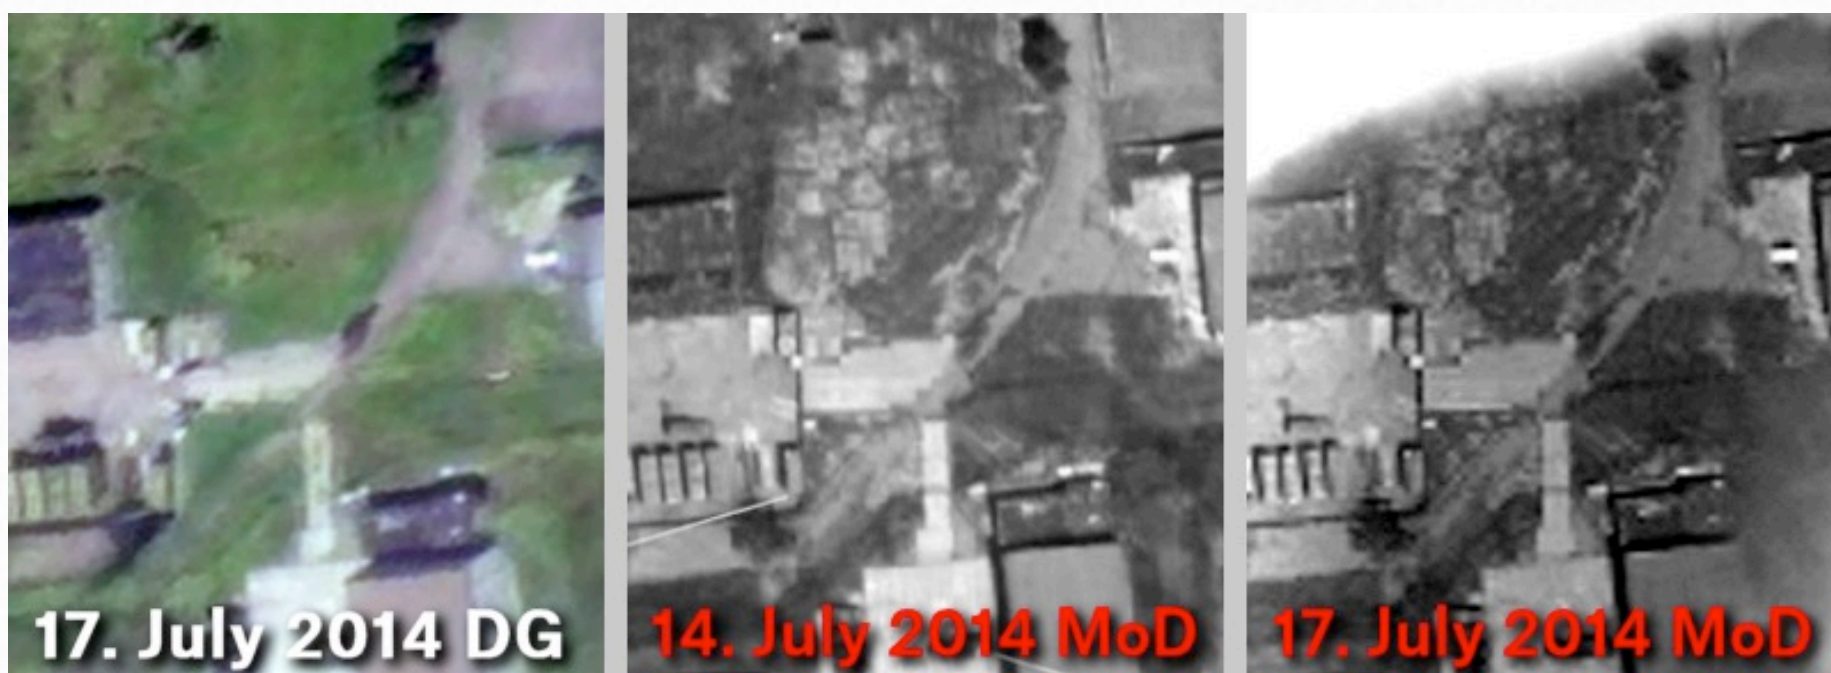
**Comparison of satellite imagery from Digital Globe of July 17, 2014 with the July 14 and 17 imagery published by the Russian MoD**

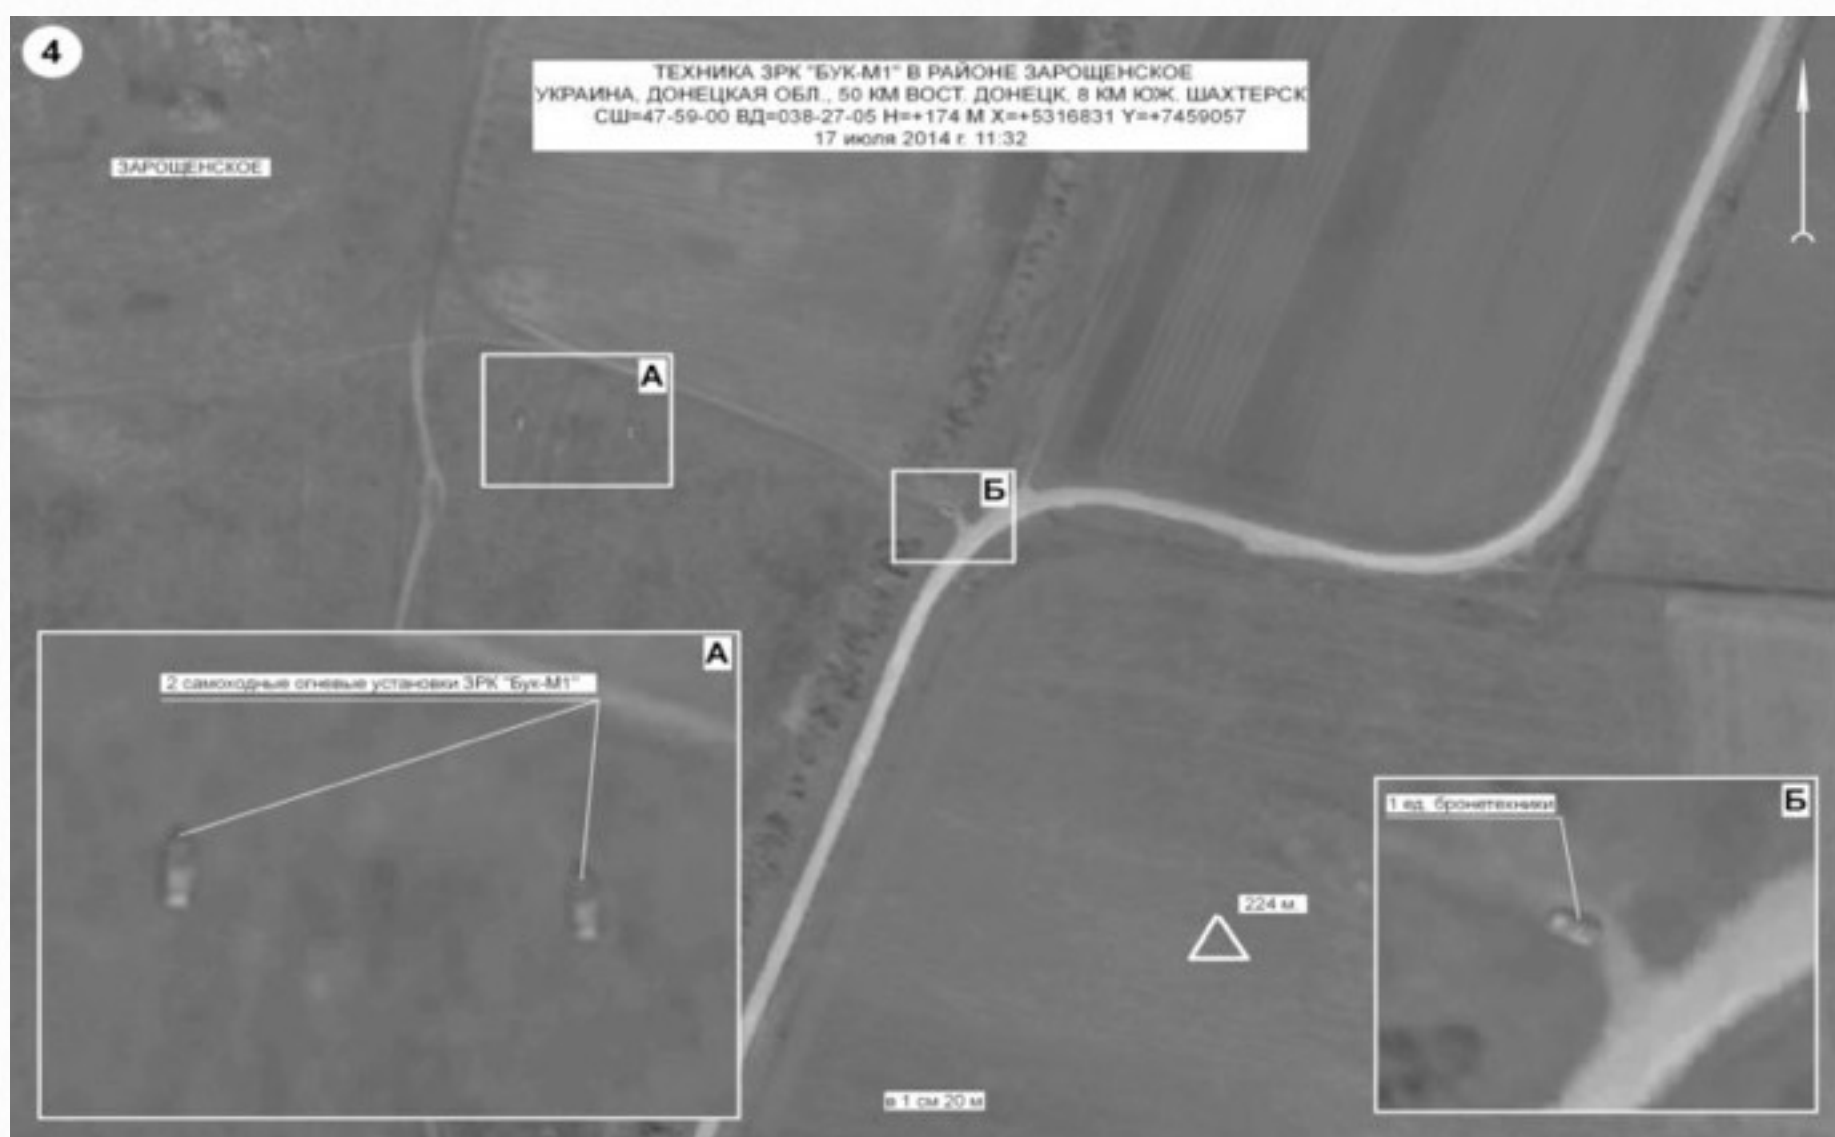
### Satellite image provided by the Russian MoD near Zaroshchenske

Even if we give the Russian MoD some leeway and allow that these two Buks near Zaroshchenske had nothing to do with the base A-1428 base, there are plenty of other questions surrounding this image. The forensic issues with this satellite image are explained later in this chapter, while the question of what happened, or more specifically what *did not* happen, in Zaroshchenske on July 17, 2014 is answered the subsequent chapter.

A similar conclusion was reached with the Zaroshchenske image. In this image, Lewis and his colleagues found that the two Buk missile launchers in the field were digitally added:

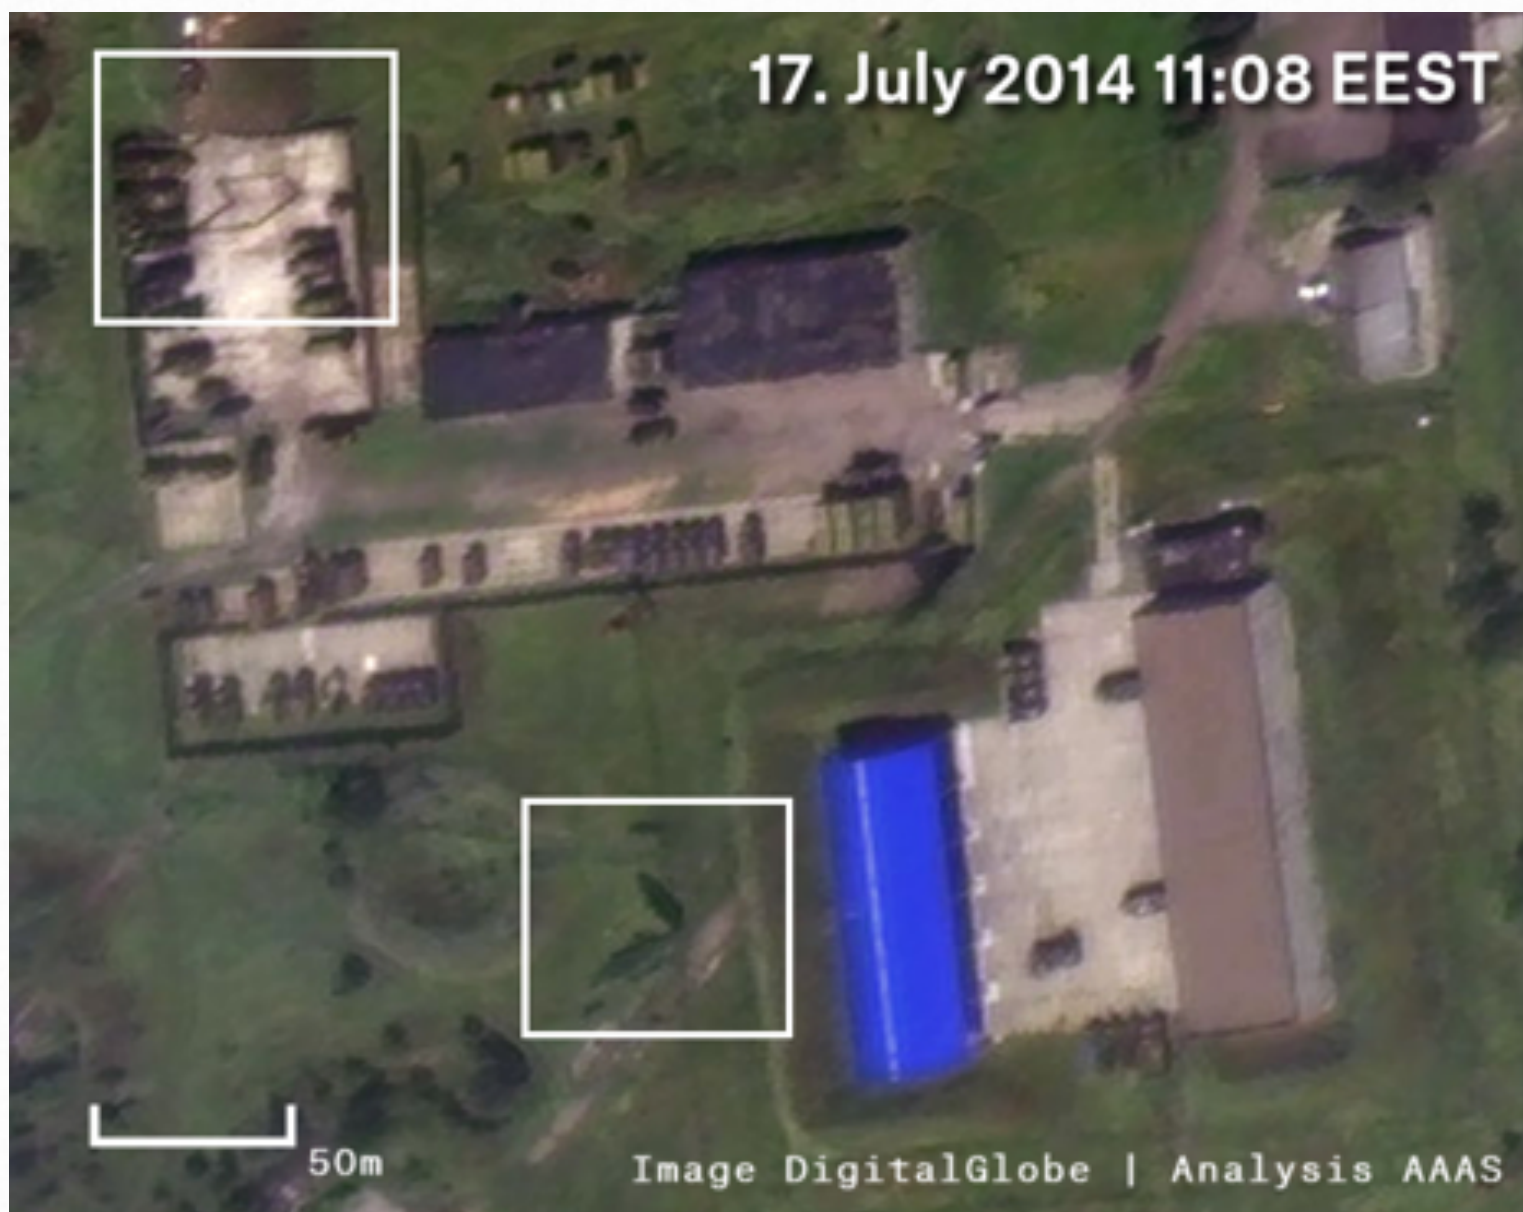
In Spring 2016 Bellingcat contacted the Geospatial Technologies Project at the American Association for the Advancement of Science (AAAS) with a request to independently review the satellite images provided by the Russian MoD on July 21, 2014. AAAS tasked two analysts who each independently reviewed these images, and the AAAS responded to Bellingcat with details of their findings. They found that the shadows of two objects (seen below) on the Russian MoD's satellite images do not correspond with the given dates provided by Russia, meaning that either the time, date, or both time and date of the satellite image are incorrect.

**Image highlighting the object used to measure solar azimuth**

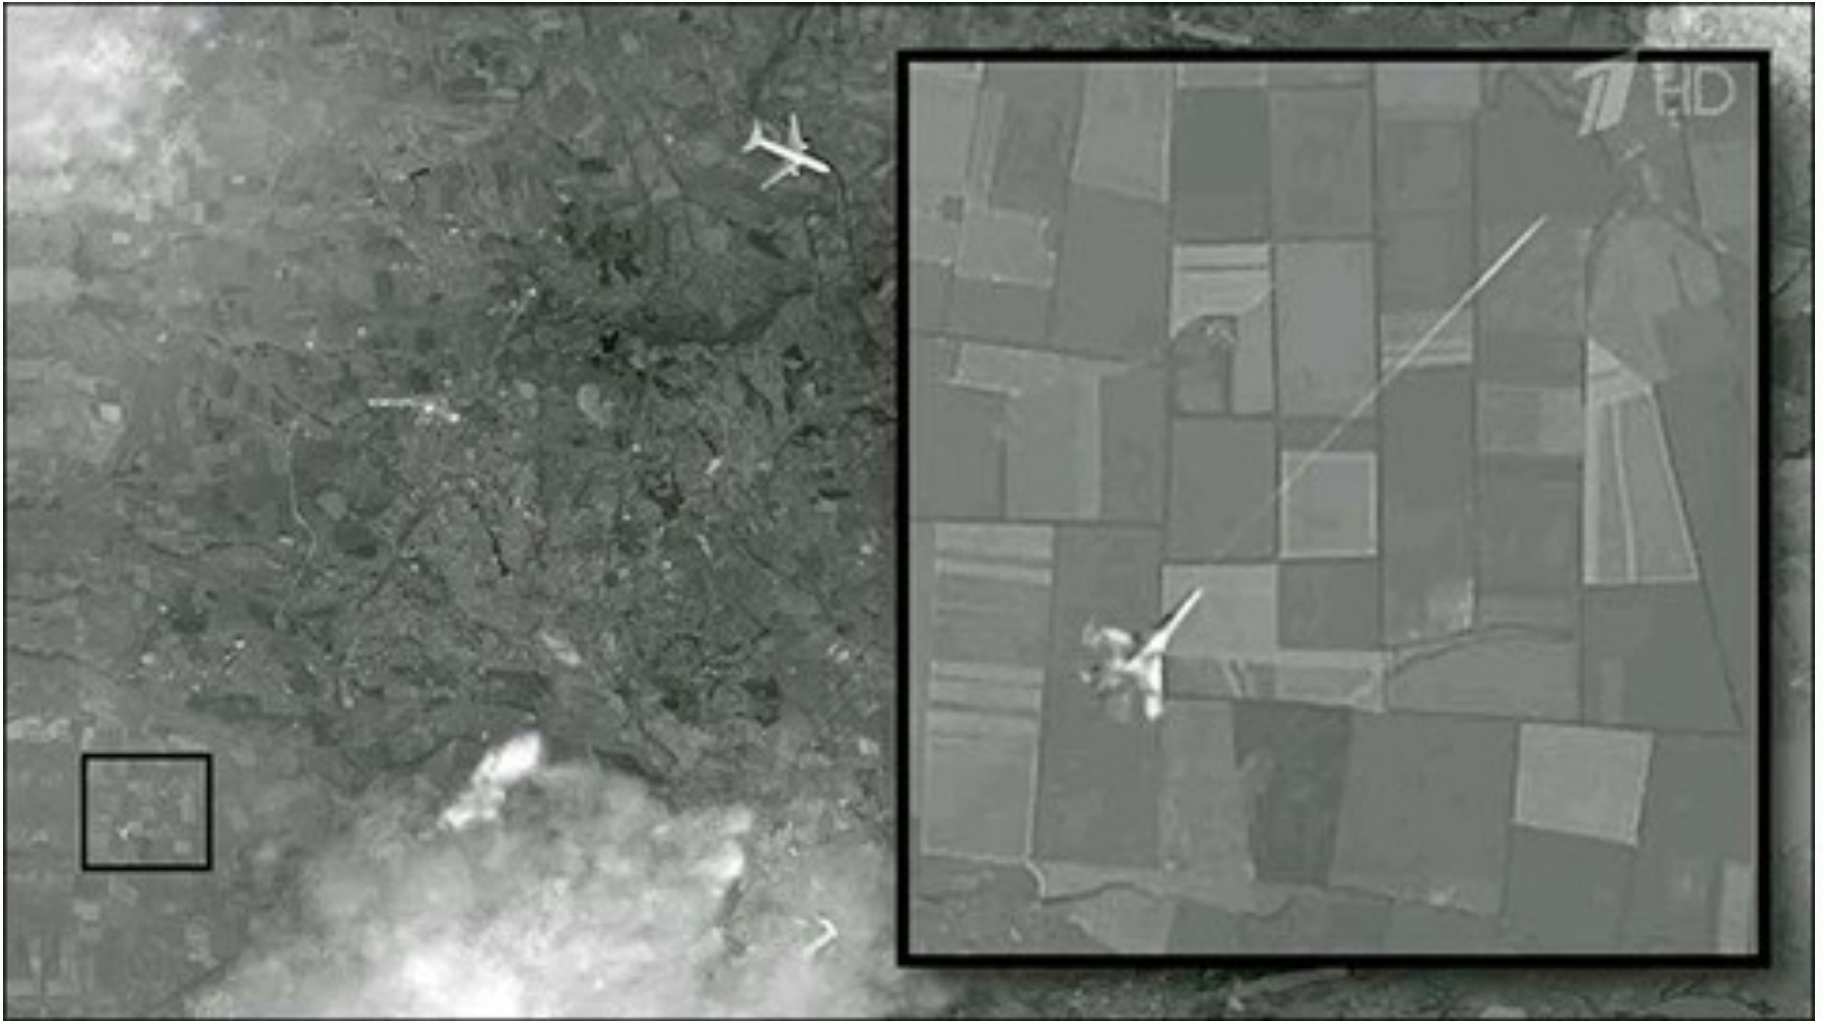
Screenshot from Channel One program showing “shoot down” of MH17

The Vice President of the “Russian Union of Engineers” told Leontiev that “We can assume that the photograph was taken by an American or British satellite. We have studied the photograph in detail and found nothing suggesting that it is fake.”

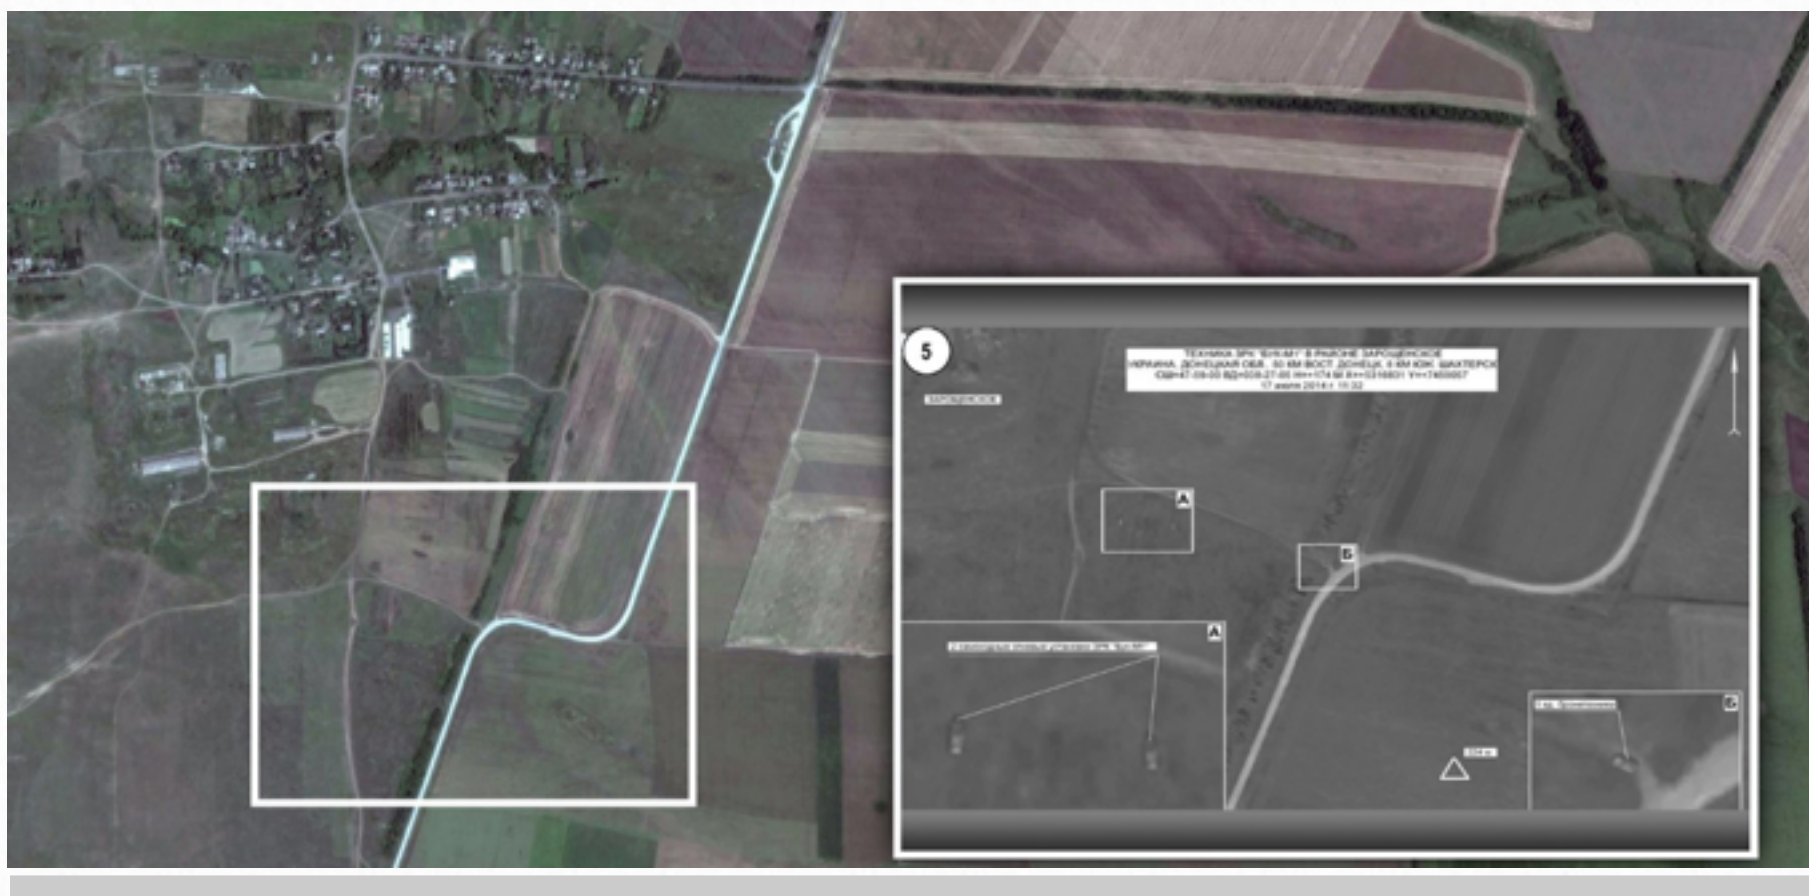
Satellite images captured on July 16 and 21, 2014 show no signs of any track marks from the movements of large vehicles or burn marks from missile launches at the site shown in the Russian MoD satellite imagery. In addition, satellite imagery analysis by Dr. Jeffrey Lewis using the Tungstene forensic imagery analysis software shows the Russian MoD imagery of the area close to Zaroshchenske are heavily modified, with the Buk missile launchers features apparently pasted into the image (see page 56 for more details).

### **Russian MoD's proposed missile launch site, near Zaroshchenske**

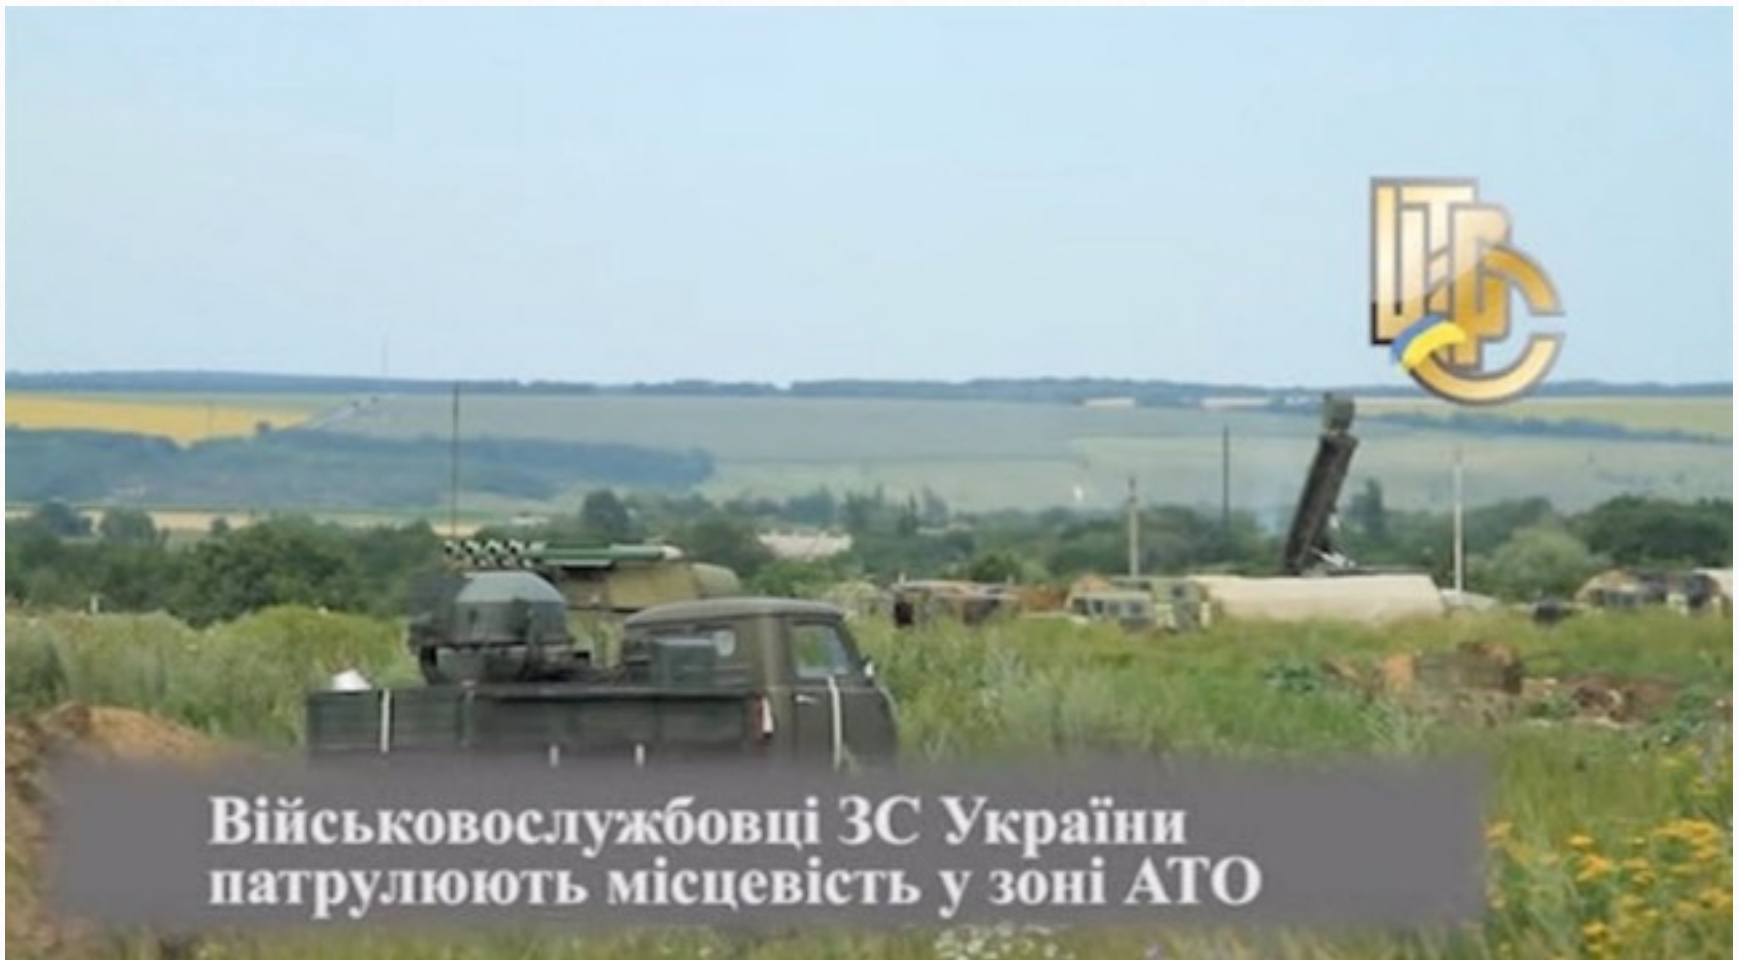
**Screenshot from segment filmed by Ukrainian Military TV showing a Ukrainian Buk, aired on July 16, 2014**

Another Ukrainian Buk in question is the one filmed during [a segment aired by Ukrainian Military TV on July 16, 2014](#) - the day before the downing of MH17. In this video segment, Ukrainian equipment at an undisclosed location “in the ATO zone” (referring to the territory of the Anti-Terrorist Operation) is shown, along with an interview with military officials. Many raised questions about this deployment of Buk anti-aircraft missile systems, especially considering the timing of the video and the downing of MH17.
