# MH17

## The Open Source Investigation Three Years Later

## Introduction

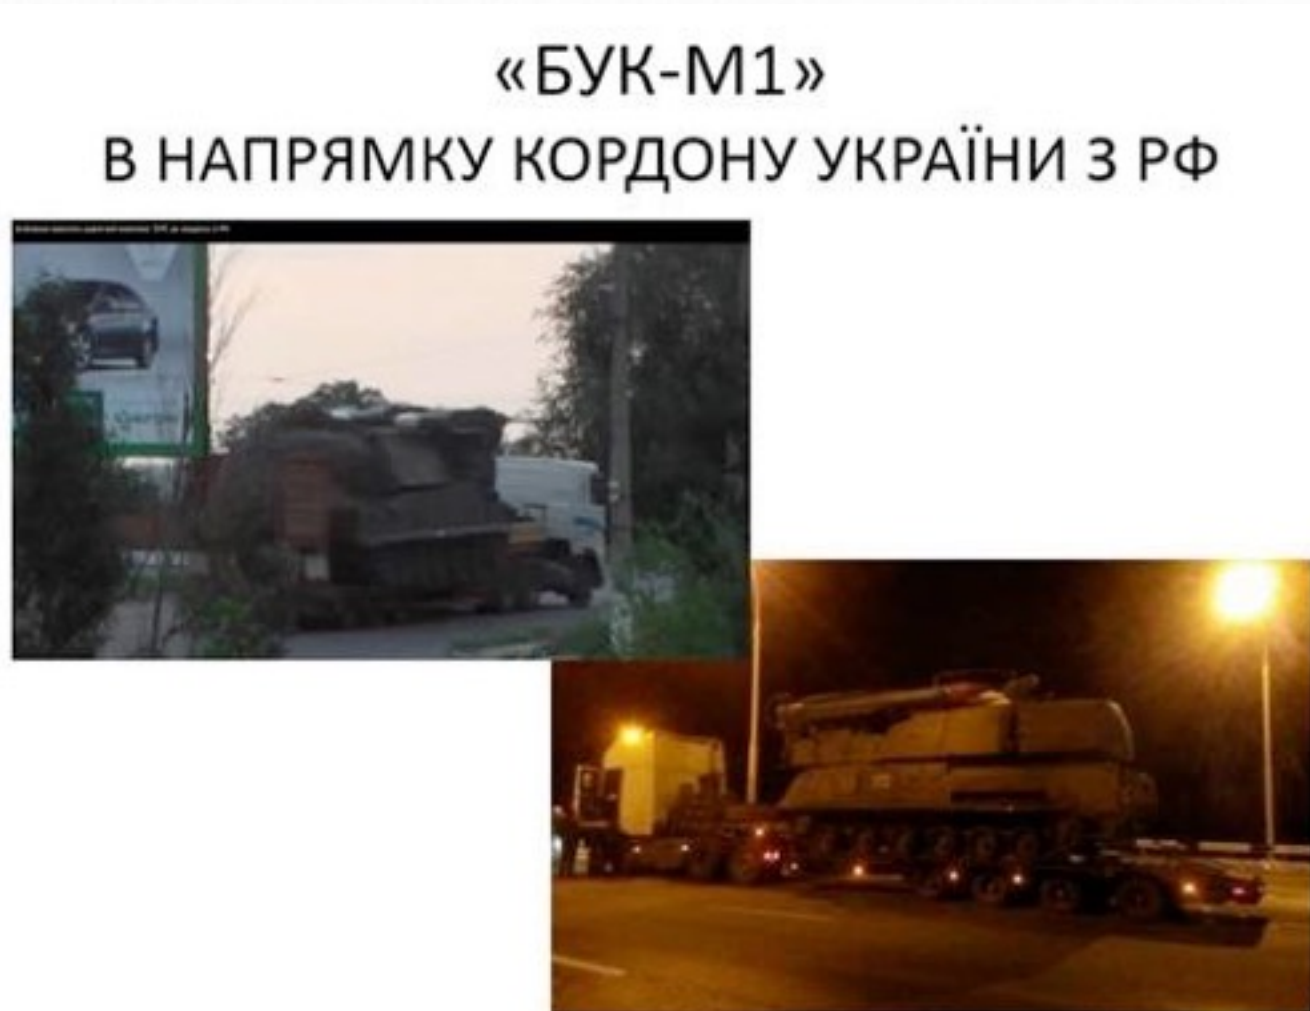
**Image shared by the SBU on July 19, 2014. On the top is Buk 332 in Luhansk on July 18, and on the bottom is Ukrainian Buk 312 on March 19, 2014 near Donetsk.**

These Buks are completely different and have little in common. The Ukrainian Buk 312 was filmed at the Yasinovatsky post, just north of Donetsk, Ukraine, on March 19, 2014. This video was filmed while the Ukrainian Armed Forces were evacuating their military equipment during growing unrest in the country's east. This Buk 312 was transported to the airfield in Kramatorsk, where it was later photographed and seen in satellite images. There is no evidence that Buk 312 was ever deployed anywhere near the frontline or in separatist-held territory at or near July 17, 2014.

One of the most common alternative theories about the downing of MH17 online is the claim that a Ukrainian Buk with the number 312 was responsible for the tragedy, and not Russian Buk 332 of the 53rd Anti-Aircraft Missile Brigade. Much of this idea is rooted in a mistake made by the SBU on July 19, 2014, showing both the Buk that downed MH17 in Luhansk, and a Buk numbered 312 being hauled by a similar-looking truck.

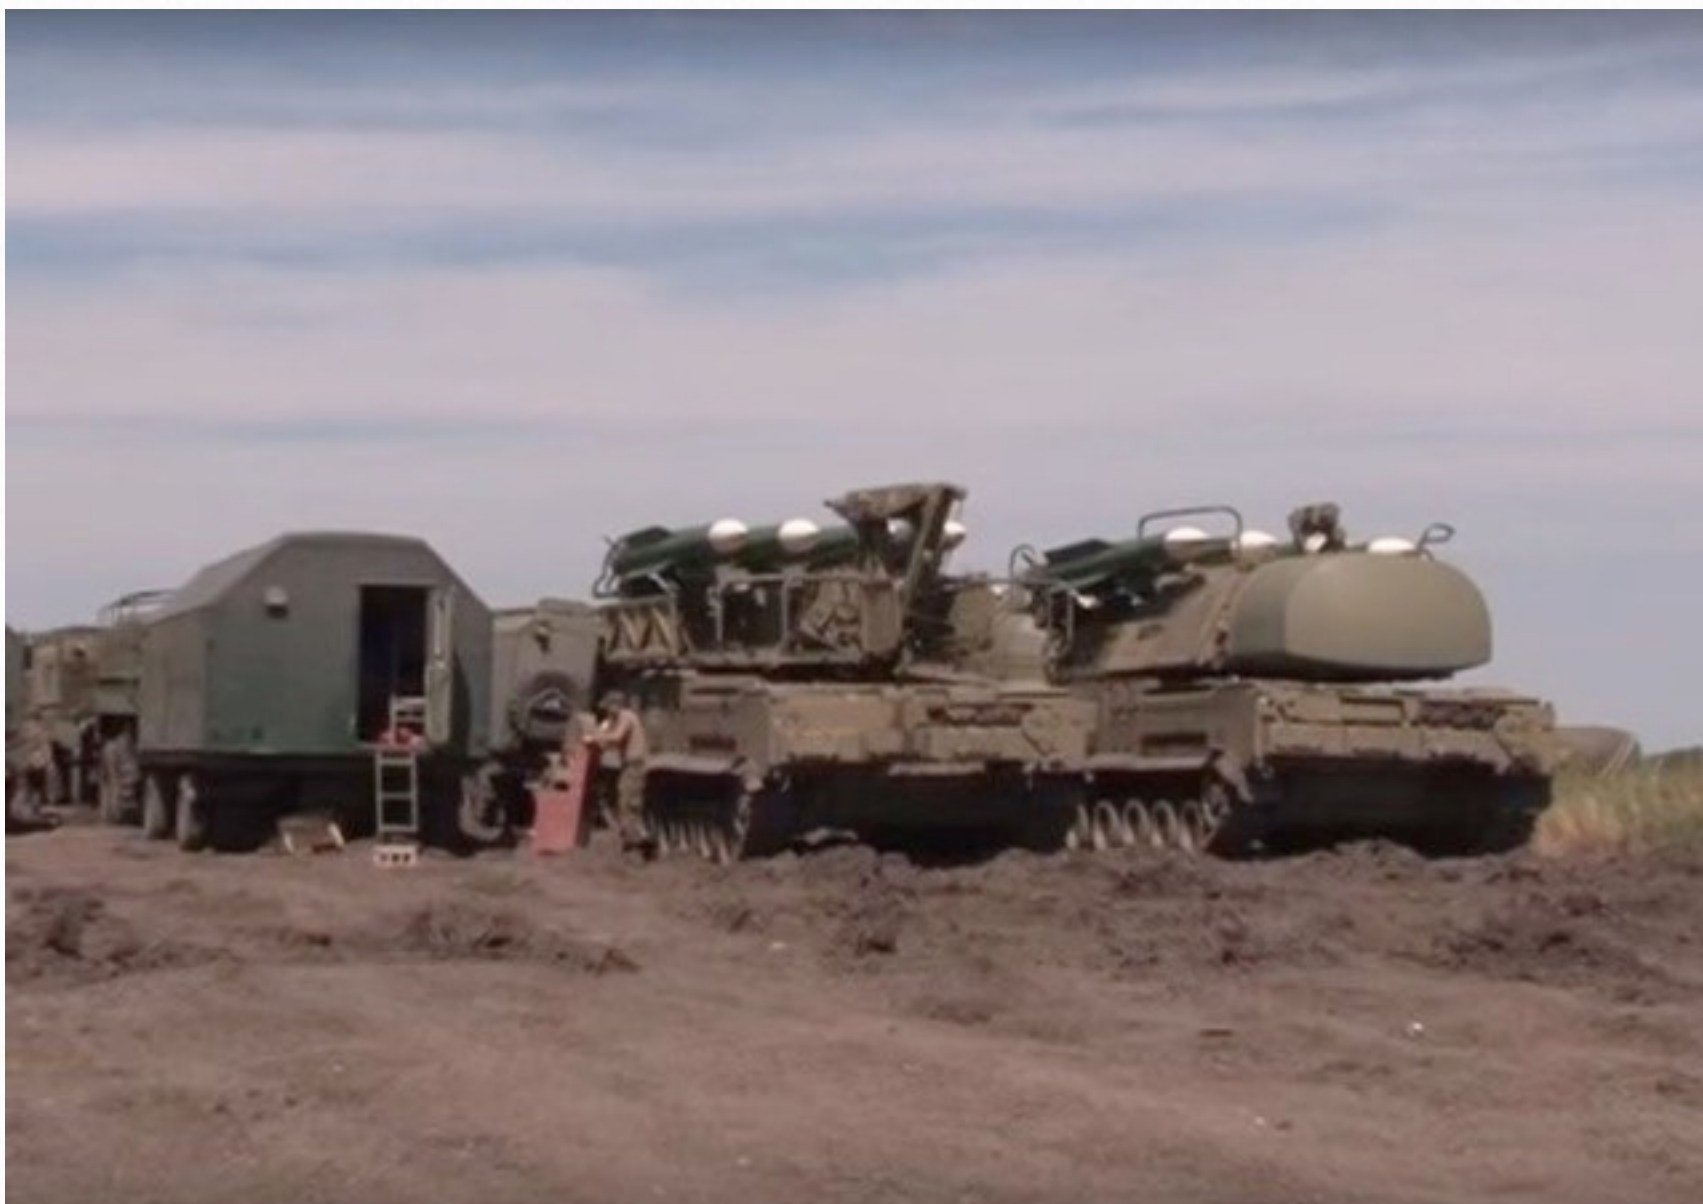
### **Buk systems in Dovhenke, Ukraine from Ukrainian Military TV footage**

In fact, this video was filmed at the “Luna” military camp at Dovhenke, about 130 kilometers northwest of the MH17 crash site. The location is technically in the Kharkiv Oblast, putting it quite a distance away from the frontline of the conflict. Therefore, there is no evidence that the Bucs in this television segment had anything to do with MH17, as there are no indications that they were deployed anywhere near the MH17 crash site or separatist-controlled territory.

Another Ukrainian Buk in question is the one filmed during [a segment aired by Ukrainian Military TV on July 16, 2014](#) - the day before the downing of MH17. In this video segment, Ukrainian equipment at an undisclosed location “in the ATO zone” (referring to the territory of the Anti-Terrorist Operation) is shown, along with an interview with military officials. Many raised questions about this deployment of Buk anti-aircraft missile systems, especially considering the timing of the video and the downing of MH17.

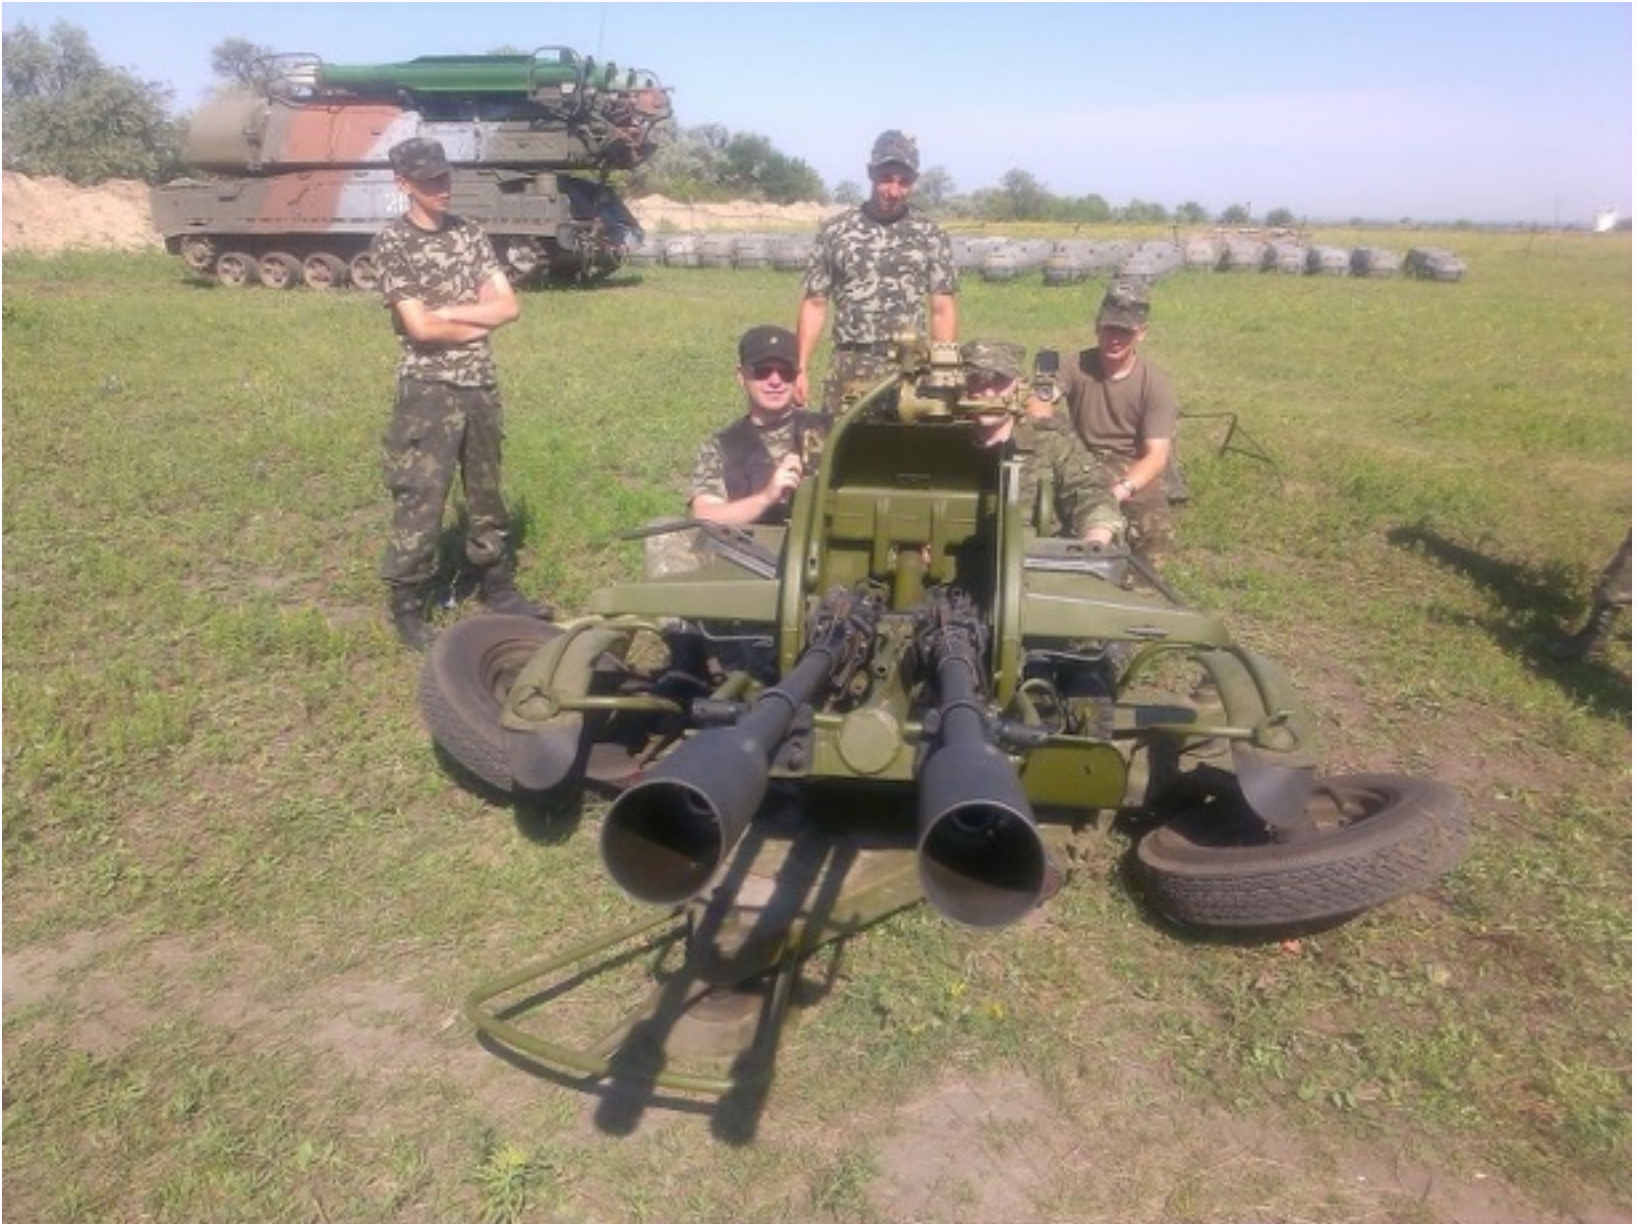
**Photograph of a Buk missile launcher uploaded by a Ukrainian chaplain on July 15, 2014**

A similar concern was raised about photographs shared on July 15, 2014 by a chaplain of the Ukrainian Armed Forces. He uploaded a handful of photographs that showed a Buk missile launcher in a field, with a geotag that indicated that he was near the frontline in the Donetsk Oblast. However, the photographs were eventually geolocated: they were actually taken at the Myrohorod military base in the Poltava Oblast, and the chaplain likely uploaded the pictures onto Vkontakte while he was near the frontlines, automatically adding a geotag for the location of the upload rather than where they were snapped.

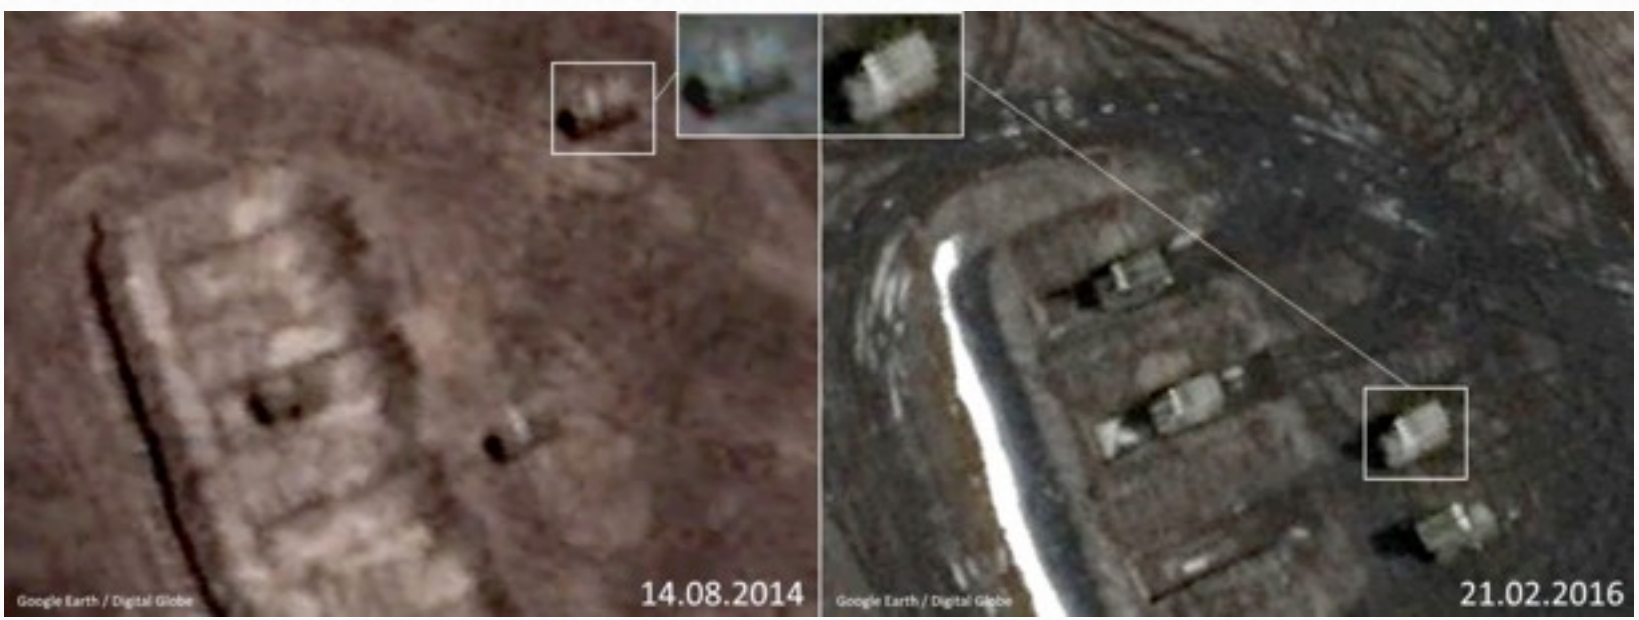
**Satellite images of Buk systems deployed at the Myhorod air base, including on August 2014**

Additionally, there are [numerous videos available](#) showing the transport of Buks from Ukraine's 223rd Anti-Aircraft Regiment and other military equipment to the Myrhorod base in April 2014.
